Eagle Eye Real Estate Inspection Services

Full General Home Inspection

Property address: **Your Home Town
USA**

Inspection date: **XX/XX/2014**

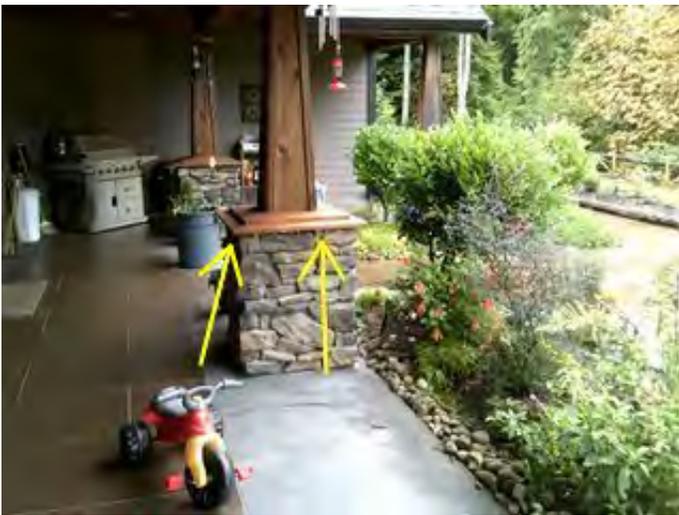
Photo 1-1

One or more hornet, bee or wasp nests were found at the building exterior. These can pose a safety hazard. A qualified person should remove nests or exterminate as necessary.

Bee nest under pedestal cap on rear porch.

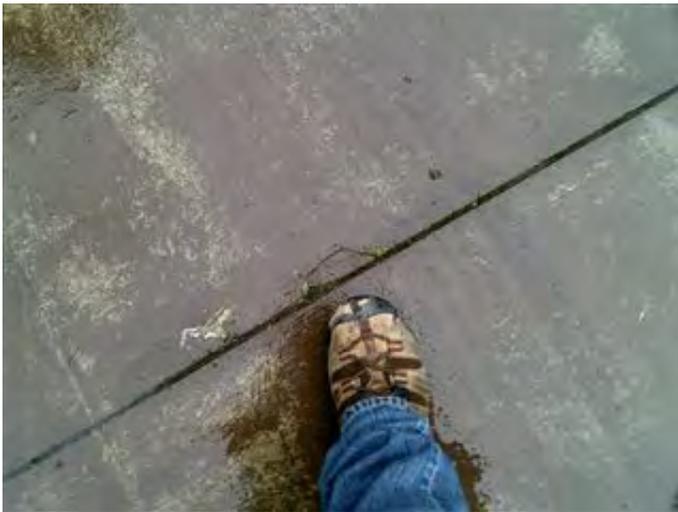
Minor deterioration (e.g. cracks, holes, settlement, heaving) was found in the driveway, but no trip hazards were found. The client may wish to have repairs made for cosmetic reasons.

Photo 4-1
Driveway.

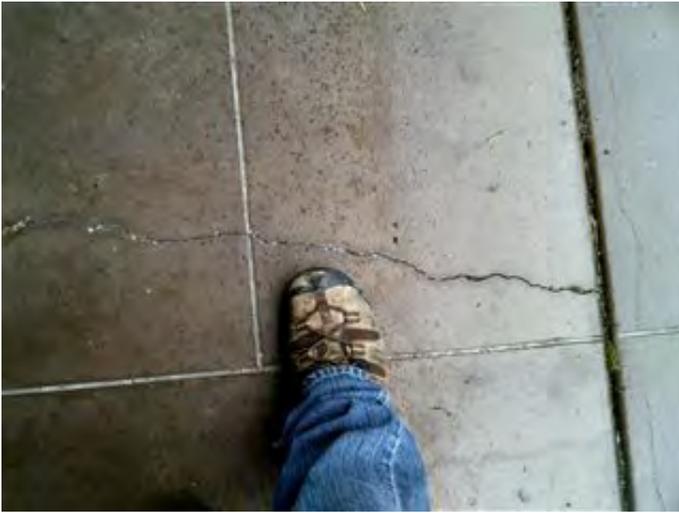
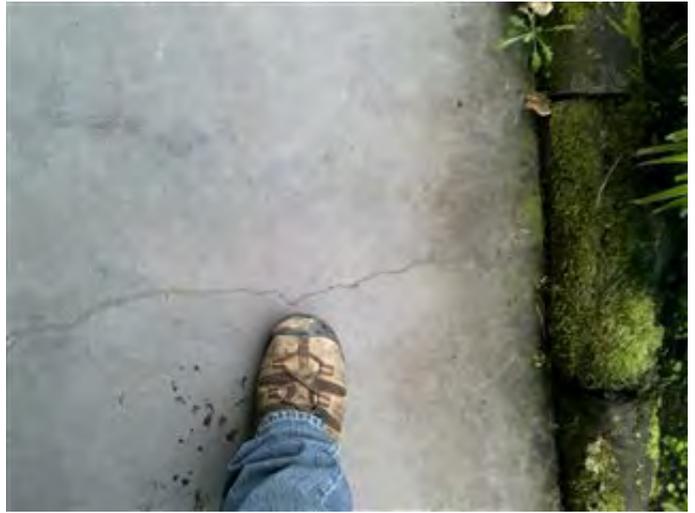
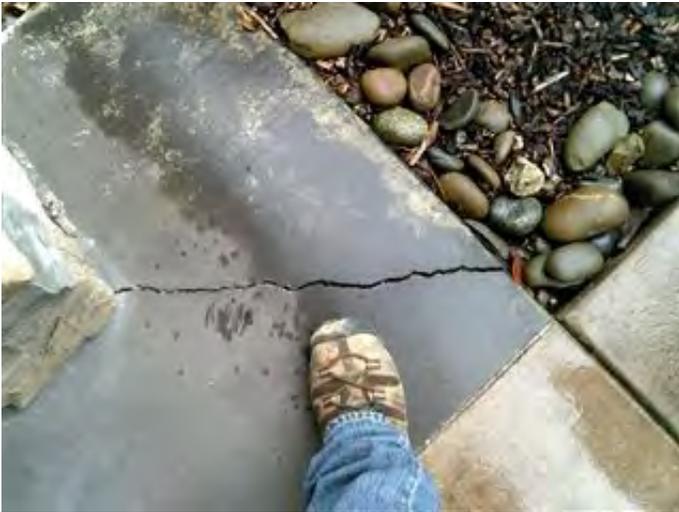
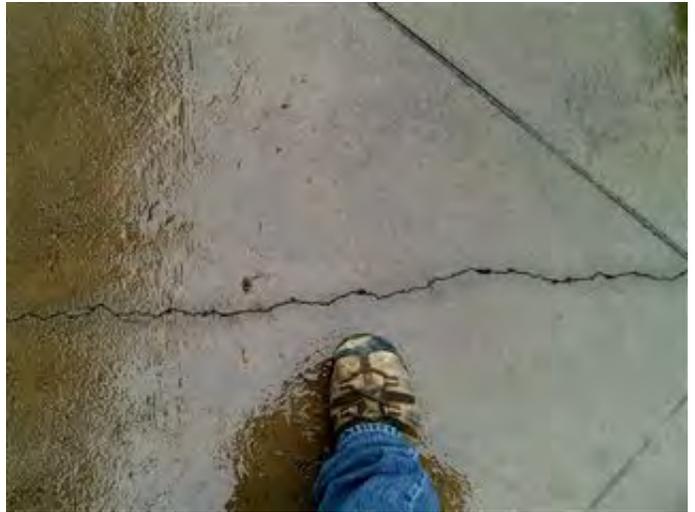
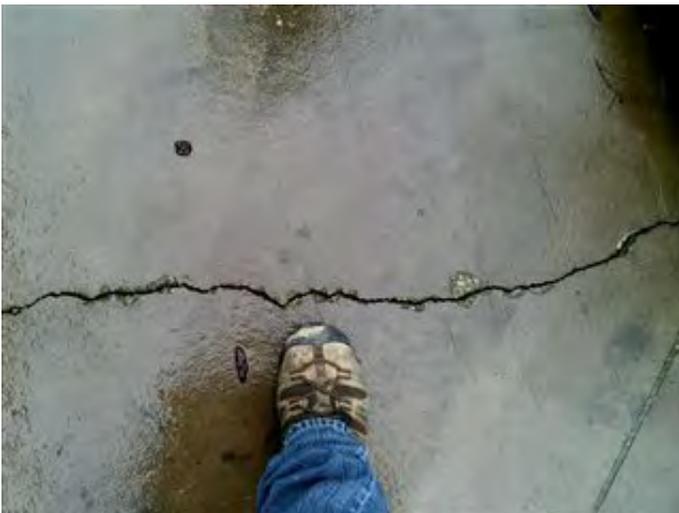
Minor deterioration (e.g. cracks, holes, settlement, heaving) was found in sidewalks or patios, but no trip hazards were found. The client may wish to have repairs made for cosmetic reasons.

Photo 5-1
Front porch.

Photo 5-2
Front porch.

Photo 5-3
Front porch.

Photo 5-4
South sidewalk.

Photo 5-5
Rear sidewalk.

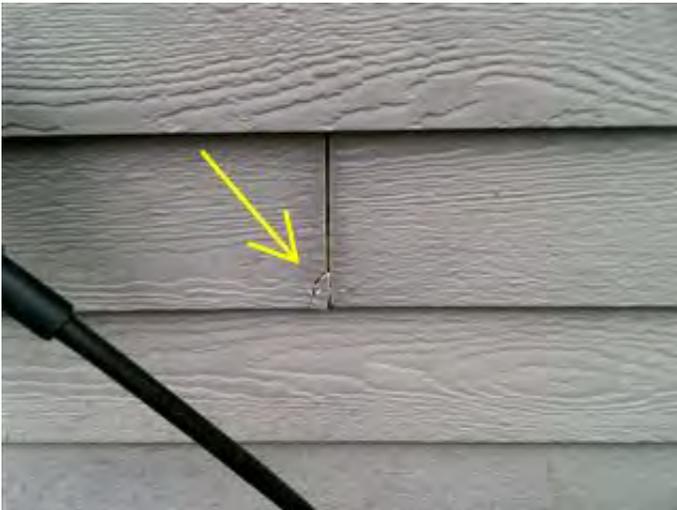
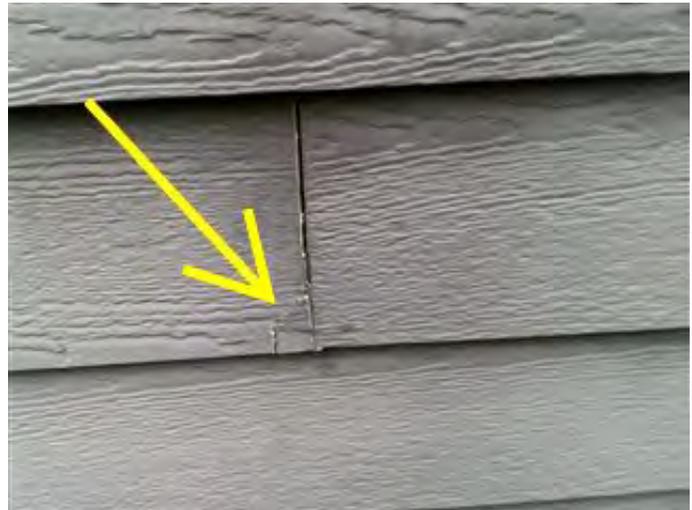
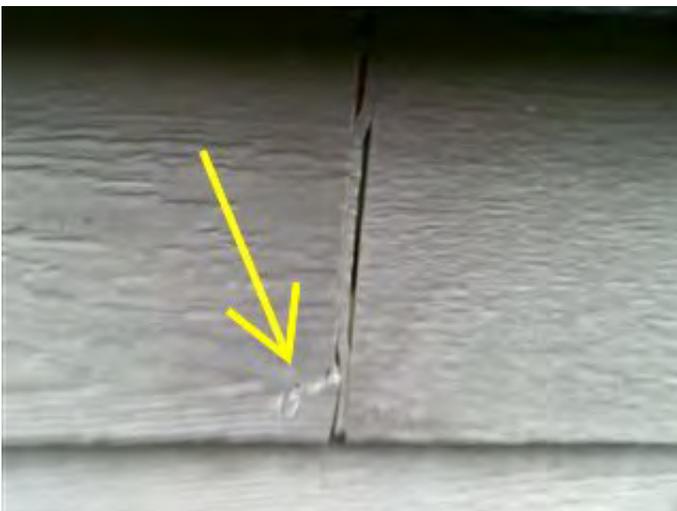
Some sections of siding and/or trim were damaged. Recommend that a qualified person repair, replace or install siding or trim as necessary.

Photo 6-1
Damaged siding at butt joint on south side.

Photo 6-2
Damaged siding at butt joint on south side.

Photo 6-3
Damaged siding at butt joint on south side.

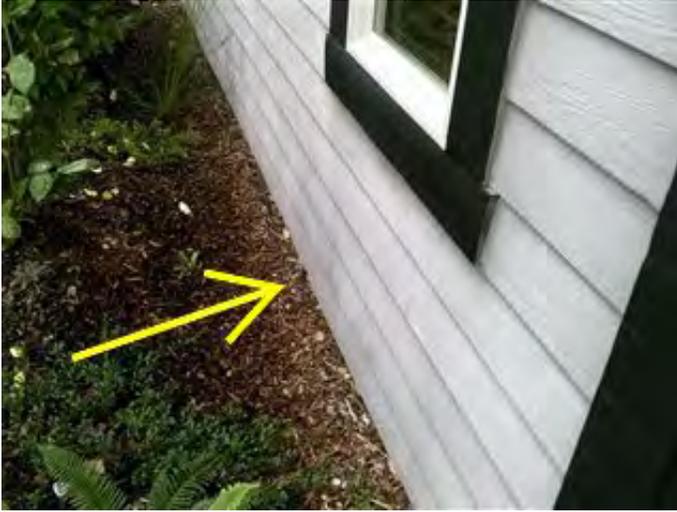
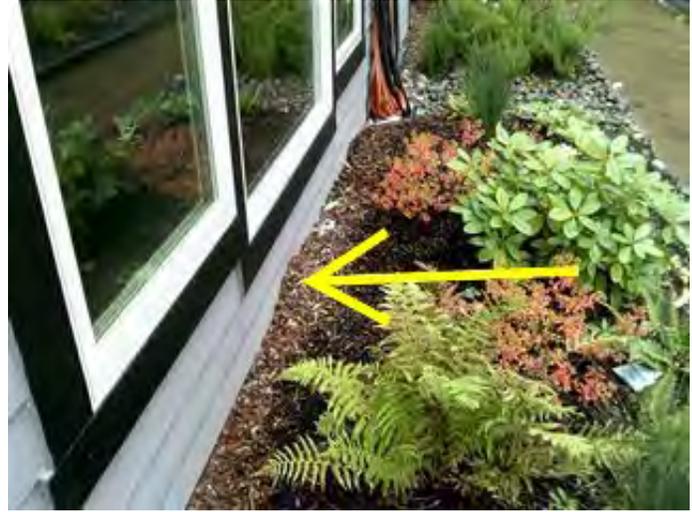
Soil was in contact with or less than 6 inches from siding or trim. Regardless of what material is used for siding, it should not be in contact with the soil. If made of wood, siding or trim will eventually rot. For other materials, ground or surface water can infiltrate siding or trim and cause damage to the wall structure. Wood-destroying insects are likely to infest and damage the wall structure. This is a conducive condition for wood-destroying organisms. Recommend grading or removing soil as necessary to maintain a 6-inch clearance. Note that damage from fungal rot and/or insects may be found when soil is removed, and repairs may be necessary.

Photo 7-1
Earth siding contact at SE corner.

Photo 7-2
Earth siding contact on east side under master bedroom windows.

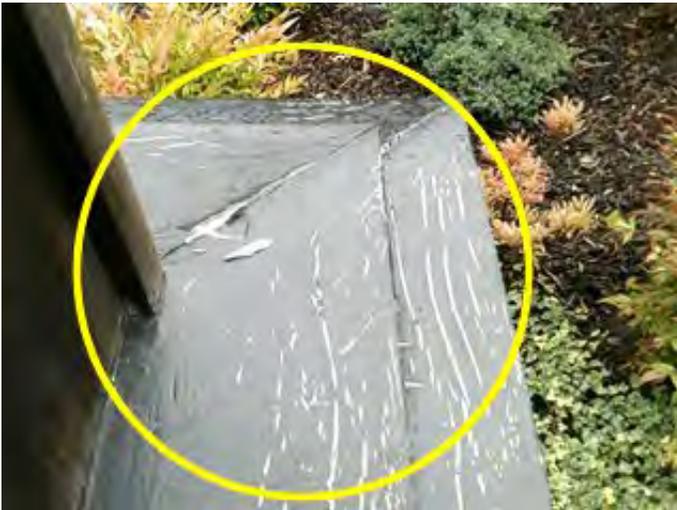
The paint or stain finish in some areas was failing (e.g. peeling, faded, worn, thinning). Siding and trim with a failing finish can be damaged by moisture. Recommend that a qualified contractor prep (e.g. clean, scrape, sand, prime, caulk) and repaint or restain the building exterior where necessary and per standard building practices. Any repairs needed to the siding or trim should be made prior to this.

Photo 8-1
Deteriorated paint on pedestal cap.

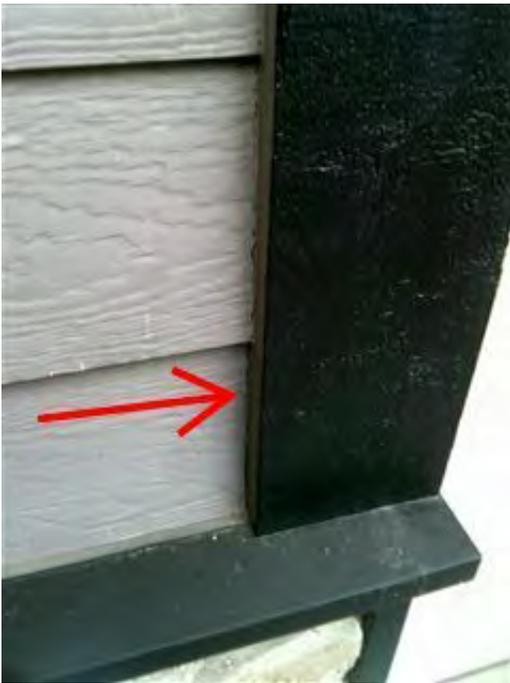
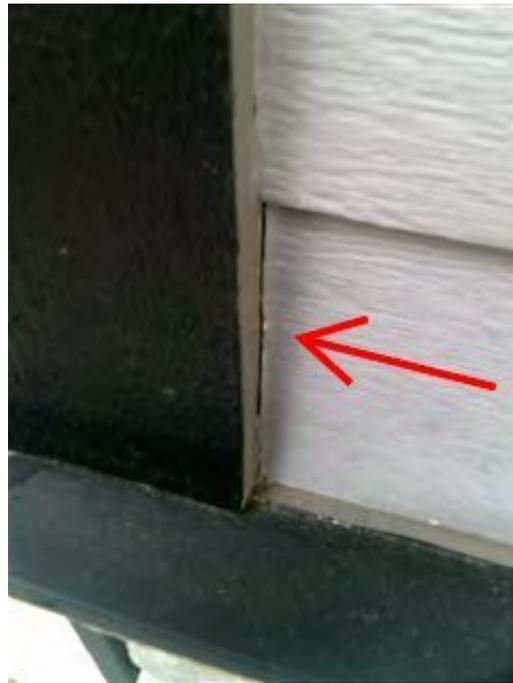
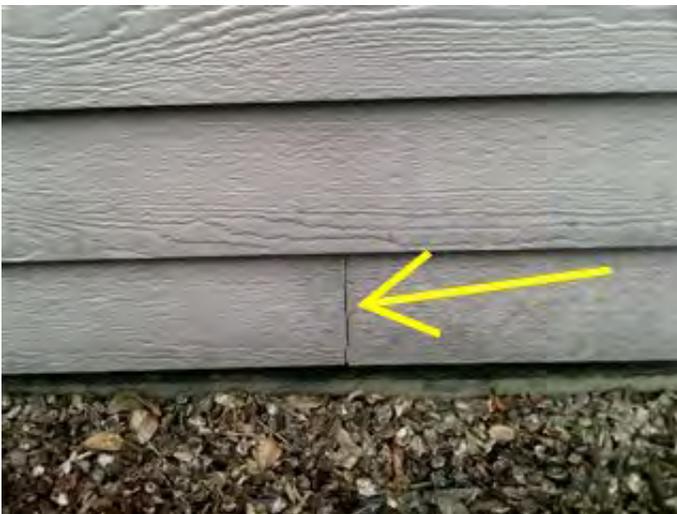
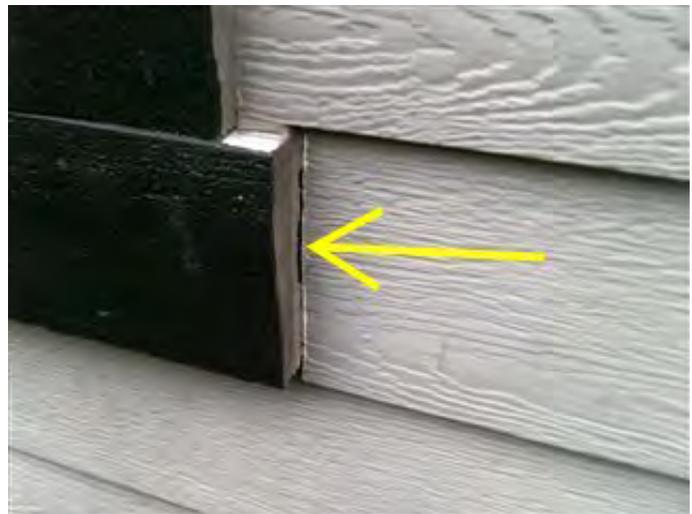
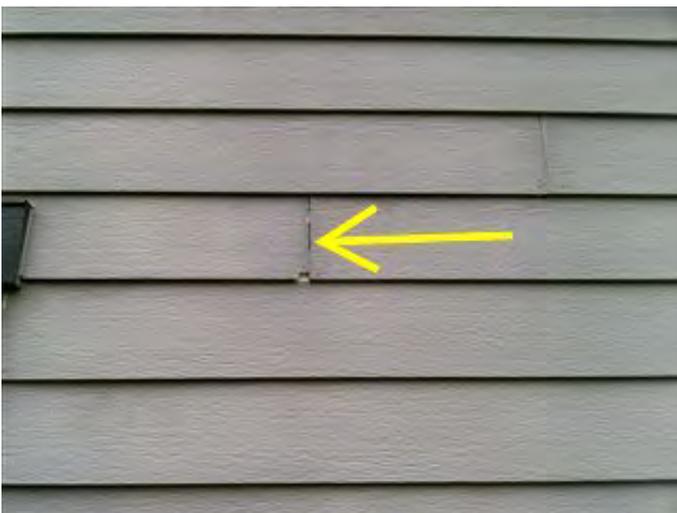
Caulk was deteriorated in some areas. For example, at siding butt joints, at siding-trim junctions and at wall penetrations. Recommend that a qualified person renew or install caulk as necessary. Where gaps are wider than 1/4 inch, an appropriate material other than caulk should be used. For more information, visit:

Photo 9-1
Deteriorated caulk at siding trim junction on garage.

Photo 9-2
Deteriorated caulk at siding trim junction on garage.

Photo 9-3
Deteriorated caulk at siding butt joint on south side.

Photo 9-4
Deteriorated caulk at siding trim joint on south side.

Photo 9-5
Deteriorated caulk at siding butt joint on south side.

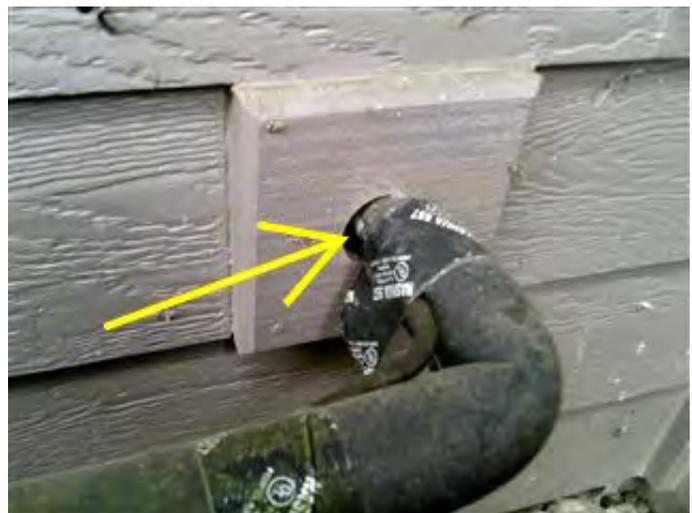
Photo 9-6
Gap around refrigerant lines on north wall.

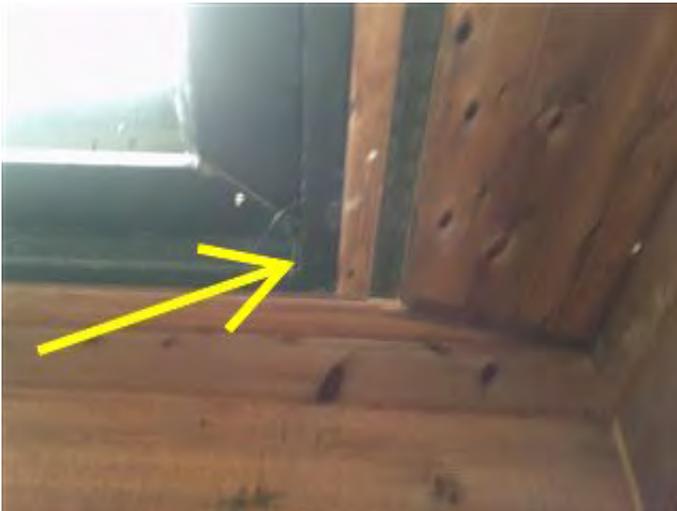
Water was leaking behind one or more gutters. Rainwater can come in contact with the building exterior or accumulate around the foundation as a result. The edge of the roof structure may become damaged by rot or water. This is a conducive condition for wood-destroying organisms. Recommend that a qualified person evaluate and repair as necessary. For example, by installing flashing or tightening loose gutters.

Photo 10-1
Gutter on rear porch leaking behind.

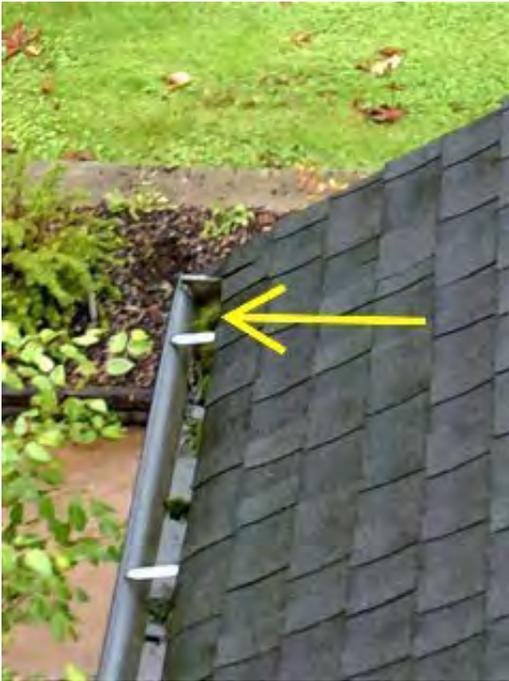
Significant amounts of debris have accumulated in one or more gutters or downspouts. Gutters can overflow and cause water to come in contact with the building exterior, or water can accumulate around the foundation. This is a conducive condition for wood-destroying organisms. Recommend cleaning gutters and downspouts now and as necessary in the future.

Photo 11-1
Debris in gutter at NE corner.

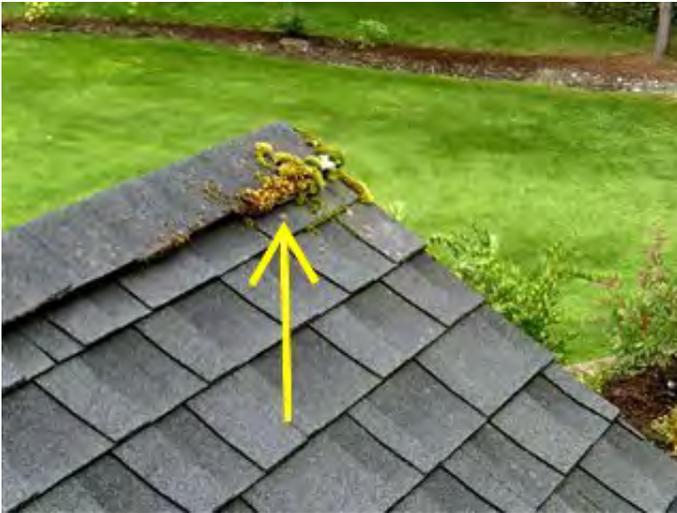
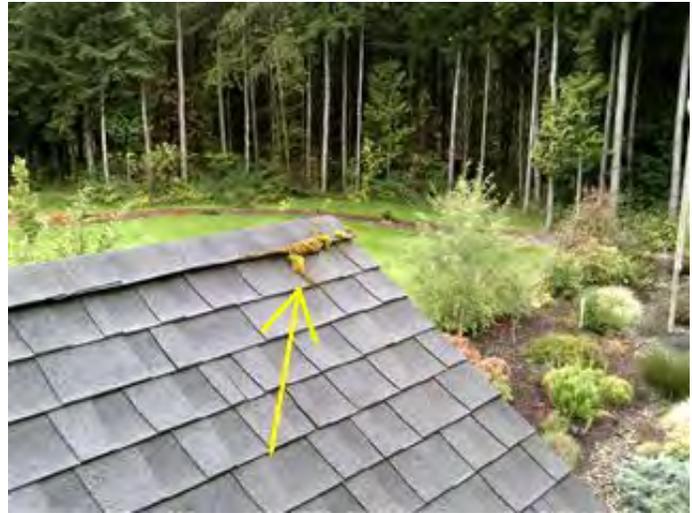
Moss was growing on the roof. As a result, shingles can lift or be damaged. Leaks can result and/or the roof surface can fail prematurely. Efforts should be made to kill the moss during its growing season (wet months). Typically, zinc or phosphate-based chemicals are used for this and must be applied periodically. For information on various moss treatment products and their pros and cons, visit:

Photo 12-1
Moss on dormer ridge.

Photo 12-2
Moss on dormer ridge.

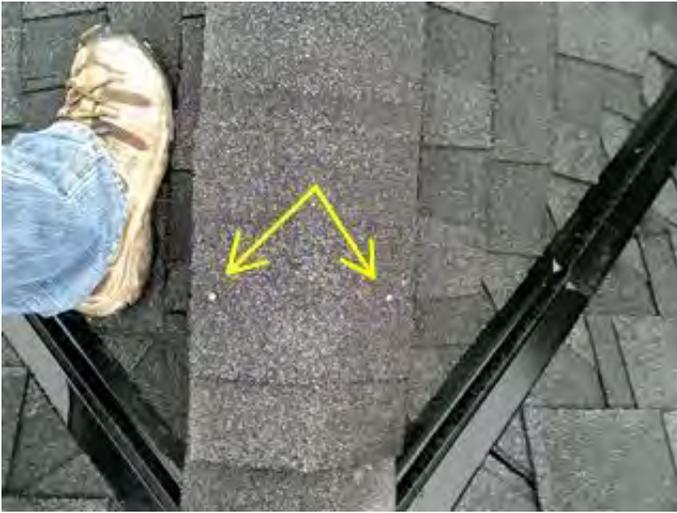
Nail heads were exposed at one or more shingles. More than just a few exposed nail heads may indicate a substandard roof installation. Recommend applying an approved sealant over exposed nail heads now and as necessary in the future to prevent leaks.

Photo 13-1
Exposed nails on ridge.

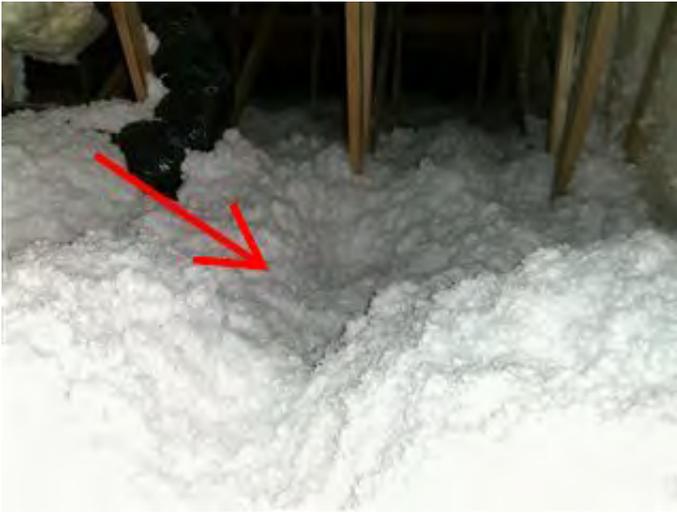
The ceiling insulation in one or more areas of the attic was compacted or uneven. Heating and cooling costs may be higher due to reduced energy efficiency. Recommend that a qualified person repair, replace or install insulation as necessary and per standard building practices (typically R-38).

Photo 14-1
Uneven insulation in attic #A.

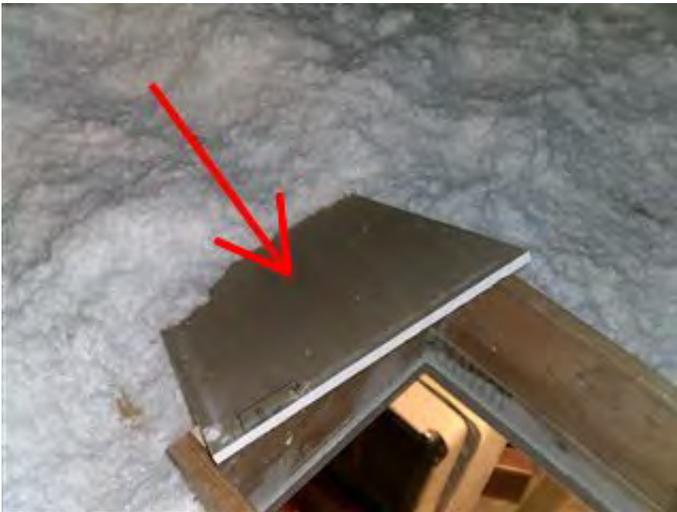
One or more attic access hatches or doors were not insulated, or had substandard insulation. Recommend installing insulation as necessary and per current standards at hatches or doors for better energy efficiency. For more information, visit:

Photo 15-1
Missing insulation on hatch #B.

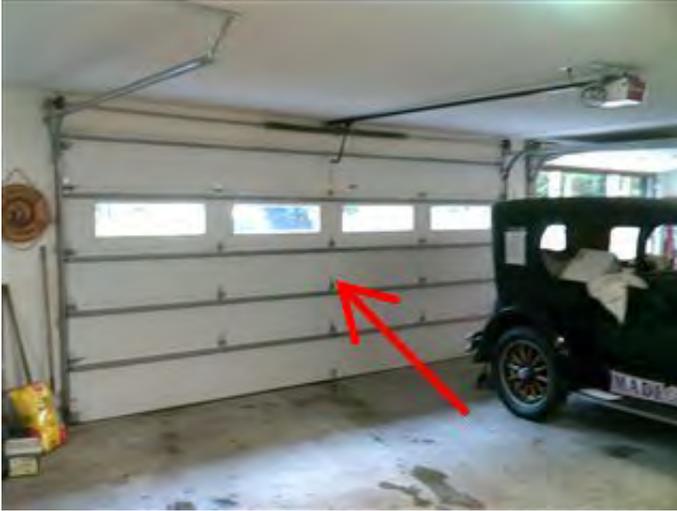
Photo 17-1

The auto-reverse mechanism on one or more automatic openers for garage vehicle doors was inoperable. This is a potential safety hazard. A qualified contractor should evaluate and repair as necessary. For more information on garage door safety issues, visit:

Auto-reverse was inoperable.

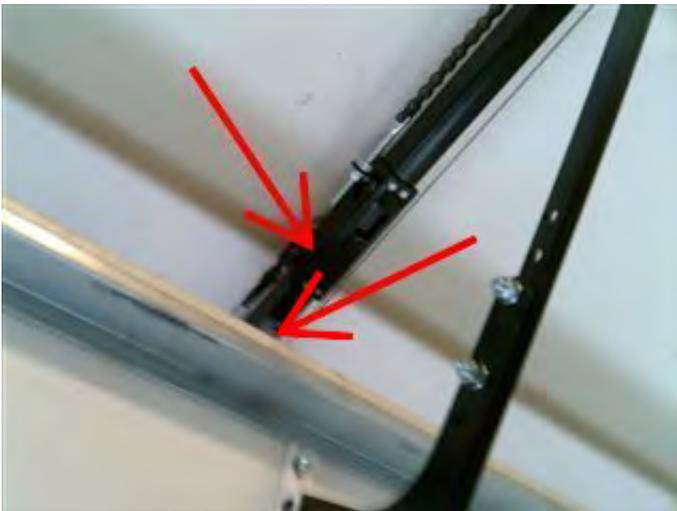
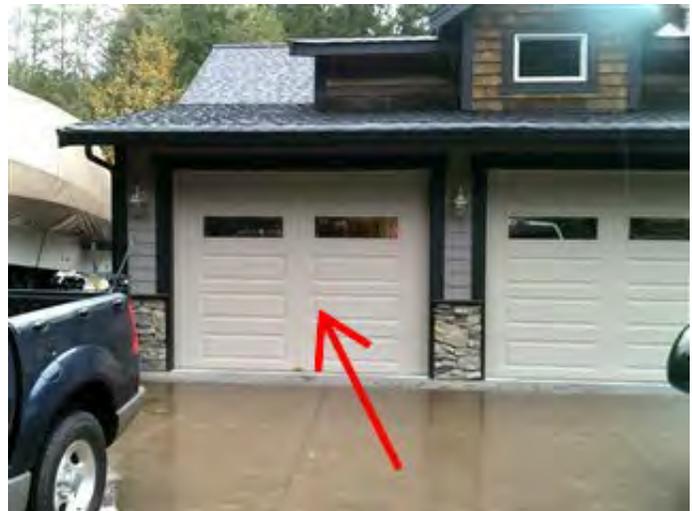
The north garage door would not open manually when released from the automatic opener. The door made contact with the traveling bracket on the opener. Recommend having a qualified contractor evaluate and make repairs as necessary.

Door would not open when disconnected from automatic opener.

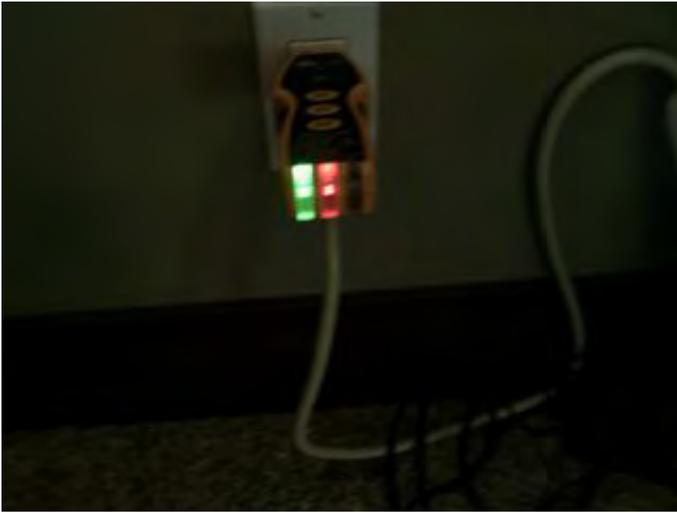
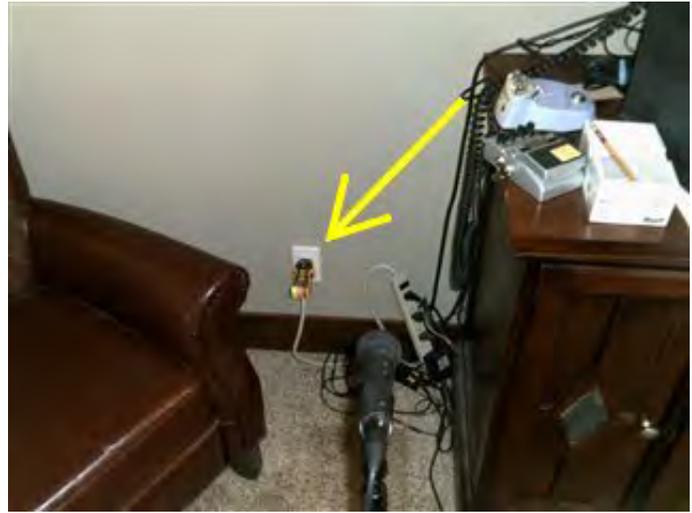
One or more modern, 3-slot electric receptacles (outlets) were found with an open ground. This is a shock hazard when appliances that require a ground are used with these receptacles. Examples of such appliances include computers and related hardware, refrigerators, freezers, portable air conditioners, clothes washers, aquarium pumps, and electrically operated gardening tools. Recommend that a qualified electrician repair as necessary so all receptacles are grounded per standard building practices.

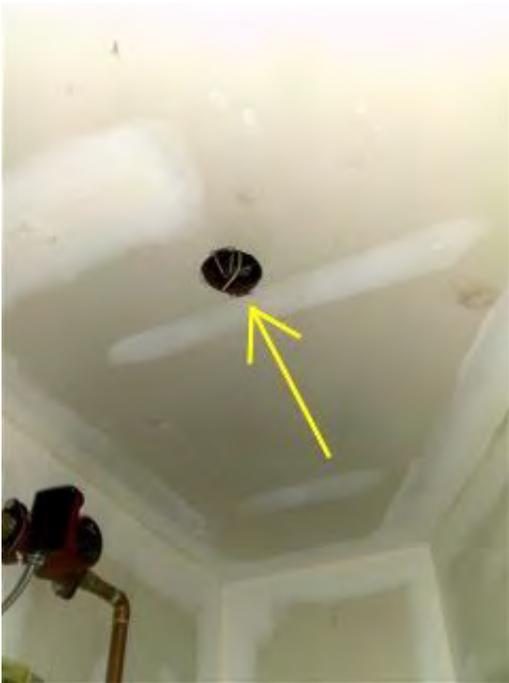
Photo 21-1
Mechanical room.

One or more cover plates for switches, receptacles (outlets) or junction boxes were missing or broken. These plates are intended to contain fire and prevent electric shock from occurring due to exposed wires. Recommend that a qualified person install cover plates where necessary.

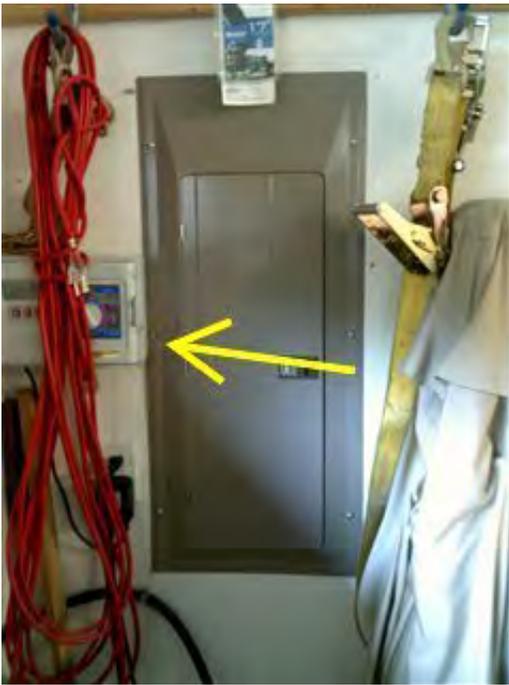
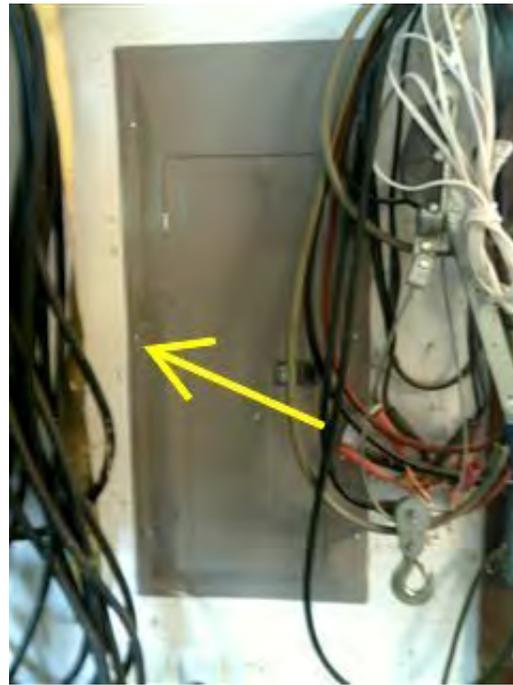
One or more screws that attach the cover or dead front to panel(s) #A and B were missing or not installed. Recommend installing screws where missing so the cover or dead front is secure. Only screws with blunt tips approved for this purpose should be installed, so wiring inside the panel is not damaged. Because energized wires may be located directly behind screw holes, the client should consider having a qualified electrician replace missing screws.

Photo 23-1
Panel #A (left).

Photo 23-2
Panel #B (right).

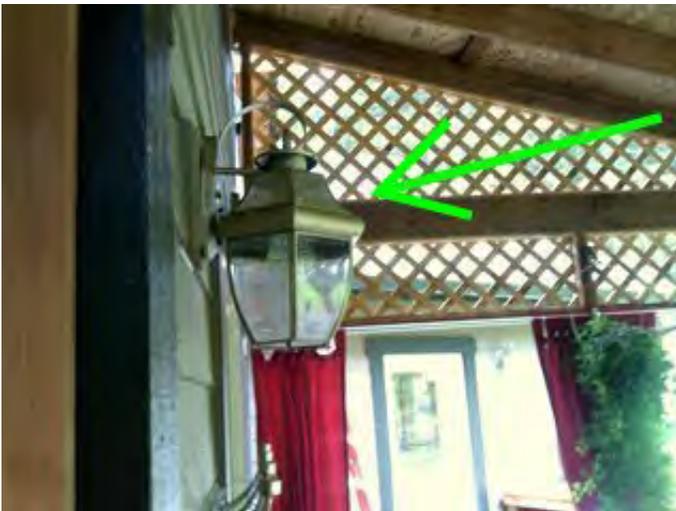
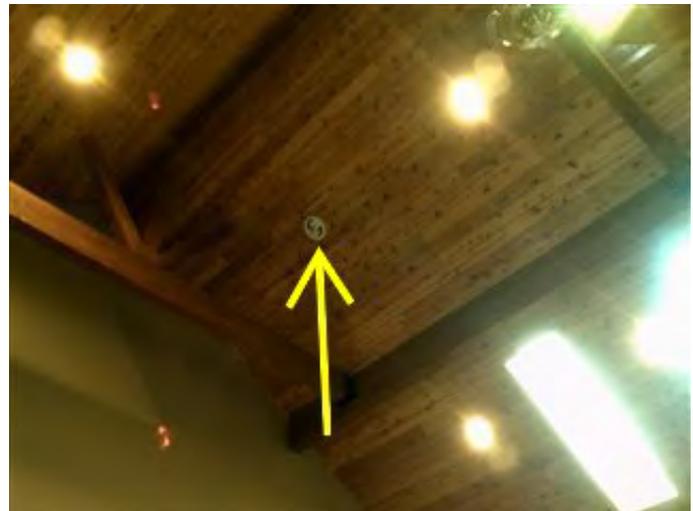
One or more light fixtures were inoperable (didn't turn on when nearby switches were operated). Recommend further evaluation by replacing bulbs and/or consulting with the property owner. If replacing bulbs doesn't work and/or no other switch(es) can be found, then recommend that a qualified electrician evaluate and repair or replace light fixtures as necessary.

Photo 24-1
North patio by hot tub.

Photo 24-2
Living room.

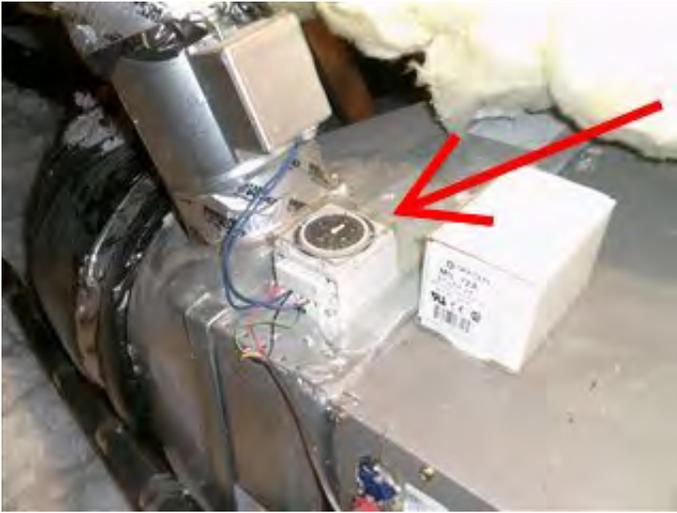
A 24 or 12 hour timer was installed in the air handler and served as a simple ventilation system. The timer can be configured to operate the fan automatically one or more times per day for a set length of time. These fans help reduce moisture and stale air inside the house. Guidelines vary for when and how long such fans should be configured to operate depending on the size of the house, number of occupants and rating of the fan. Recommend reviewing instructions or documentation for the timer and configuring the fan as necessary. The inspector notes these systems when present, but does not determine their adequacy, or if the timer is operable. For more information, visit:

Photo 32-1
24 hour timer on furnace.

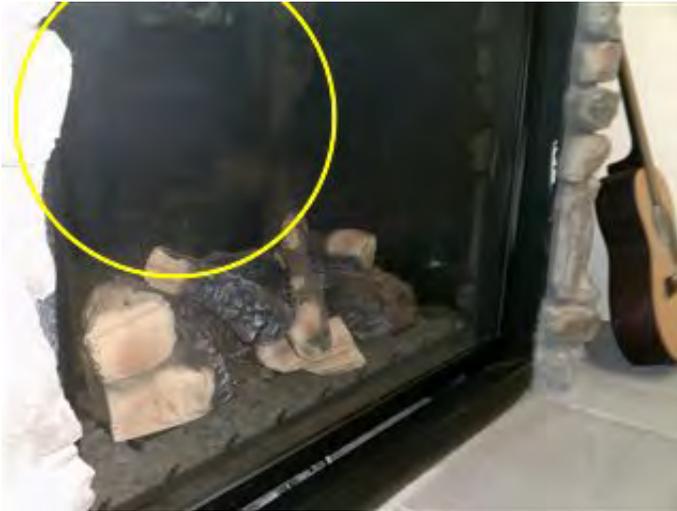
The glass front on the gas fireplace had a hazy film. This is typically a mineral residue left from water vapor as the gas burns. It may be possible to clean this fogging by removing the glass from the fireplace and using a gas appliance ceramic glass cleaner, available through gas fireplace and stove distributors and installers. Ammonia-based products, such as common glass cleaners, should not be used since they can cause damage or etching to the glass, or make the haze permanent. It may be possible for a homeowner to remove the glass for cleaning, if the instructions for the fireplace are available and if the homeowner is experienced in such repairs. Consult with a qualified specialist for more information, or to have them do the cleaning.

Photo 34-1
Fogging on living room fireplace.

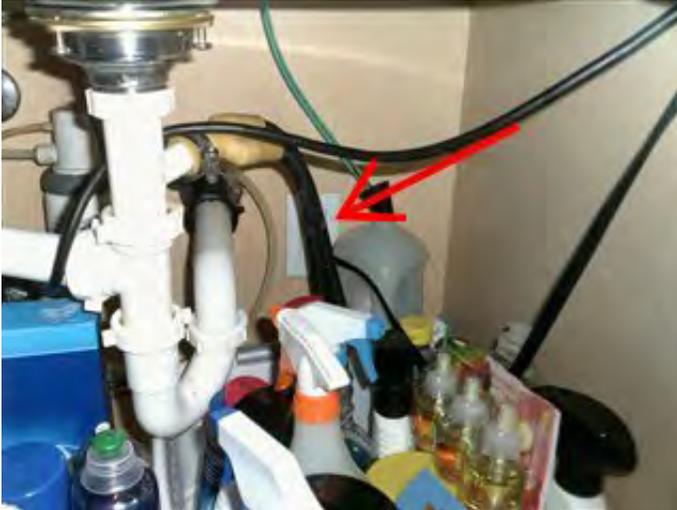
No high loop or air gap was visible for the dishwasher drain. A high loop is created by routing the drain line up to the bottom surface of the counter top above and securely fastening it to that surface. An air gap is a device that makes the drain line non-continuous. Both of these prevent waste-water backflow from entering the dishwasher, and possibly flooding out of the dishwasher if/when a siphon occurs. Some newer dishwashers have

these devices built in. The client should try to determine if these devices are built in to this brand and model of dishwasher (e.g. review installation instructions). If not, or if this cannot be determined, then recommend that a qualified contractor install a high loop and air gap per standard building practices.

Photo 35-1
No air gap or high loop on dishwasher drain lines.

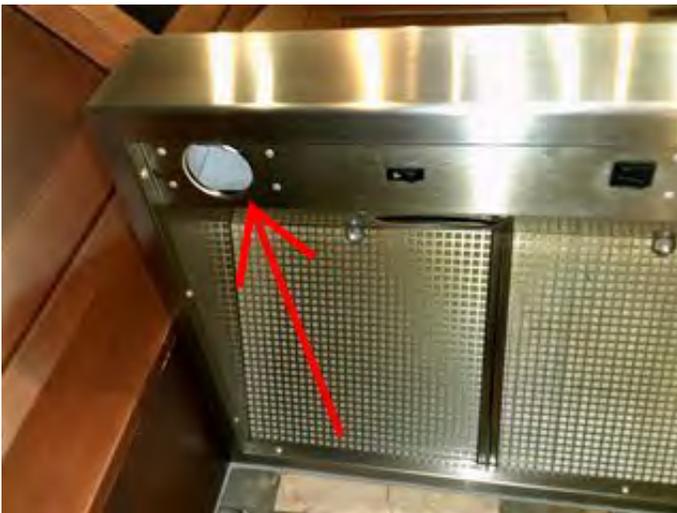
One or more light bulbs were missing in the range hood light fixture. The inspector was unable to determine if the light fixture was fully operable.

Photo 38-1
Missing bulb in cooktop hood.

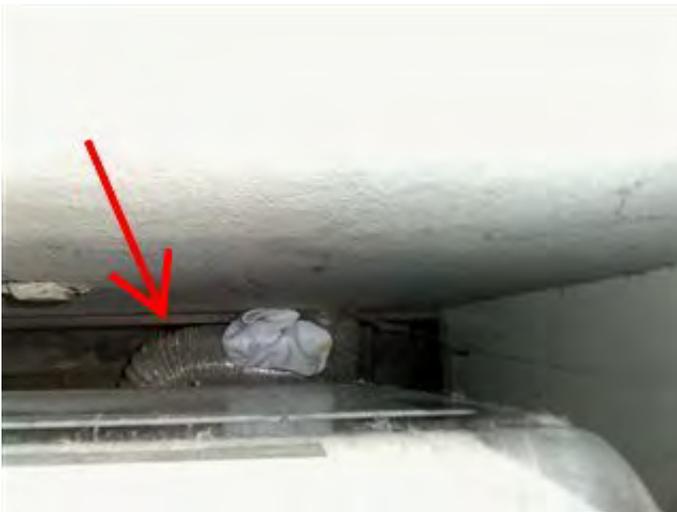
Photo 40-1

The clothes dryer was equipped with a vinyl or mylar, accordion-type, flexible exhaust duct. The U.S. Consumer Product Safety Commission considers these types of ducts to be unsafe, and a fire hazard. They can trap lint and are susceptible to kinks or crushing, which can greatly reduce the air flow and cause overheating. Recommend that such ducts be replaced with a rigid or corrugated semi-rigid metal duct, and by a qualified contractor if necessary. For more information, visit:

Mylar dryer duct.

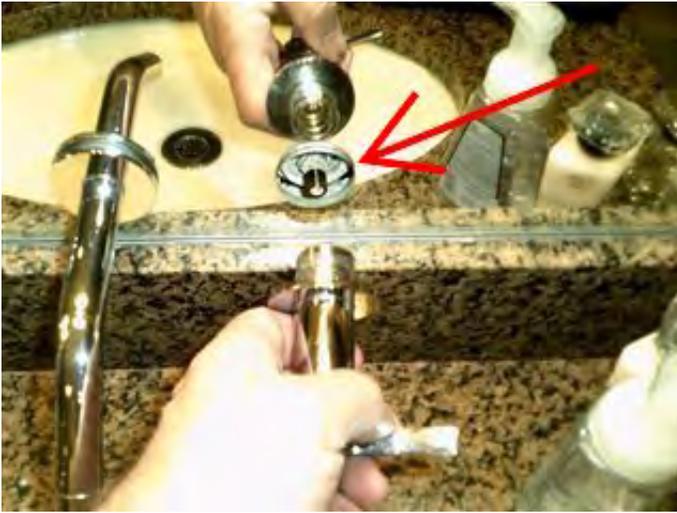
One or more sink faucet handles at location(s) #C were loose. Recommend that a qualified person repair or replace as necessary.

Photo 41-1
Master bathroom #C right sink.

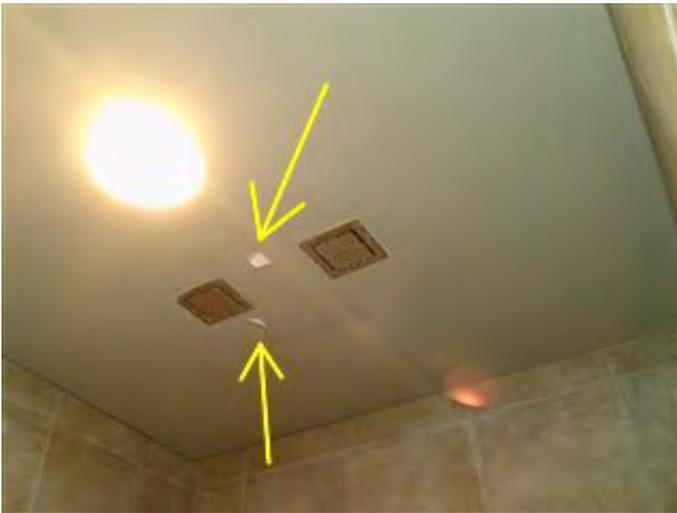
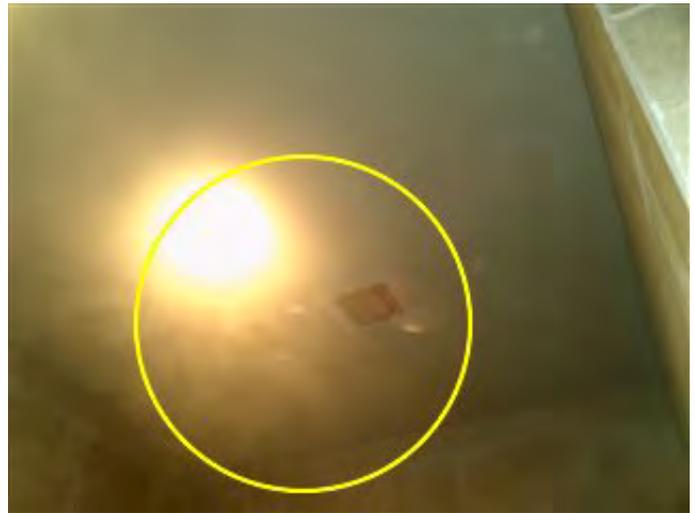
The Ceiling by the shower at location(s) #C was water-damaged. Recommend that a qualified person repair as necessary.

Photo 43-1
Damaged paint in shower #C ceiling.

Photo 43-2
Water sprayed on ceiling when shower was turned on in shower #C.

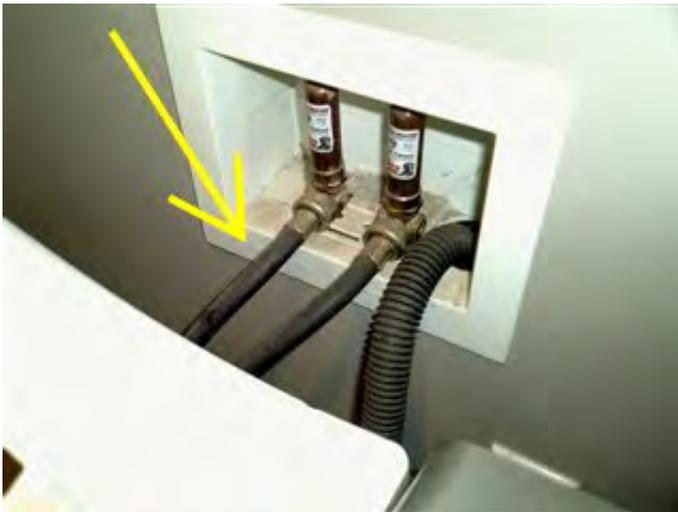
Rubber water supply hoses were installed at the clothes washer. These hoses are prone to bursting when deteriorated, which can result in flooding and significant water damage. Recommend upgrading to braided, stainless steel hoses.

Photo 44-1
Rubber washer supply hoses.

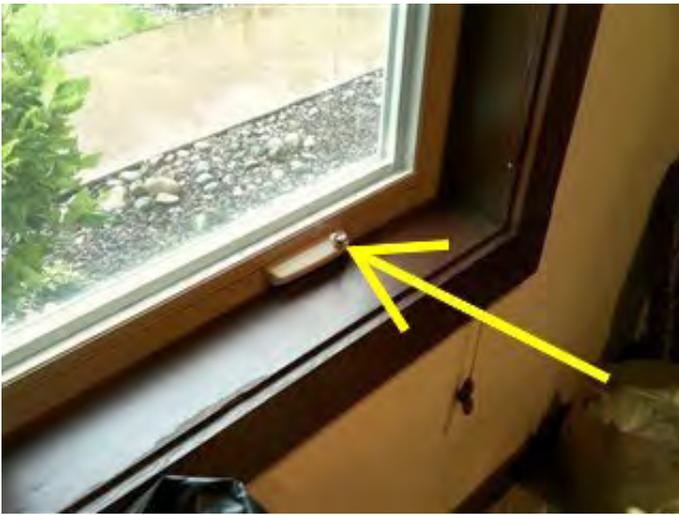
Crank handles at some windows were missing. Recommend that a qualified person replace handles or make repairs as necessary.

Photo 45-1
Missing window crank in SE bedroom.

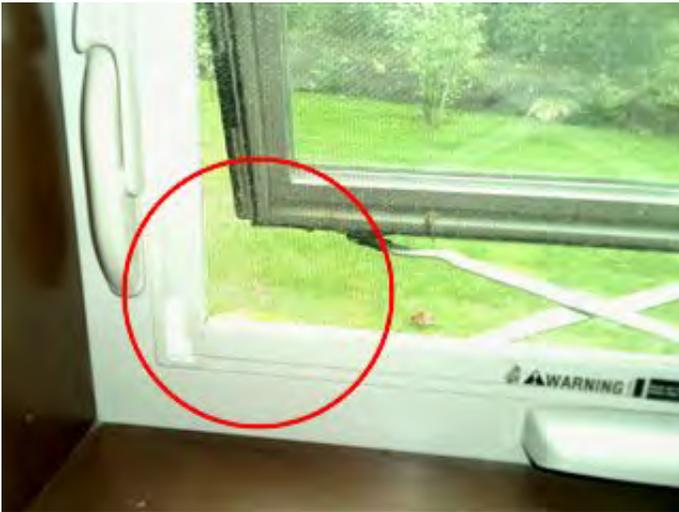
46) 🛠️ One or more window screens were damaged or deteriorated. These window(s) may not provide ventilation during months when insects are active. Recommend replacing window screens as necessary.

Photo 46-1
Damaged screen in bathroom #C toilet room.

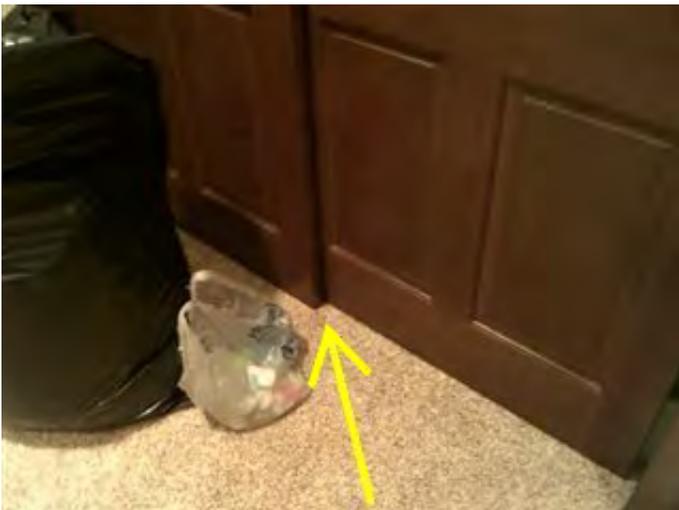
Photo 47-1

47) 🚪 Floor guides were missing at one or more sliding closet doors.

Missing floor guides in SE bedroom.
