## **Eagle Eye Real Estate Inspection Services**

# Full General Home Inspection

Property address: **Your Home Town  
USA**

Inspection date: **XX/XX/2014**

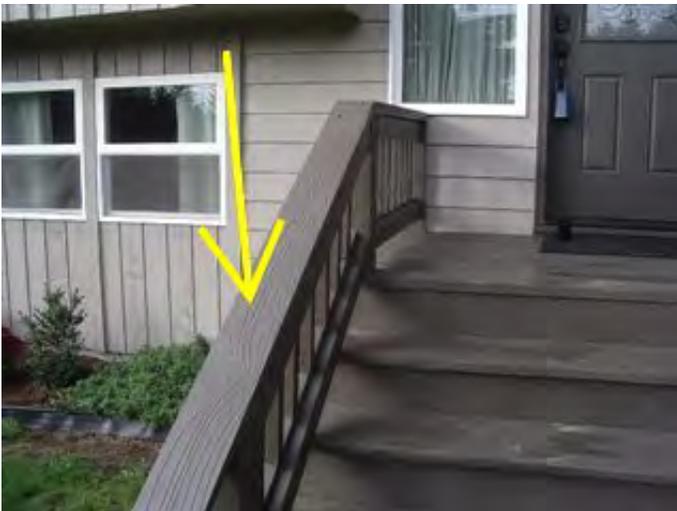
Photo 3-1

Handrails at one or more flights of stairs were not graspable and posed a fall hazard. Handrails should be 1 1/4 - 2 inches in diameter if round, or 2 5/8 inches or less in width if flat. Recommend that a qualified person install graspable handrails or modify existing handrails per standard building practices.

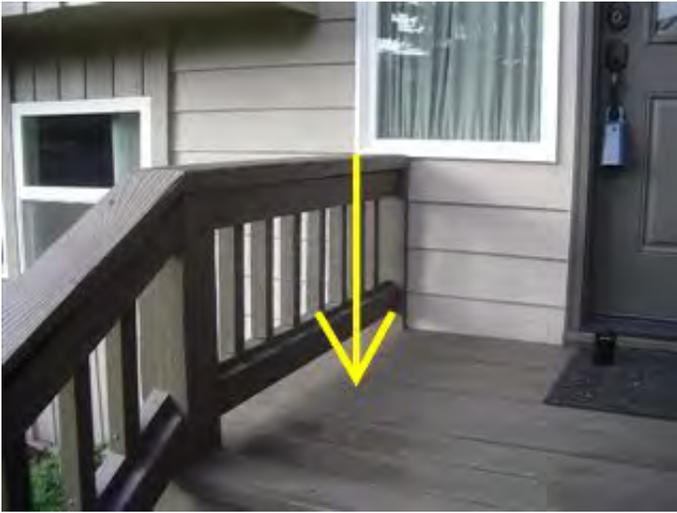
Guardrails at one or more locations with drop-offs higher than 30 inches were too low. This poses a fall hazard. Guardrails should be at least 36 inches in height. Recommend that a qualified contractor replace or repair guardrails per standard building practices.

Photo 4-1  
Entry railing too short.

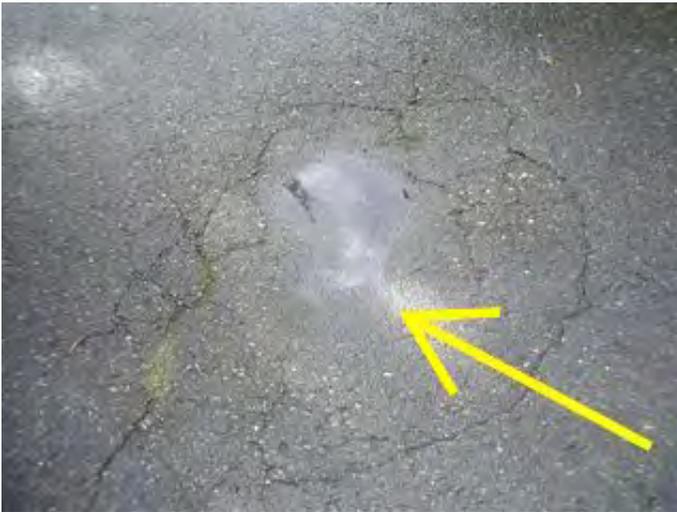
Cracks, holes, settlement, heaving and/or deterioration resulting in trip hazards were found in the driveway. For safety reasons, recommend that a qualified contractor repair as necessary.

Photo 5-1  
Driveway.

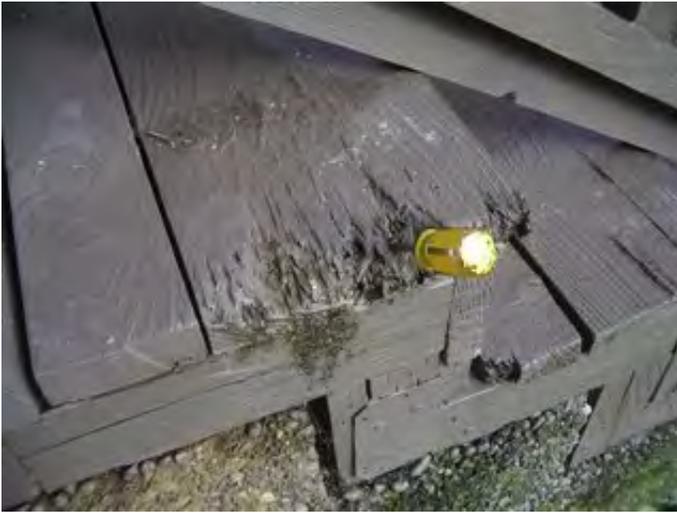
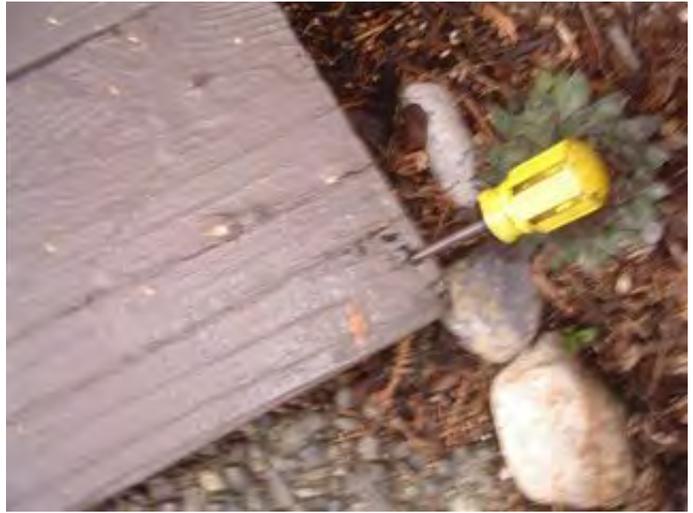
Fungal rot was found in treads at one or more sets of exterior stairs. Fungal rot in some stair components may pose a safety hazard. Recommend that a qualified person evaluate and repair as necessary. All rotten wood should be replaced.

Photo 6-1  
Rot in treads at entry.

Photo 6-2  
Entry steps.

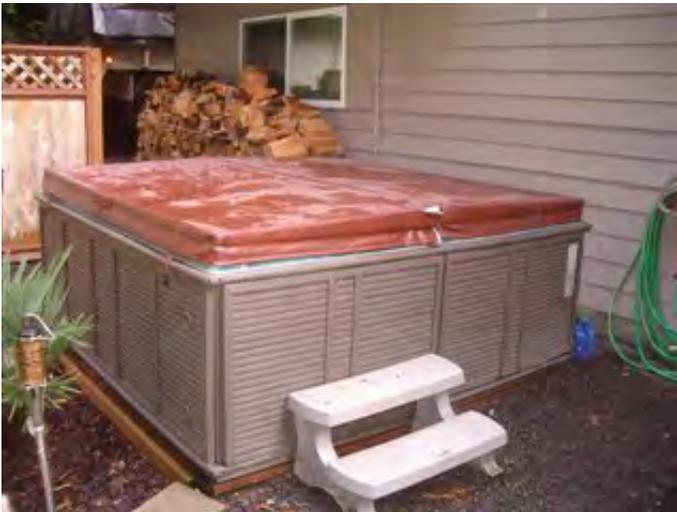
Photo 7-1

A hot tub was installed. Hot tubs, related equipment and supply hookups are specialty systems and are excluded from this inspection. Comments in this report related to this system are made as a courtesy only and are not meant to be a substitute for a full evaluation by a qualified specialist. Regular maintenance is required, and safety issues may exist. Recommend that a qualified specialist evaluate and, if needed, maintain or repair.

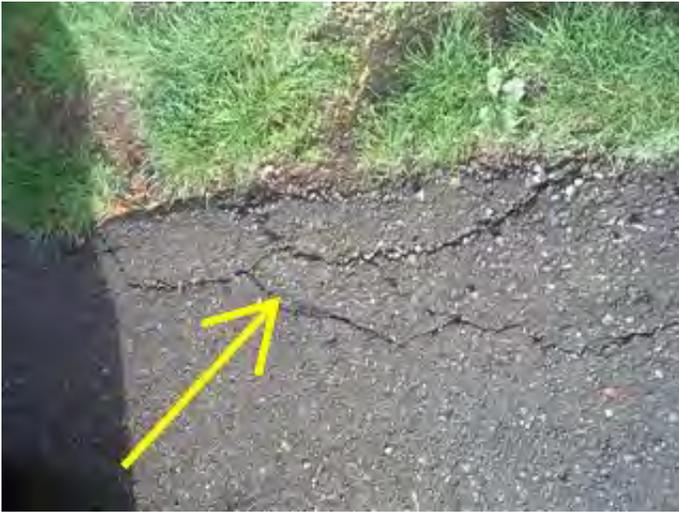
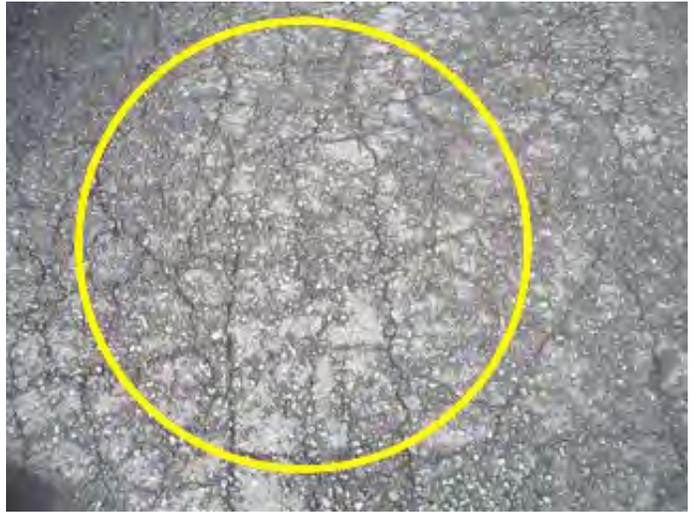
The asphalt driveway surface was worn and is prone to developing cracks from water penetration. Recommend that a qualified person reseal the driveway. For more information, visit: <http://www.reporhost.com/?RAD>

Photo 8-1  
Driveway.

Photo 8-2  
Driveway.

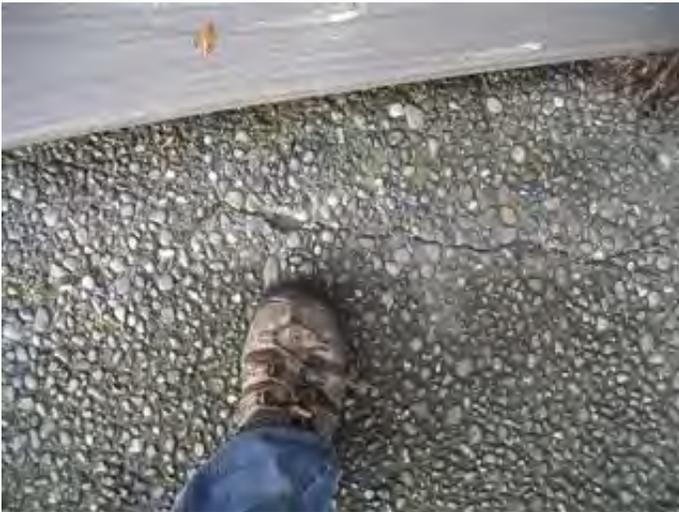
9) **i** Minor deterioration (e.g. cracks, holes, settlement, heaving) was found in sidewalks or patios, but no trip hazards were found. The client may wish to have repairs made for cosmetic reasons.

Photo 9-1  
Entry sidewalk.

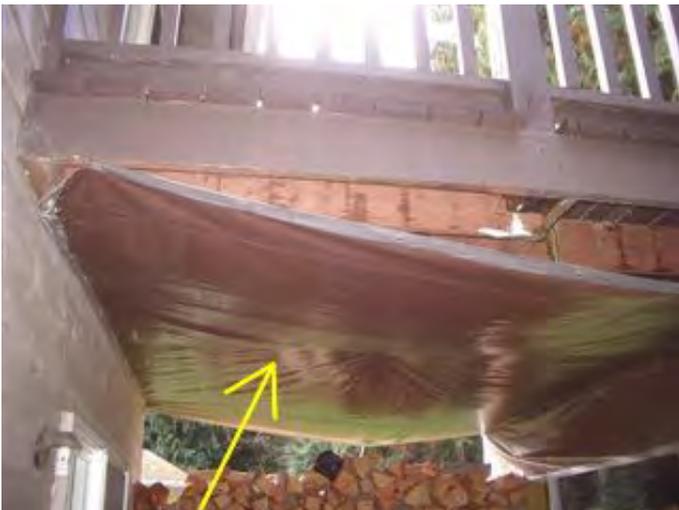
Photo 10-1

10) **i** The rear deck sub-structure was obscured by tarps and couldn't be fully evaluated.

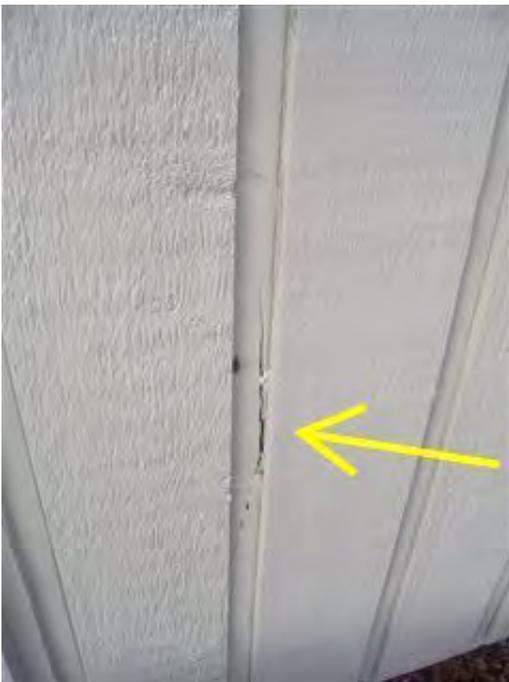
Photo 11-1

Some sections of siding and/or trim were split. Recommend that a qualified person repair, replace or install siding or trim as necessary.

Split siding on north wall.

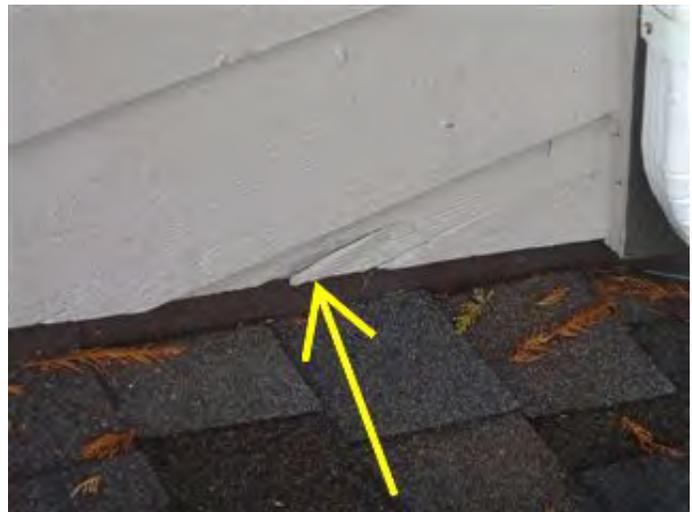
Photo 11-2

Damaged siding on upper roof over garage.

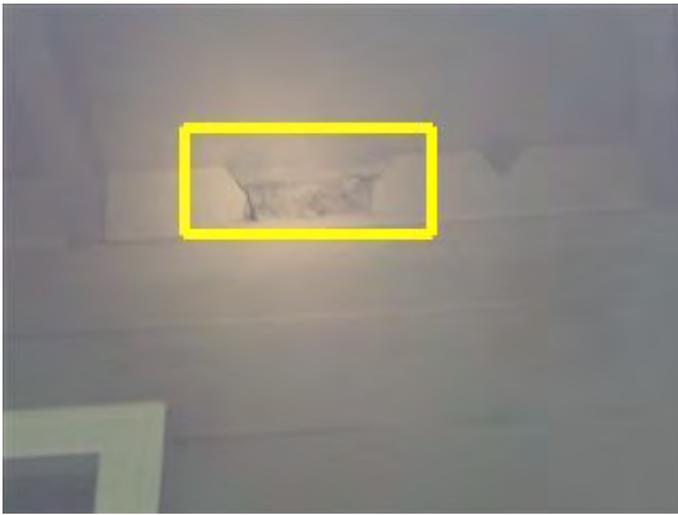
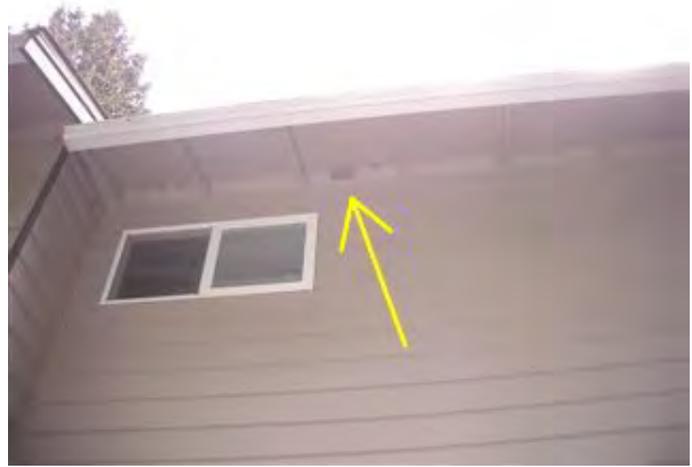
One or more holes or gaps were found in siding or trim. Vermin, insects or water may enter the structure. Recommend that a qualified person repair as necessary.

Photo 12-1  
Damaged bird block on south side.

Photo 12-2  
Damaged bird block on south side.

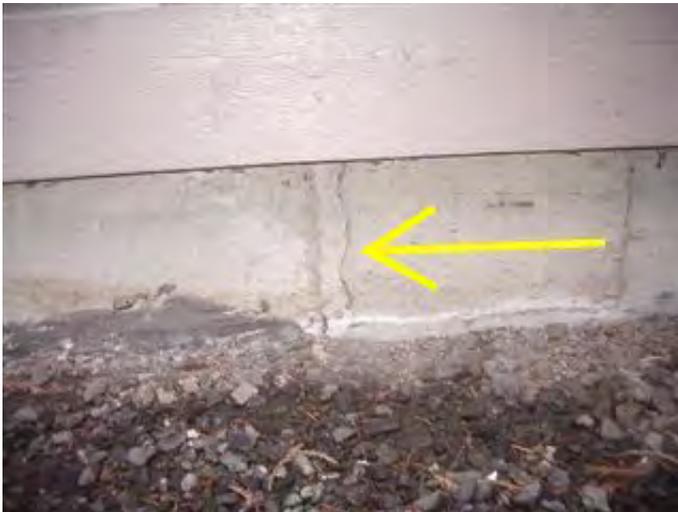
One or more minor cracks (1/8 inch or less) were found in the foundation. These didn't appear to be a structural concern, but recommend sealing them to prevent water infiltration and monitor them in the future. Numerous products exist to seal such cracks including hydraulic cement, non-shrinking grout, resilient caulks and epoxy sealants.

Photo 13-1  
Minor crack in foundation on north side.

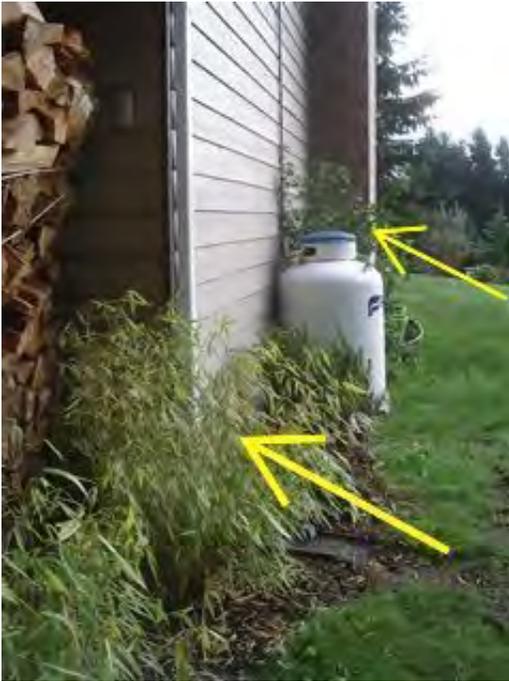
Vegetation such as trees, shrubs and/or vines was in contact with or close to the building exterior. Vegetation can serve as a pathway for wood-destroying insects and can retain moisture against the exterior after it rains. This is a conducive condition for wood-destroying organisms. Recommend pruning, moving or removing vegetation as necessary to maintain at least 6 inches of space between it and the building exterior. A 1-foot clearance is better.

Photo 14-1  
Vegetation on east side of house.

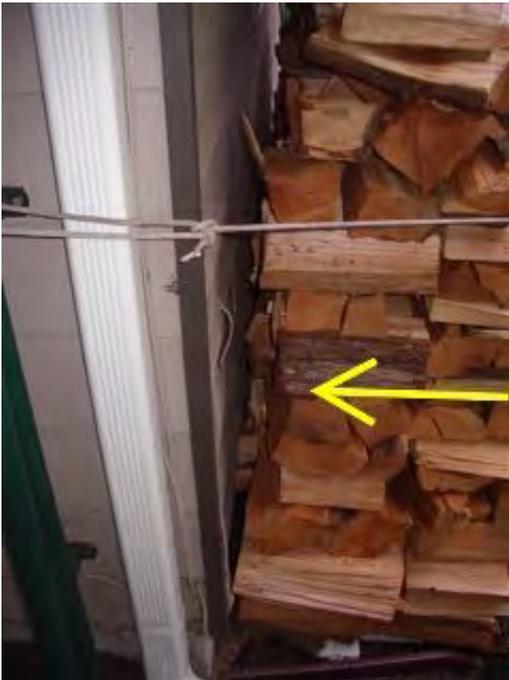
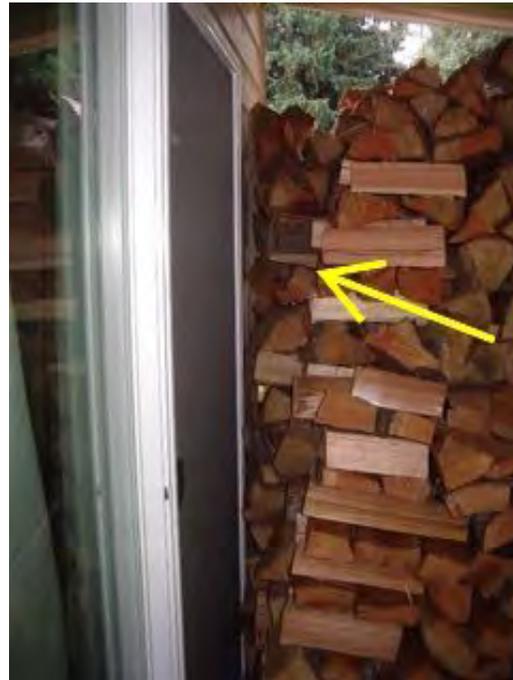
16) **i** Firewood was stored so that it was in contact with or close to the building exterior. This is a conducive condition for wood-destroying organisms. Recommend storing firewood outdoors in an open area, and as far away from buildings as practical to keep insects away from buildings. For more information visit: <http://www.reporthost.com/?FWWDI>

Photo 16-1  
Firewood stacked next to house at SW corner.

Photo 16-2  
Firewood stacked next to house at SE corner.

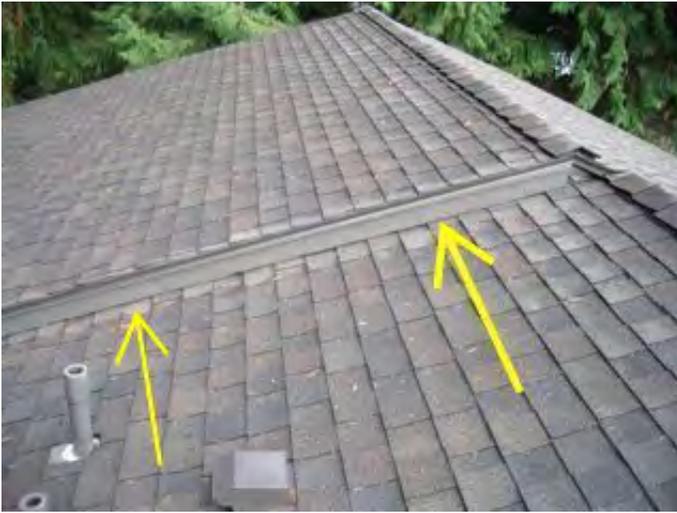
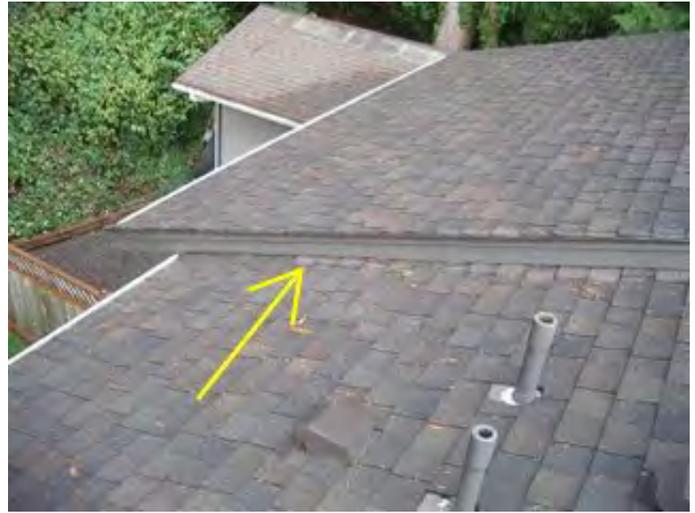
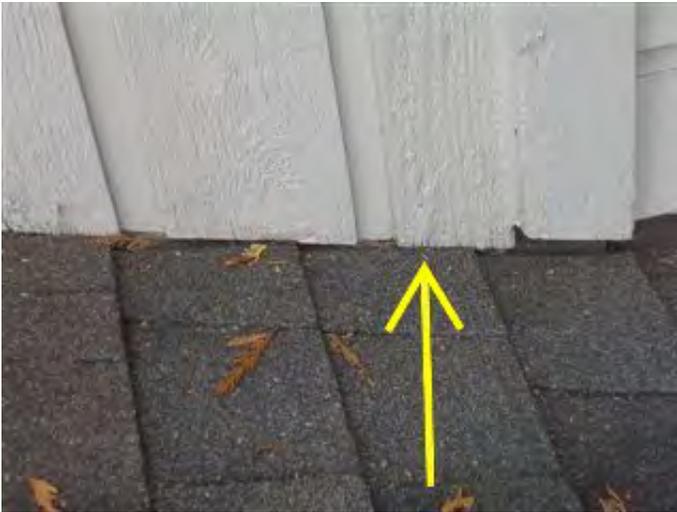
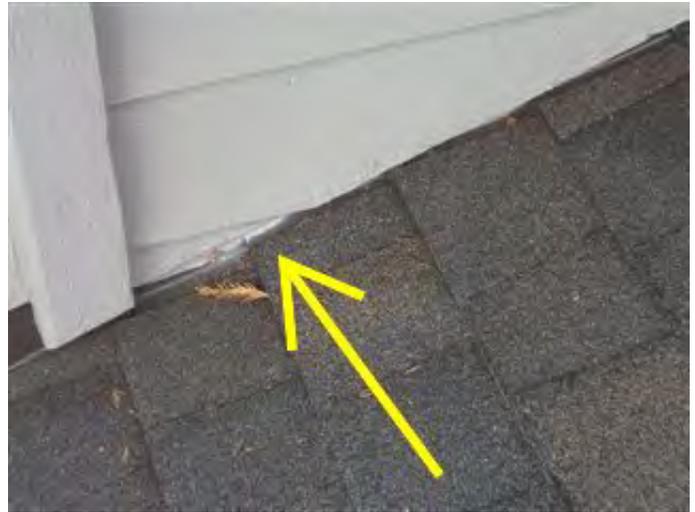
The siding or trim on one or more exterior walls was in contact with or too close to roof surfaces below. This is a conducive condition for wood-destroying organisms. There should be a gap of 1 1/2 to 2 inches between a roof surface and siding above. The gap is meant to prevent water from wicking up into the bottom edge of the siding and causing fungal rot, or damaging the siding. There may also be inadequate space for additional layers of roofing materials in the future. Recommend that a qualified contractor repair per standard building practices. For example, by trimming the siding.

Photo 18-1  
Trim in contact with roof covering.

Photo 18-2  
Trim in contact with roof covering.

Photo 18-3  
Siding in contact with roof cover over garage.

Photo 18-4  
Siding in contact with roof cover over garage.

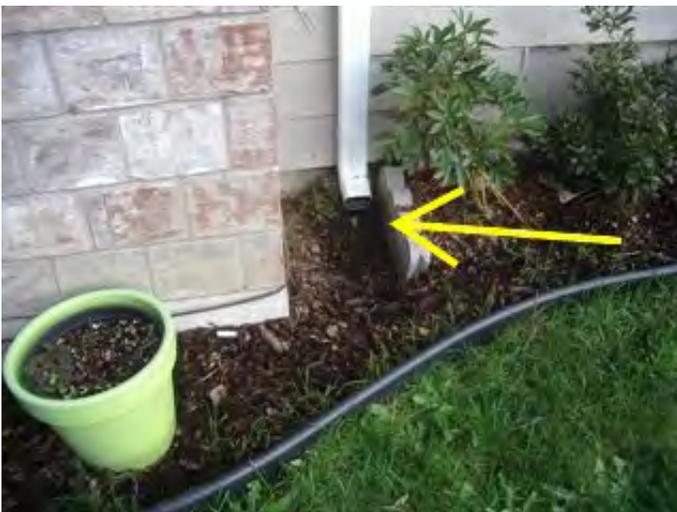
Photo 19-1

Extensions such as splash blocks or drain pipes for one or more downspouts were missing. Water can accumulate around the building foundation or inside crawl spaces or basements as a result. Recommend that a qualified person install, replace or repair extensions as necessary so rainwater drains away from the structure.

Missing downspout extension on east side.

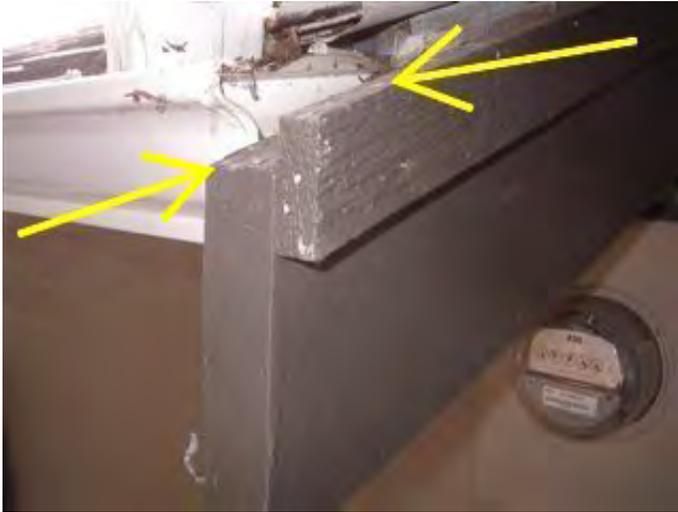
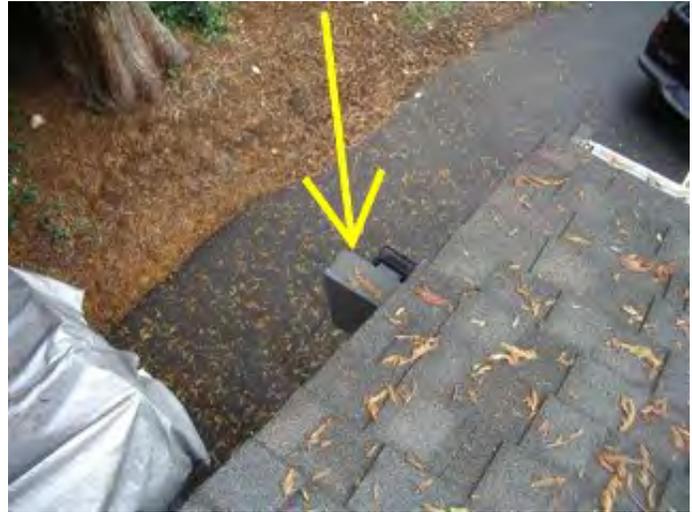
Barge boards, which are the trim boards at gable ends of roofs, and exterior roof beams were exposed at their ends and subject to rot from exposure to rain runoff. This is a conducive condition for wood-destroying organisms. Shingles or flashing should be installed over them to prevent rot. Recommend that a qualified person install flashing over exposed barge boards and beams where missing and per standard building practices.

Photo 20-1  
Exposed barge board on west side of garage.

Photo 20-2  
Exposed beam missing flashing.

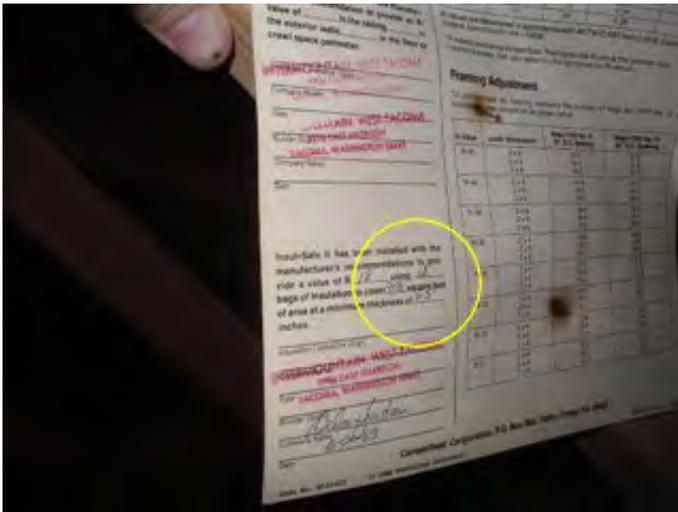
The ceiling insulation installed in the attic was substandard and appeared to have an R-18 rating that's significantly less than current standards (R-38). Heating and cooling costs will likely be higher due to poor energy efficiency. Recommend that a qualified contractor install insulation for better energy efficiency and per standard building practices.

Photo 21-1  
Insulation certificate in attic indicating a value of R-18.

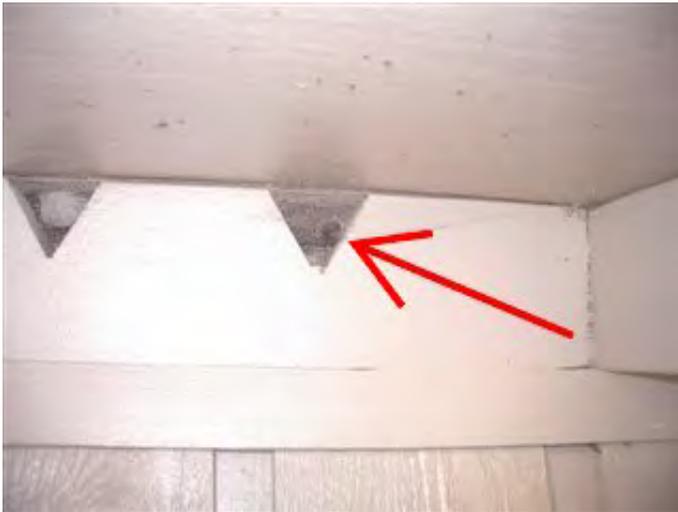
One or more attic or roof vent screens were missing, deteriorated or damaged. Recommend that a qualified person replace or repair screens as necessary to prevent birds or vermin from entering the attic.

Photo 22-1  
Damaged soffit vent screen over garage.

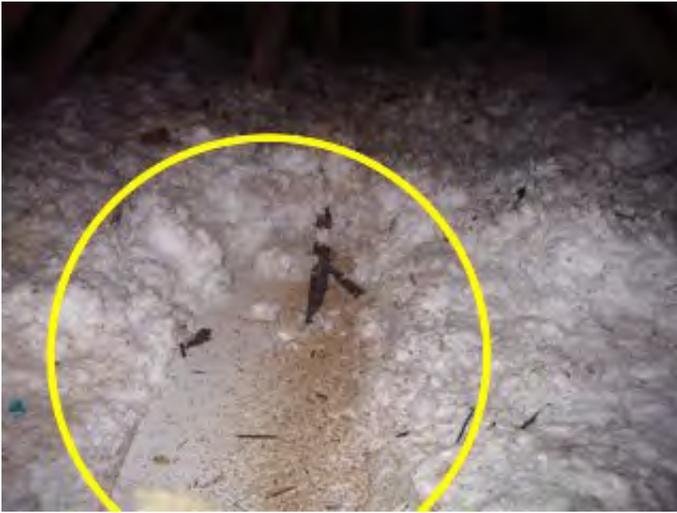
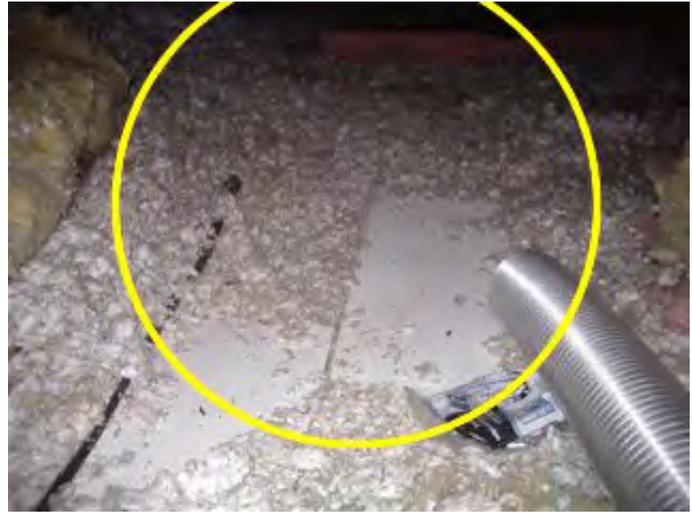
The ceiling insulation in one or more areas of the attic was compacted or uneven. Heating and cooling costs may be higher due to reduced energy efficiency. Recommend that a qualified person repair, replace or install insulation as necessary and per standard building practices (typically R-38).

Photo 23-1  
Uneven insulation in attic.

Photo 23-2  
Uneven insulation in attic.

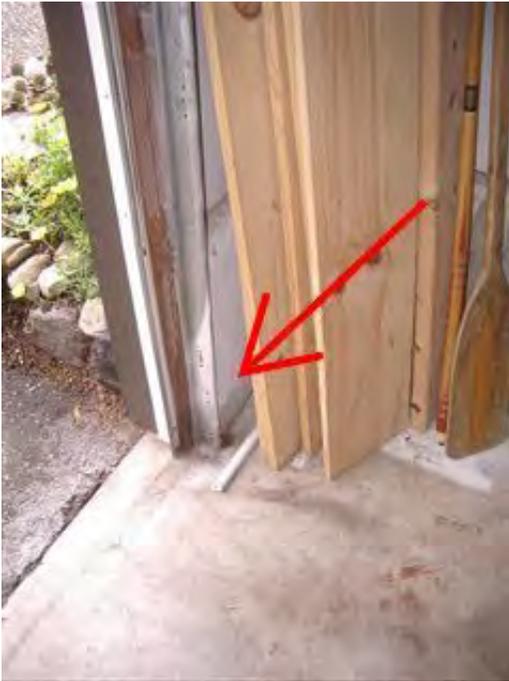
No photoelectric sensors were installed for one or more garage vehicle doors' automatic opener. These have been required on all automatic door openers since 1993 and improve safety by triggering the door's auto-reverse feature without need for the door to come in contact with the object, person or animal that is preventing the door from closing. Recommend that a qualified contractor install photoelectric sensors where missing for improved safety. For more information on garage door safety issues, visit:

Photo 25-1  
No photoelectric sensors.

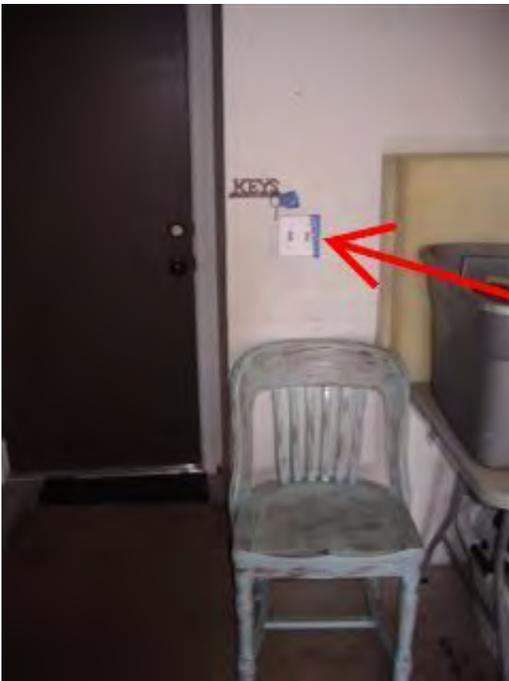
26) 🚑 The wall-mounted control for one or more automatic garage vehicle door openers was less than 5 feet off the floor, or within reach of children. This is a safety hazard. Children should not be able to operate automatic garage vehicle door openers. A qualified person should relocate controls for door openers so they are at least 5 feet above floors and/or out of reach of children. For more information on garage door safety issues, visit:

Photo 26-1  
Control switch for automatic opener too low.

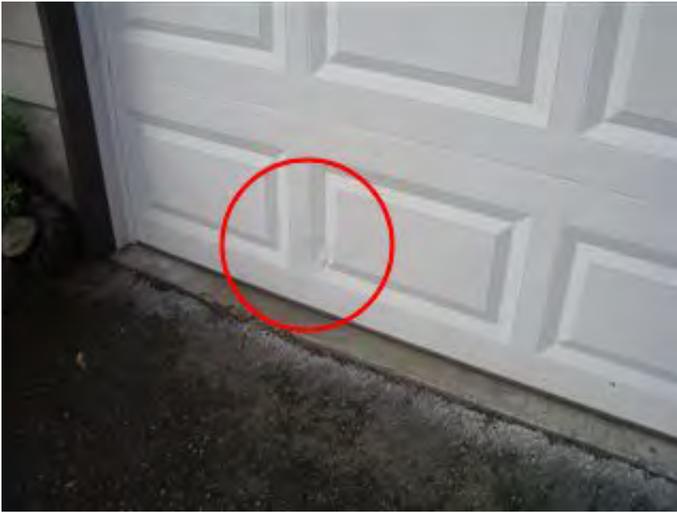
28) ⓘ One or more garage vehicle doors had minor damage or deterioration.

Photo 28-1  
Minor damage to vehicle door.

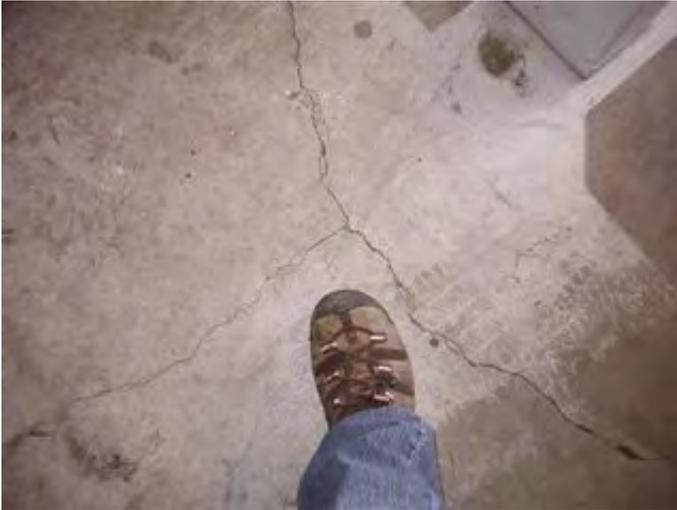
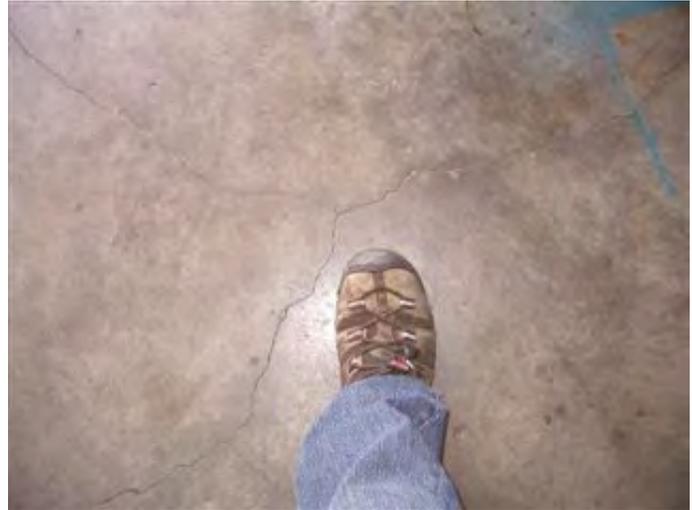
Minor cracks were found in the concrete slab floor. These are common and appeared to be only a cosmetic issue.

Photo 29-1  
Garage.

Photo 29-2  
Garage.

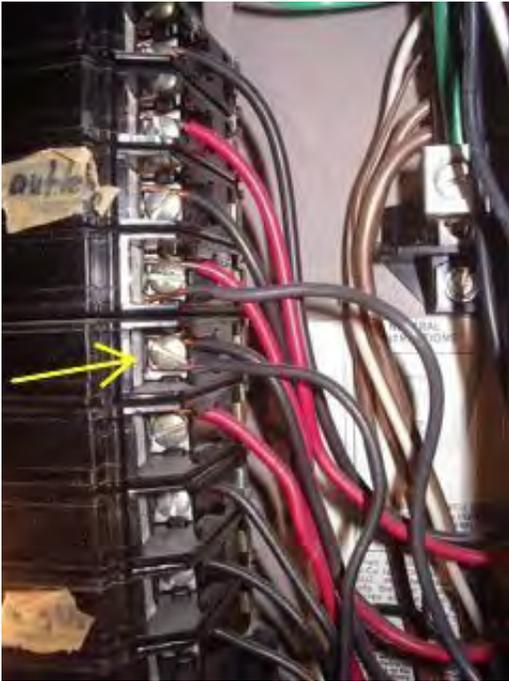
One or more circuit breakers in panel(s) #A were "double tapped," where two or more wires were installed in the breaker's lug. Most breakers are designed for only one wire to be connected. This is a safety hazard since the lug bolt can tighten securely against one wire but leave other(s) loose. Arcing, sparks and fires can result. Recommend that a qualified electrician repair as necessary. For more information, visit:

Photo 31-1  
Double tap in panel #A.

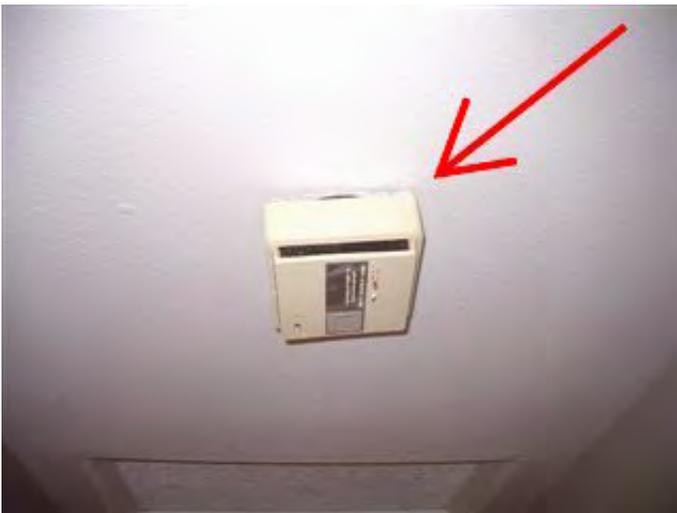
Based on the age of this structure and the appearance of existing smoke alarms, the alarms may have been installed more than 10 years ago. According to [National Fire Protection Association](http://www.nfpa.org), aging smoke alarms don't operate as efficiently and often are the source for nuisance alarms. Older smoke alarms are estimated to have a 30% probability of failure within the first 10 years. Newer smoke alarms do better, but should be replaced after 10 years. Unless you know that the smoke alarms are new, replacing them when moving into a new residence is also recommended by NFPA. For more information, visit: <http://www.reporthost.com/?SMKALRMLS>

Photo 32-1  
Older smoke alarm.

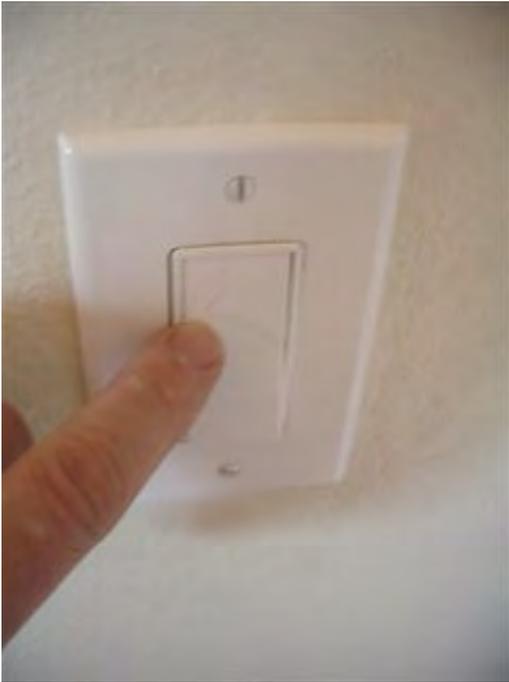
One or more wall switches were broken or damaged. Recommend that a qualified electrician replace wall

Photo 34-1  
Cracked switch in NW bedroom.

switches as necessary.

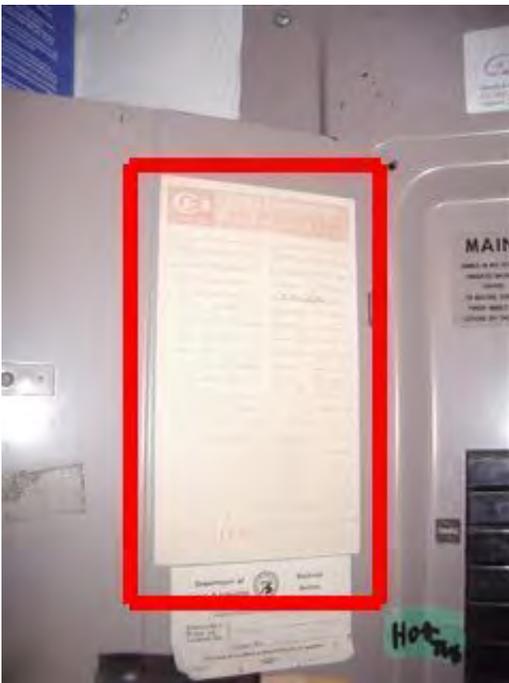
The legend for circuit breakers or fuses in panel(s) #A was missing, incomplete, illegible or confusing. This is a potential shock or fire hazard in the event of an emergency when power needs to be turned off. Recommend correcting the legend so it's accurate, complete and legible. Evaluation by a qualified electrician may be necessary.

Photo 35-1  
Faded and illegible legend in panel m#A.

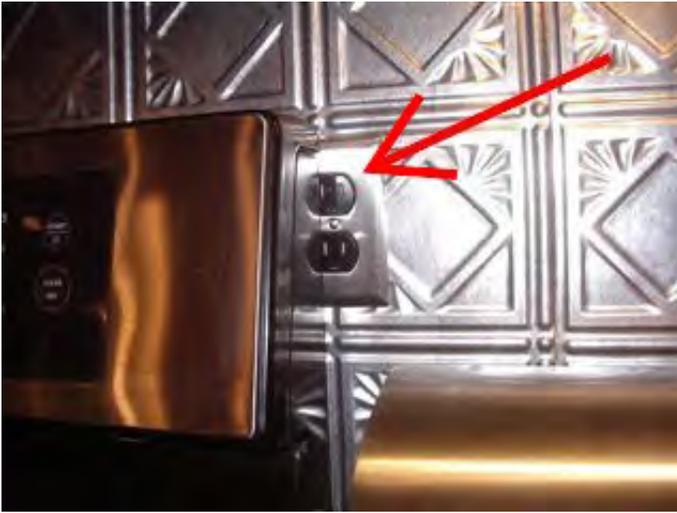
A receptacle in the kitchen was covered by the range.

Photo 36-1  
Receptacle partially covered by range.

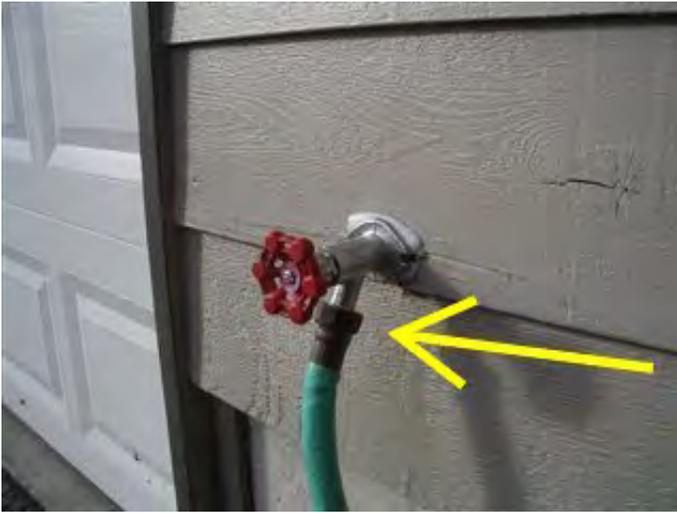
One or more hose bibs (outside faucets) were missing backflow prevention devices. These devices reduce the likelihood of gray water entering the potable water supply. Recommend installing backflow prevention devices on all hose bibs where missing. They are available at most home improvement stores and are easily installed. For more information, visit:

Photo 37-1  
No backflow device.

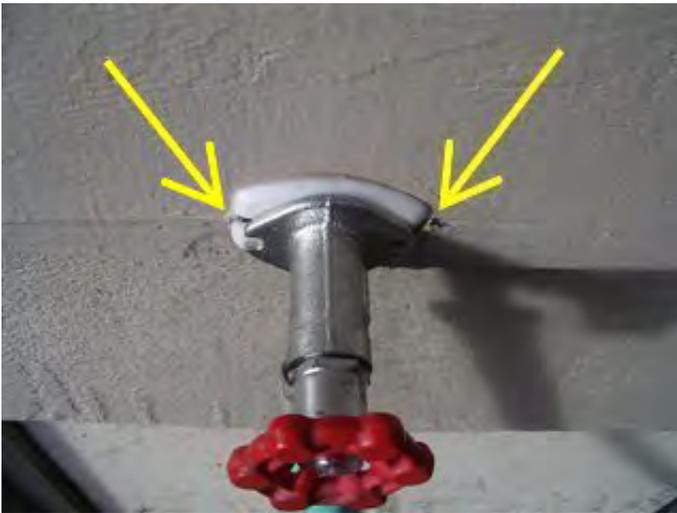
38) 🛠️ One or more hose bibs (outside faucets) weren't anchored securely to the structure's exterior. Water supply pipes can be stressed when hose bibs are turned on and off and when hoses are pulled. Leaks may occur as a result. Recommend that a qualified person install fasteners per standard building practices.

Photo 38-1  
NW corner of garage.

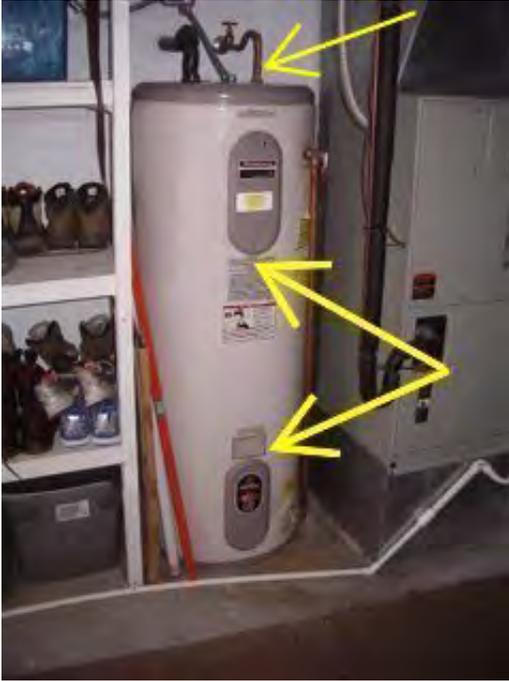
40) 🚑🔧 The water heater did not have earthquake straps or struts installed. This is a potential safety hazard in the event of an earthquake due to the risk of the water heater tipping over, gas lines breaking if it's gas-fired, or electric wiring being damaged if powered by electricity. Leaks can also occur in water-supply pipes. Recommend that a qualified person install earthquake straps or struts as necessary and per standard building practices.

Photo 40-1  
Missing seismic restraints.

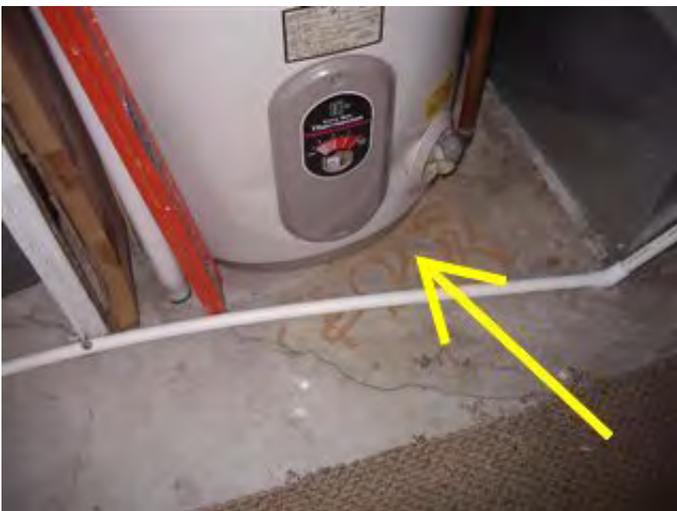
41) 🛠️ The water heater was installed in an unheated space on a concrete floor and was not resting on an insulated pad. The bottom of the casing is likely to rust, and energy efficiency may be reduced. Recommend installing an insulated pad under the water heater.

Photo 41-1  
Missing insulating pad on concrete floor.

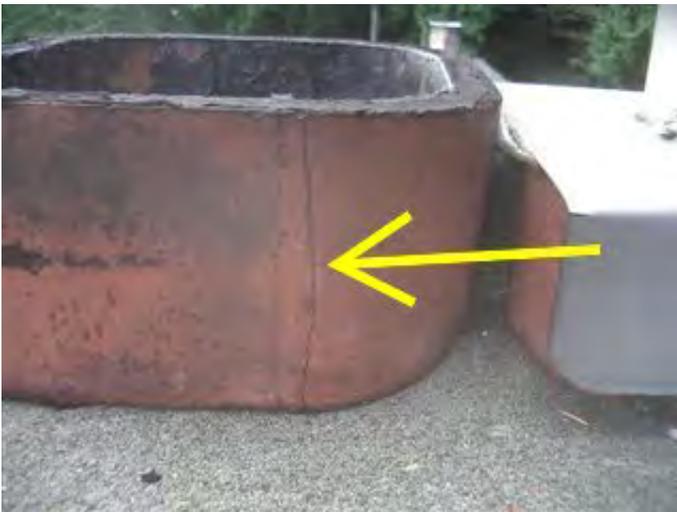
Terracotta flue tiles in one or more masonry chimney(s) were cracked or broken. This is a potential fire hazard because such cracks become wider when the chimney heats up and can allow exhaust gases to enter the building structure. Recommend that a qualified contractor evaluate, replace broken tiles and make other repairs as necessary.

Photo 45-1  
Crack in flue tile.

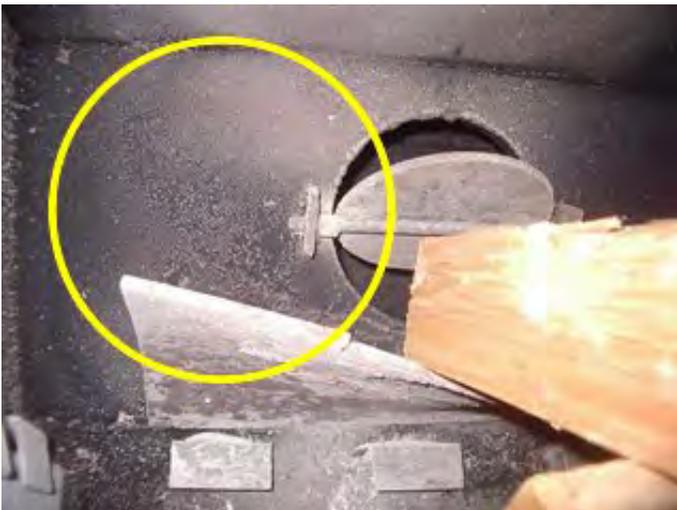
A significant amount of creosote or burning by-products (ash, soot, etc.) was visible in one or more chimneys. This is a potential fire hazard and a sign that chimney system maintenance has been deferred. The client should be aware that the type and quality of wood burned, and the moisture content of the wood, will affect the rate at which burning by-products accumulate in the chimney. When wood-burning devices are used regularly, they should be cleaned annually at a minimum. A qualified contractor should evaluate, clean, and repair if necessary.

Photo 46-1  
Creosote in smoke chamber.

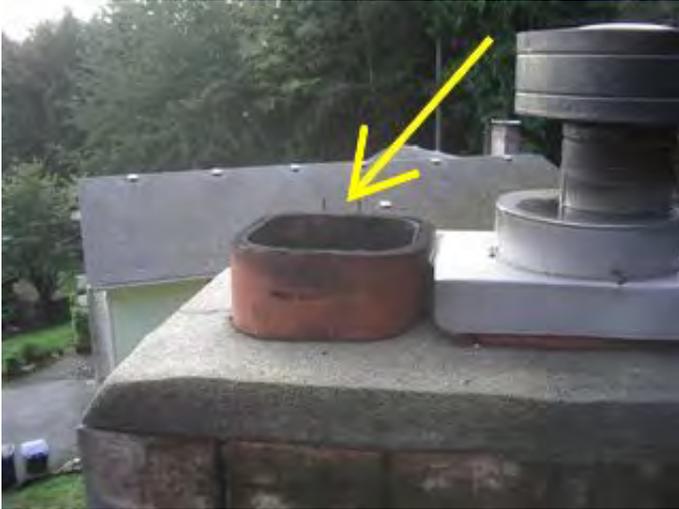
No spark screen or rain cap was installed at one or more chimney flue terminations. Spark screens reduce the chance of embers exiting the flue and causing fires. They also prevent wildlife (e.g. birds, rodents, raccoons) from entering flues. Rain caps prevent water from entering flues, mixing with combustion deposits and creating caustic chemicals which can corrode flues. They also prevent damage to masonry from freeze-thaw cycles and prevent metal components (e.g. dampers, metal firebox liners) from rusting. Recommend that a qualified person install rain caps with spark screens per standard building practices where missing.

Photo 47-1  
No spark screen or rain cap.

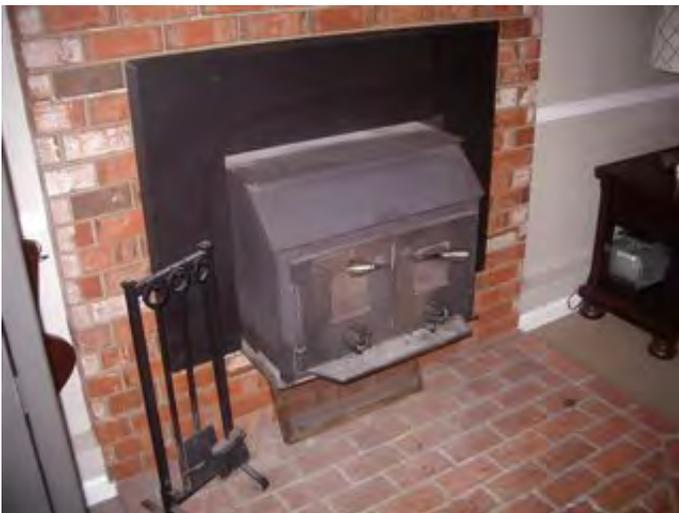
One or more wood-burning fireplaces or stoves were found at the property. When such devices are used, they should be professionally inspected and cleaned annually to prevent creosote build-up and to determine if repairs are needed. The National Fire Protection Association states that a "Level 2" chimney inspection should be performed with every sale or transfer of property with a wood-burning device. Recommend consulting with the property owner about recent and past servicing and repairs to all wood-burning devices and chimneys or flues at this property. Recommend that a qualified specialist evaluate all wood-burning devices and chimneys, and clean and repair as necessary. Note that if a wood stove insert is installed, it may need to be removed for such an evaluation. For more information, search for "chimney inspection" at: <http://www.reporthost.com/?CSIA>

Photo 48-1  
Basement.

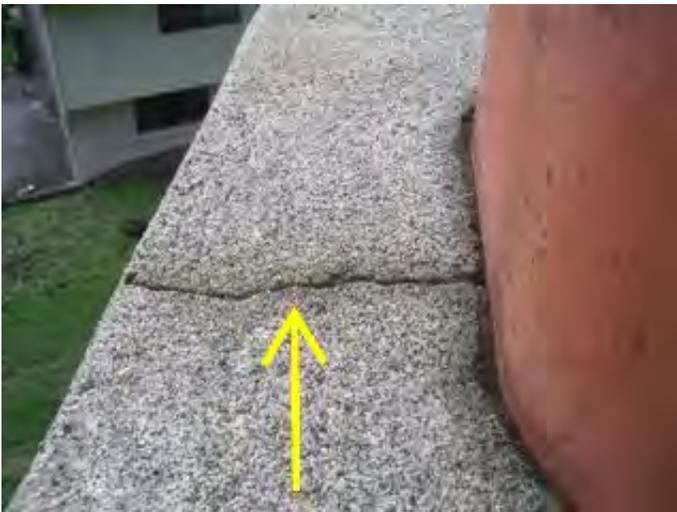
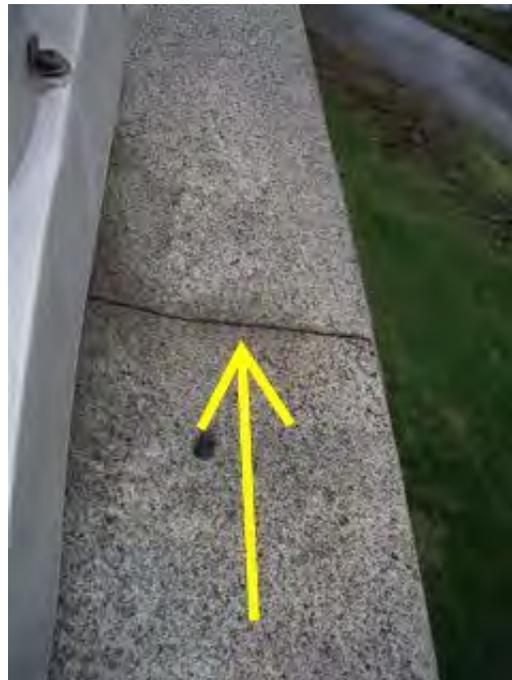
Photo 50-1  
Crack in chimney crown.

Photo 50-2  
Crack in chimney crown.

Recommend that a qualified contractor repair or replace crowns as necessary, and per standard building practices.

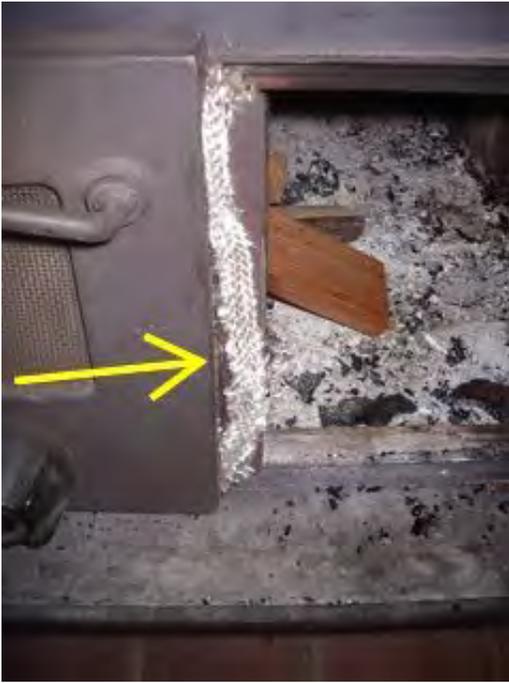
51) 🛠️ The gasket for the wood stove door was deteriorated, damaged or missing. The door may leak and efficiency can be reduced. Recommend that a qualified person replace the gasket.

Photo 51-1  
Deteriorated gasket on stove doors.

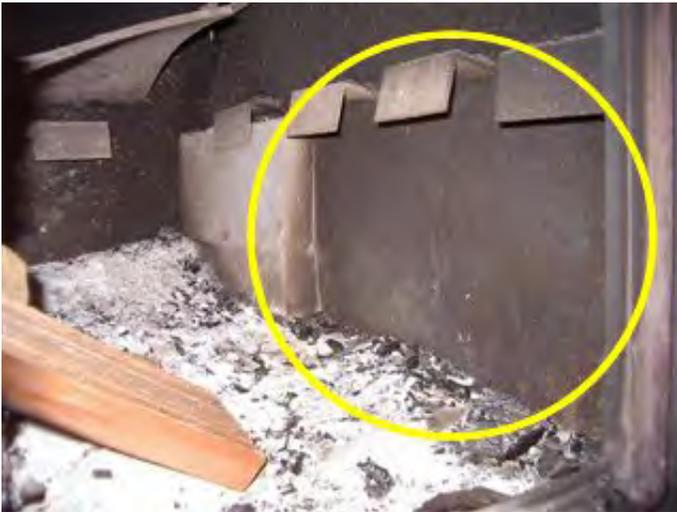
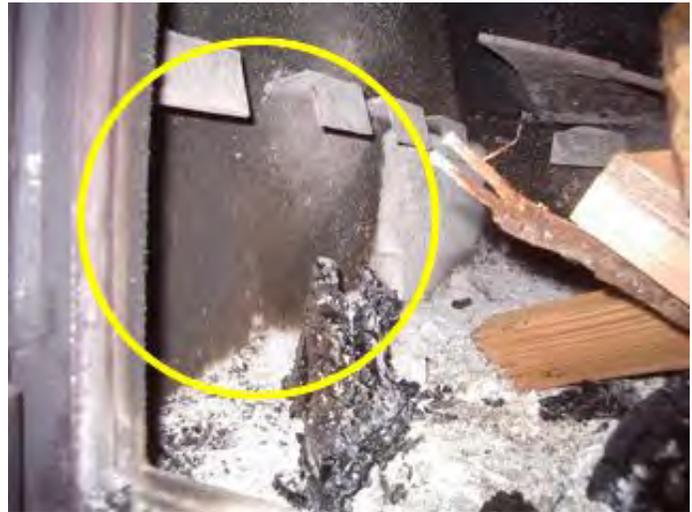
52) 🔧 Firebricks lining the wood stove were cracked, broken or missing. Recommend that a qualified person replace firebricks as necessary.

Photo 52-1  
Missing fire bricks.

Photo 52-2  
Missing fire bricks.

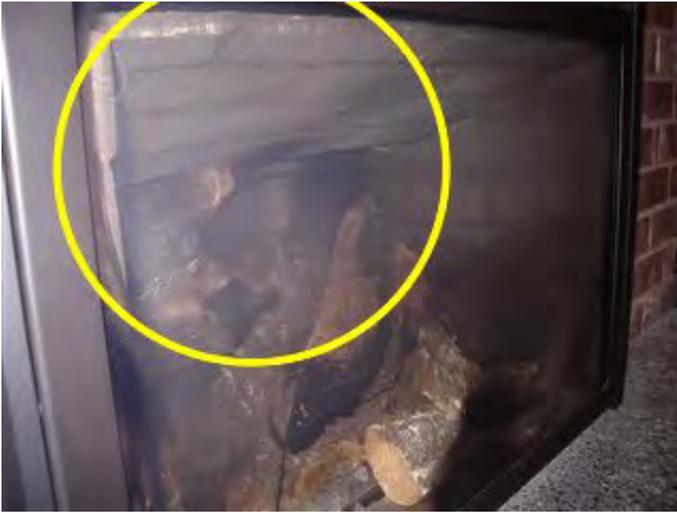
53) 🔧 The glass front on the gas fireplace had a hazy film. This is typically a mineral residue left from water vapor as the gas burns. It may be possible to clean this fogging by removing the glass from the fireplace and using a gas appliance ceramic glass cleaner, available through gas fireplace and stove distributors and installers. Ammonia-based products, such as common glass cleaners, should not be used since they can cause damage or etching to the glass, or make the haze permanent. It may be possible for a homeowner to remove the glass for cleaning, if the instructions for the fireplace are available and if the homeowner is experienced in such repairs. Consult with a qualified specialist for more information, or to have them do the cleaning.

Photo 53-1  
Fogging on glass.
