## **Eagle Eye Real Estate Inspection Services**

# Full General Home Inspection

Property address: **Your Home Town  
USA**

Inspection date: **XX/XX/2014**

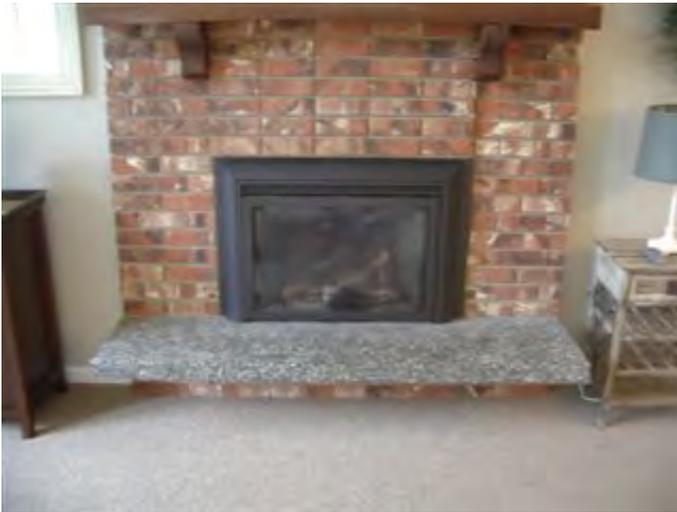
54) 🔍 One or more gas fireplaces or stoves did not respond to normal controls (e.g. on/off switch, thermostat, remote control) and was not fully evaluated as a result. The pilot light or gas supply may have been turned off, or some other condition may have prevented operation. The inspector only operates normal controls and does not light pilot lights or operate gas shut-off valves. Consult with the property owner, review all documentation for such gas appliances, and familiarize themselves with the lighting procedure. If necessary, a qualified specialist should assist in lighting such appliances, and make any needed repairs.

Photo 54-1  
Living room.

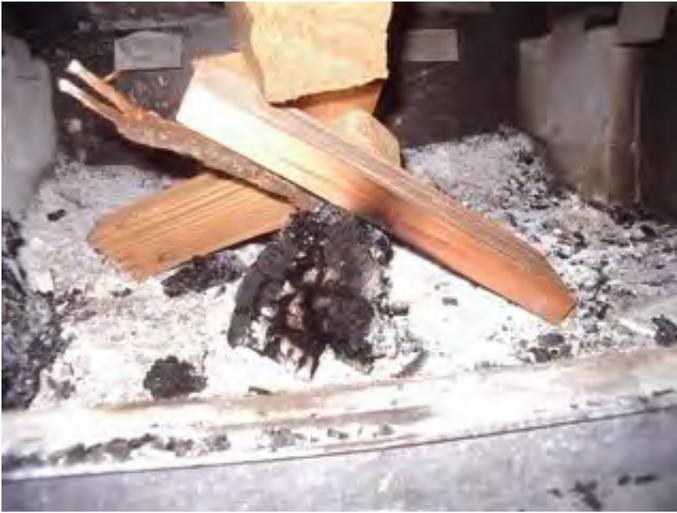
55) ⓘ Significant amounts of ash or fire materials were present in one or more fireplace or wood stove fireboxes. As a result, the inspector was unable to fully view or evaluate the firebox(es) and/or components inside (e.g. firebrick, metal liner, log lighter). These components are excluded from this inspection.

Photo 55-1  
Fire materials blocking view.

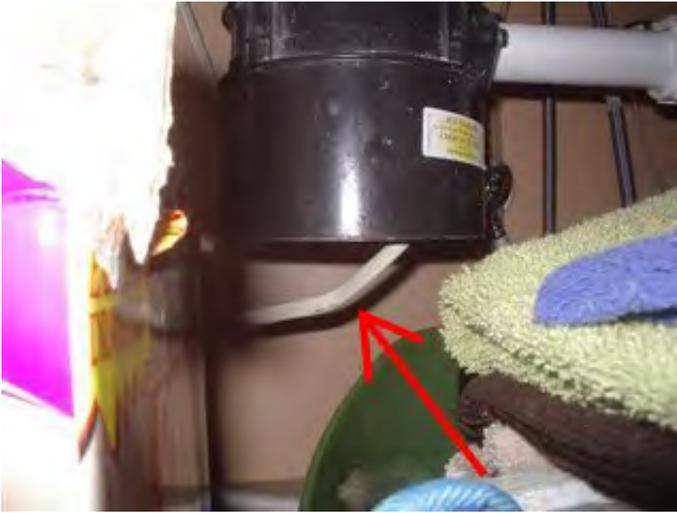
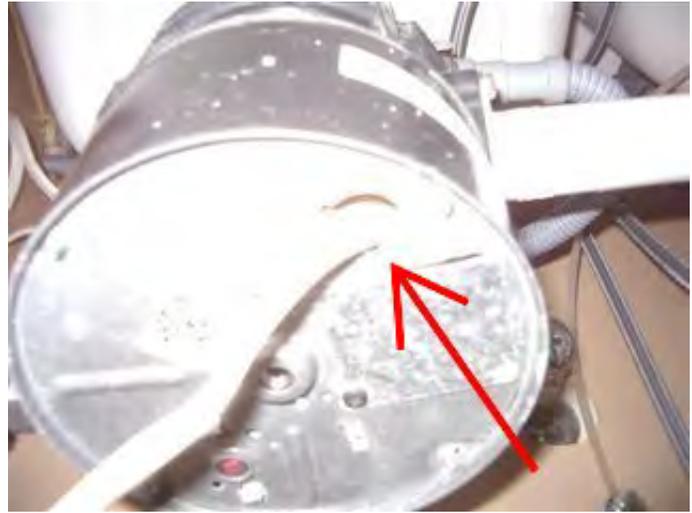
Electrical wiring for the under-sink food disposal was substandard. Non-metallic sheathed wiring was exposed and subject to damage. One or more bushings were missing for the under-sink food disposal's electric wiring. The wiring can be damaged by repeated bending or contact with sharp objects. BX-armored conduit should be installed to protect wiring, or a flexible appliance cable should be installed. This is a potential shock hazard. Recommend that a qualified contractor repair per standard building practices.

Photo 56-1  
Non metallic sheathed wire to disposal.

Photo 56-2  
Missing bushing at disposal.

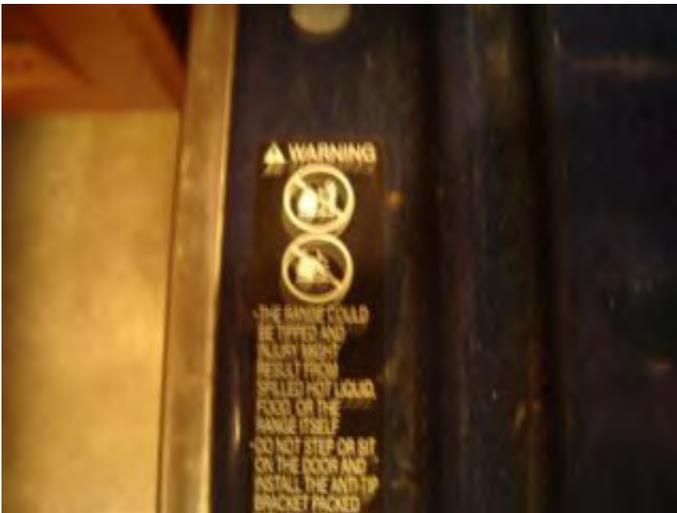
The range could tip forward. An anti-tip bracket may not be installed. This is a potential safety hazard since the range can tip forward when weight is applied to the open door, such as when a small child climbs on it or if heavy objects are dropped on it. Anti-tip brackets have been sold with all free-standing ranges since 1985. Recommend installing an anti-tip bracket to eliminate this safety hazard. For more information, visit: <http://www.reporhost.com/?ATB>

Photo 57-1  
Tip warning on range.

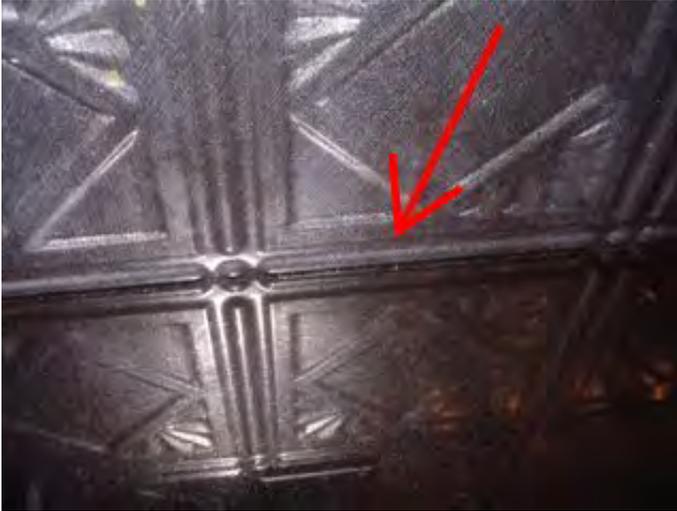
penetrate these areas and cause damage. Recommend that a qualified person repair as necessary. For example, by installing caulk.

Photo 61-1  
No caulk at backsplash.

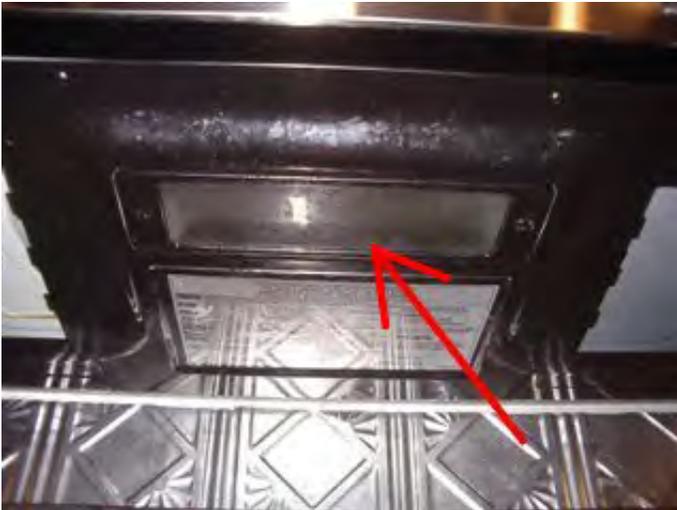
Photo 62-1  
Exhaust hood light was inoperable.

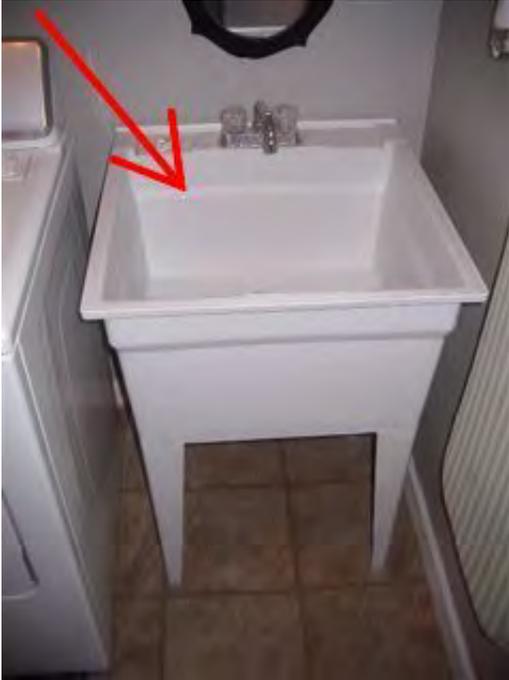
Photo 66-1  
Laundry sink was loose.

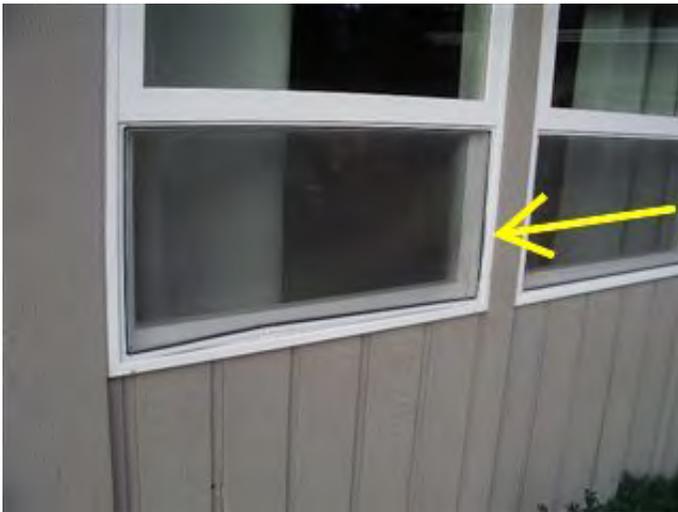
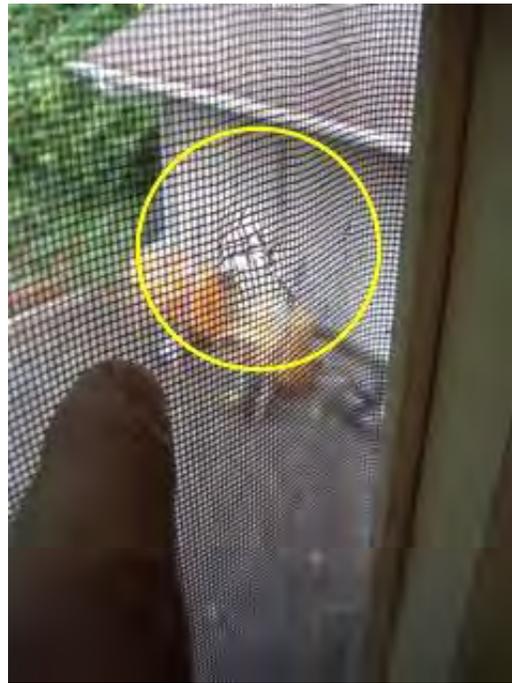
Photo 69-1  
Damaged screen on basement window on north side.

Photo 69-2  
Damaged screen in master bedroom.
