## Eagle Eye Real Estate Inspection Services

# Full General Home Inspection

Property address: **Your Home Town  
USA**

Inspection date: **XX/XX/2014**

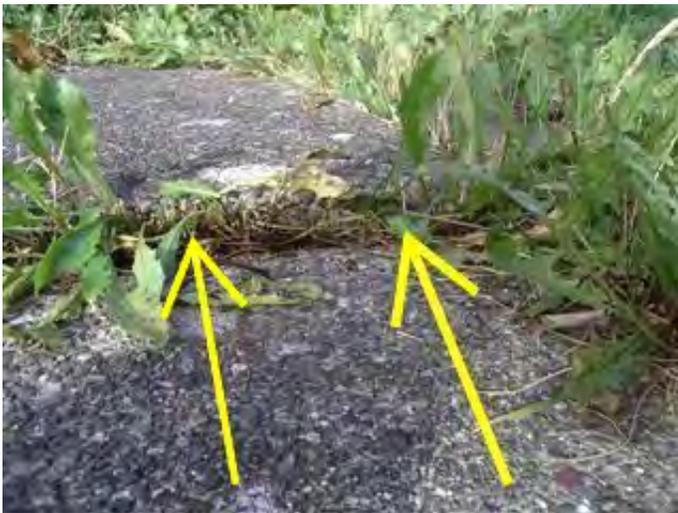
Photo 2-1

Cracks, holes, settlement, heaving and/or deterioration resulting in trip hazards were found in the sidewalks or patios. For safety reasons, recommend that a qualified contractor repair as necessary to eliminate trip hazards.

Tripping hazard in entry sidewalk.

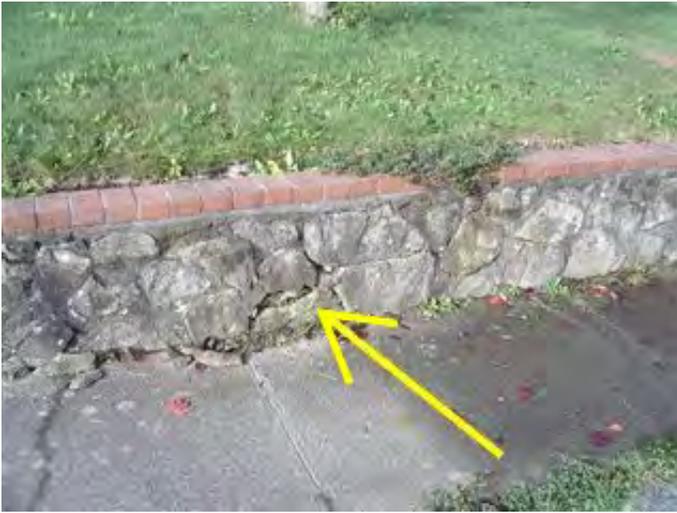
Significant cracks, deterioration, leaning and/or bowing were found in one or more retaining walls. Recommend that a qualified contractor evaluate and repair or replace sections as necessary. Note that some retaining walls, based on their height or size, may require evaluation by a structural engineer.

Photo 3-1  
Retaining wall at sidewalk.

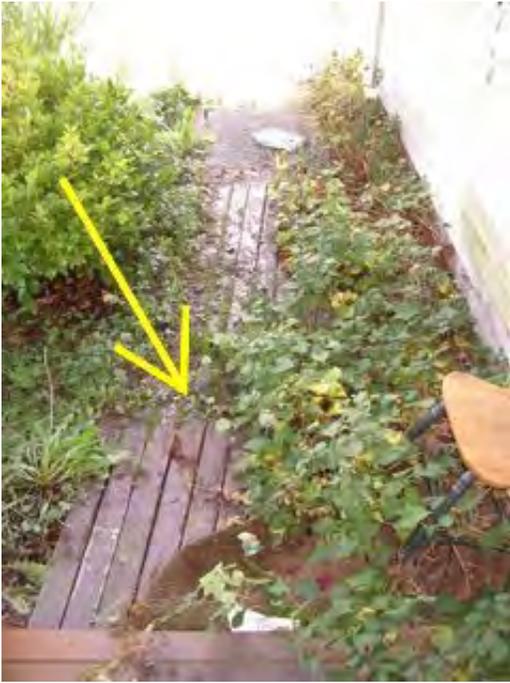
A section of boardwalk was present at the entry. Boardwalks tend to be slippery and flex when walked on. This condition may cause slip and falls. Recommend replacing the boardwalk with decking or sidewalk if possible.

Photo 4-1  
Slippery and uneven boardwalk at entry.

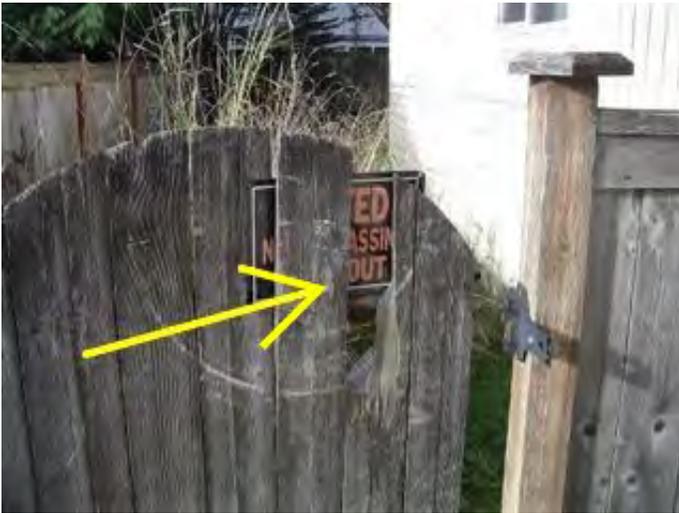
One or more fences and/or gates were damaged or deteriorated and need repair.

Photo 5-1  
Deteriorated gate on south side.

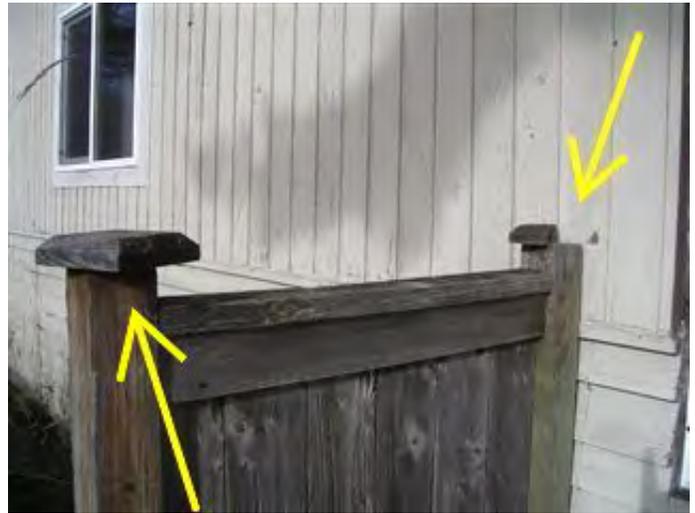
Photo 5-2  
Deteriorated fencing on south side.

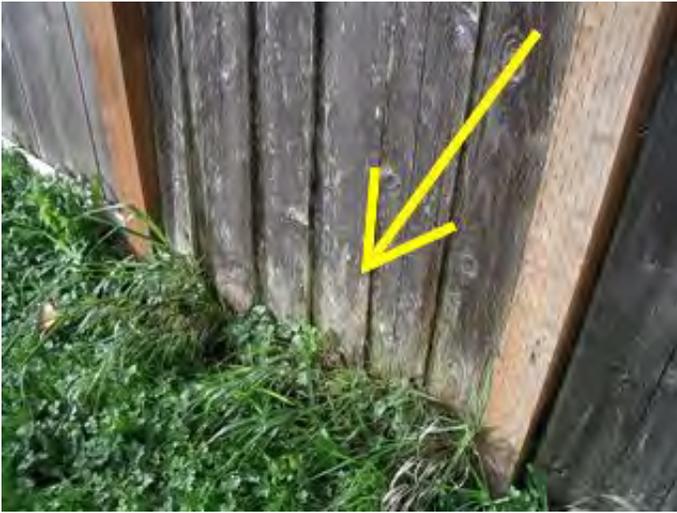
Photo 5-3  
Deteriorated fencing on south side.

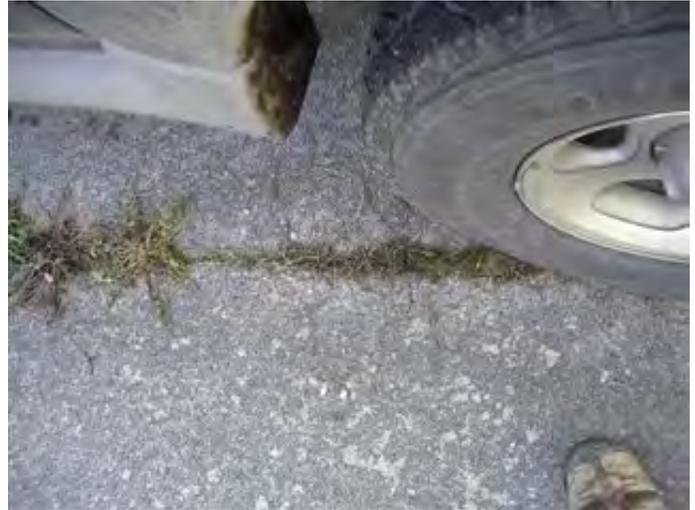
6) **i** Minor deterioration (e.g. cracks, holes, settlement, heaving) was found in the driveway, but no trip hazards were found. The client may wish to have repairs made for cosmetic reasons.

Photo 6-2  
Driveway.

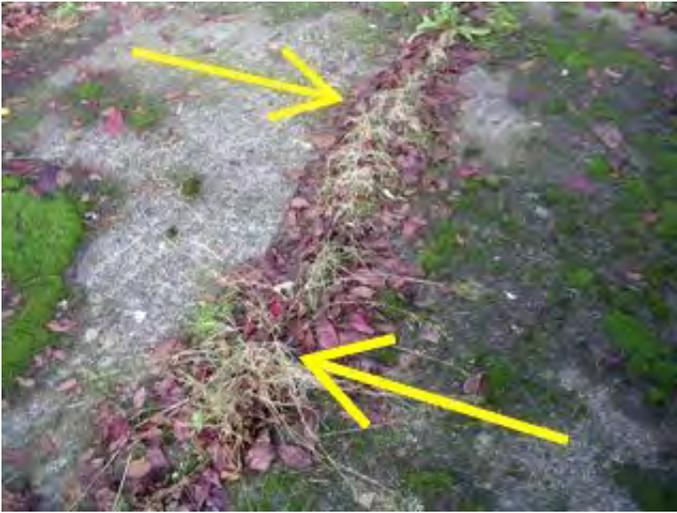
7) **i** Minor deterioration (e.g. cracks, holes, settlement, heaving) was found in sidewalks or patios. The client may wish to have repairs made for cosmetic reasons.

Photo 7-1  
Crack in rear patio.

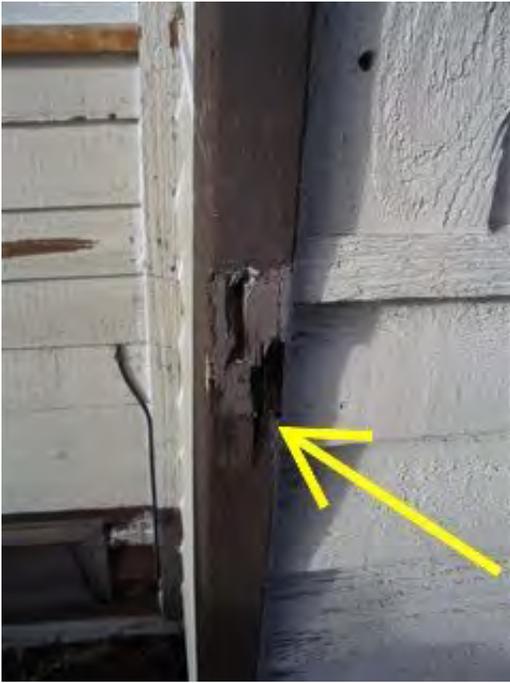
Some sections of siding and/or trim were deteriorated, split, missing and/or damaged. Recommend that a qualified person repair, replace or install siding or trim as necessary.

Photo 8-1  
Damaged trim on east side.

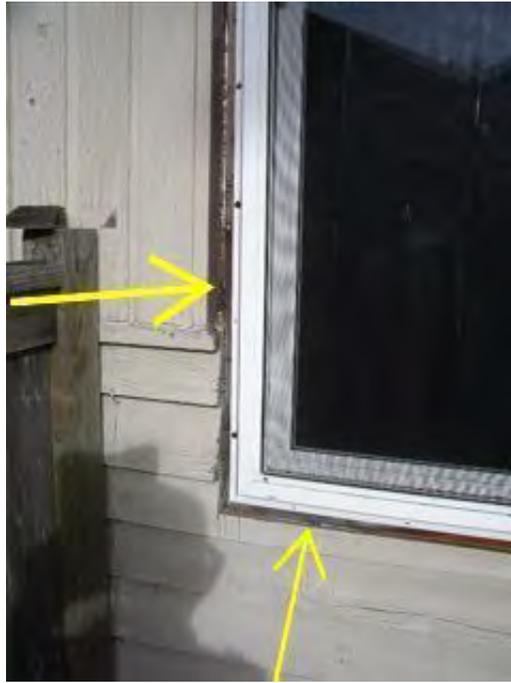
Photo 8-2  
Missing trim around garage window.

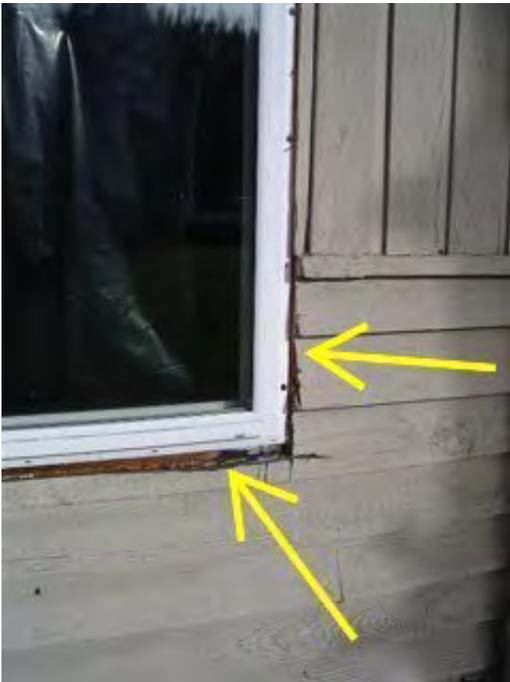
Photo 8-3  
Missing trim around garage window.

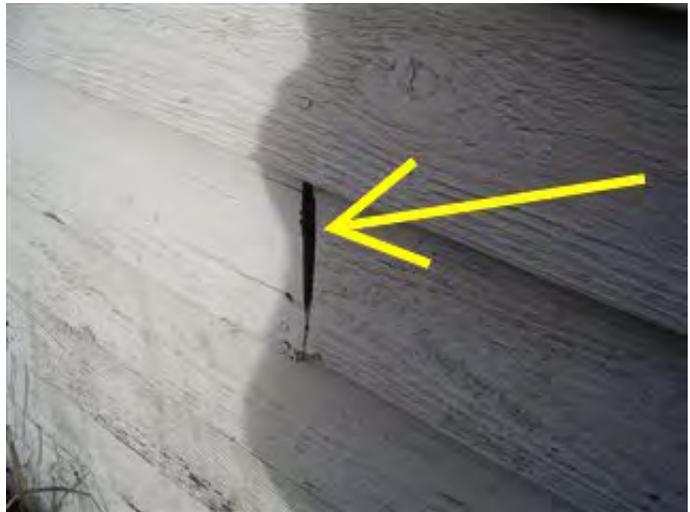
Photo 8-4  
Deteriorated siding on south side.

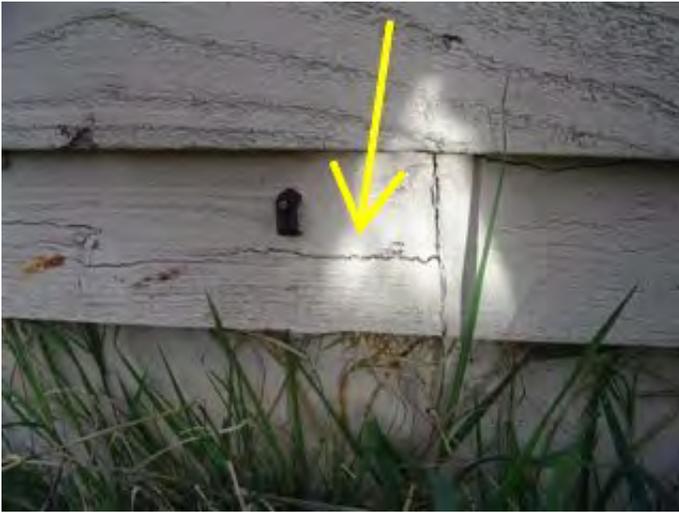
Photo 8-5  
Deteriorated siding on south side.

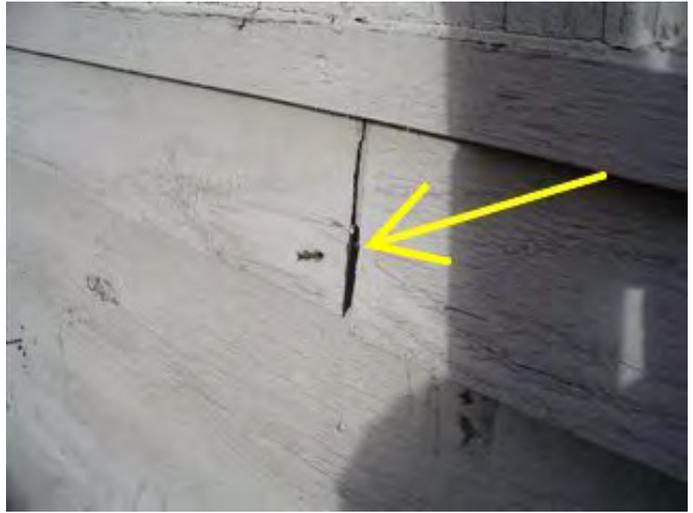
Photo 8-6  
Deteriorated siding on south side.

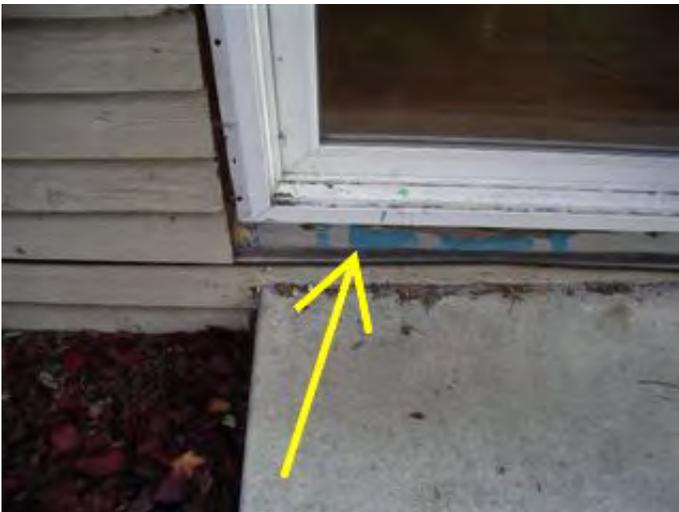
Photo 8-7  
Missing siding under rear patio door.

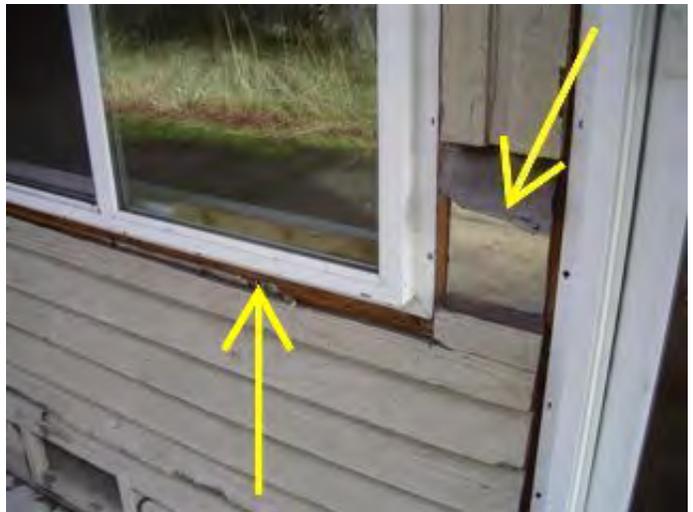
Photo 8-8  
Missing siding and trim around living room window.

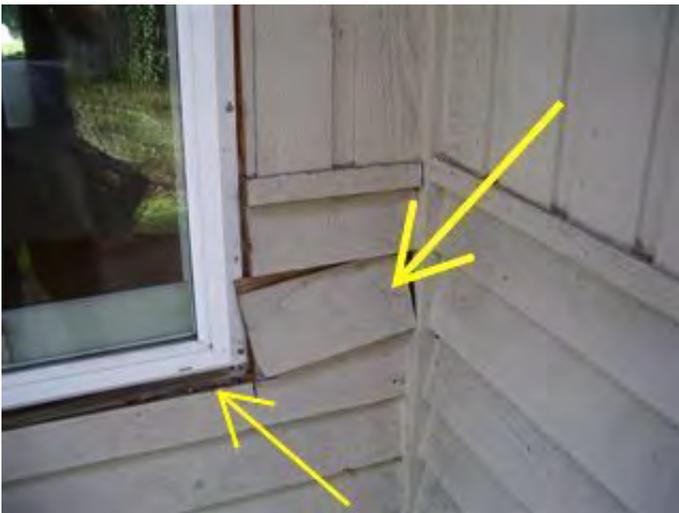
Photo 8-9  
Loose siding and missing trim around living room window.

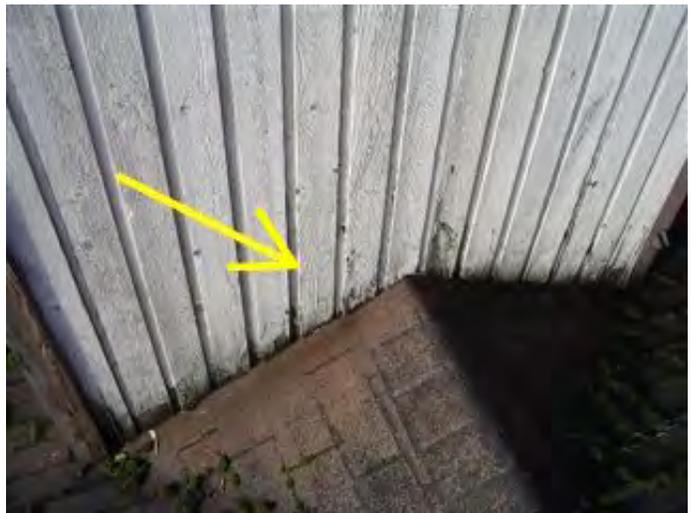
Photo 8-10  
Deteriorated siding on chimney chase.

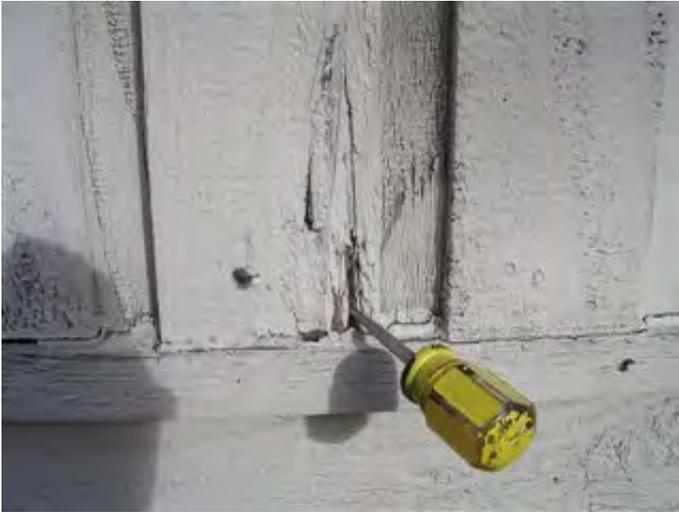
Fungal rot was found at one or more sections of siding or trim. Conducive conditions for rot should be corrected (e.g. wood-soil contact, reverse perimeter slope). Recommend that a qualified person repair as necessary. All rotten wood should be replaced.

Photo 9-1  
Rot in siding on south side.

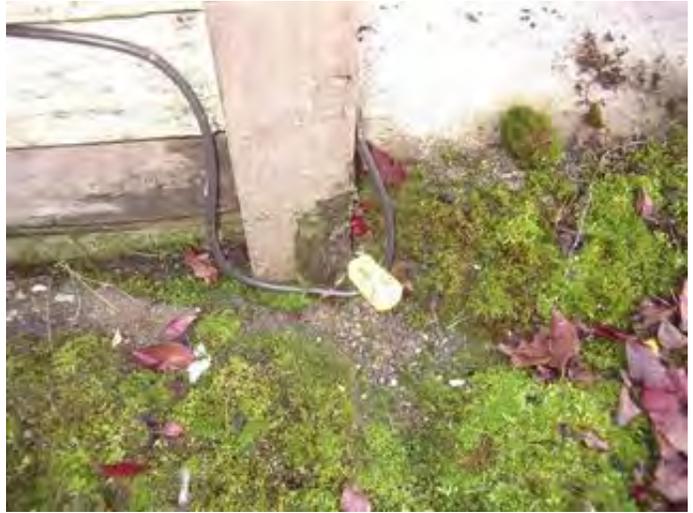
Photo 9-2  
Rot in trim board on chimney chase.

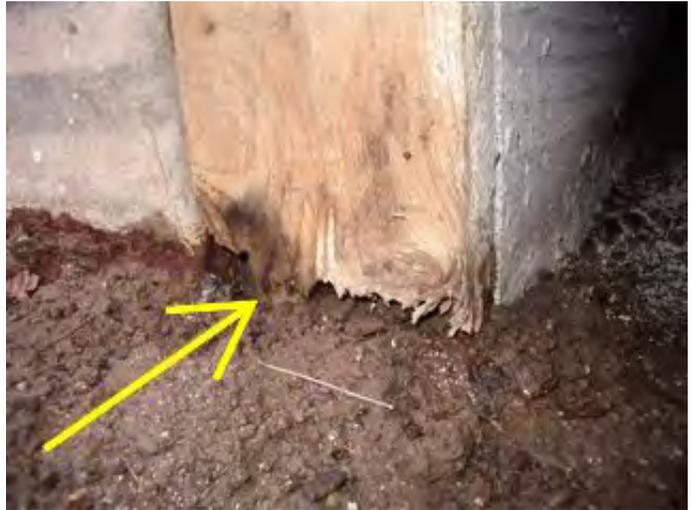
Photo 9-4  
Rot in frame of crawl access.

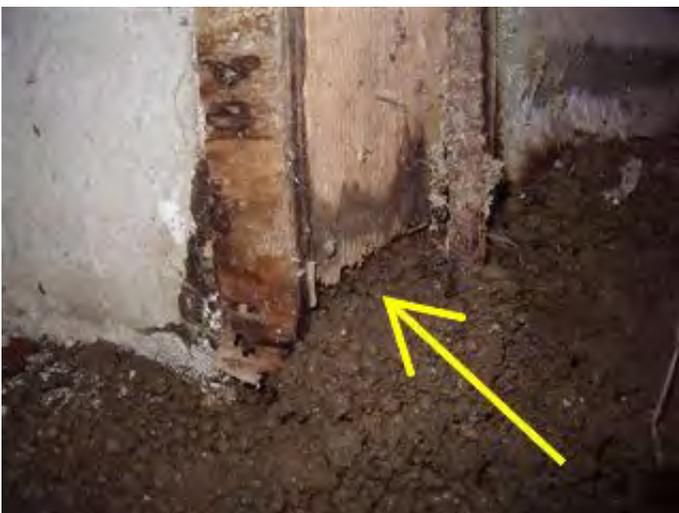
Photo 9-5

Rot in frame of crawl access.

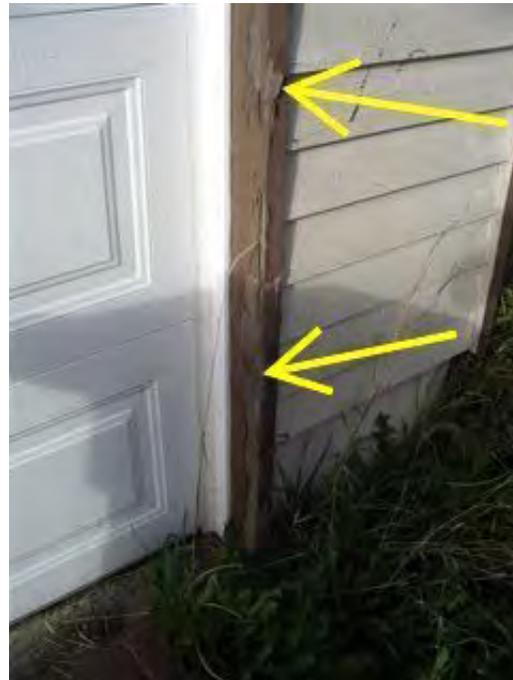
The paint or stain finish in some areas was failing (e.g. peeling, faded, worn, thinning). Siding and trim with a failing finish can be damaged by moisture. Recommend that a qualified contractor prep (e.g. clean, scrape, sand, prime, caulk) and repaint or restain the building exterior where necessary and per standard building practices. Any repairs needed to the siding or trim should be made prior to this.

Photo 12-2  
Deteriorated paint on garage.

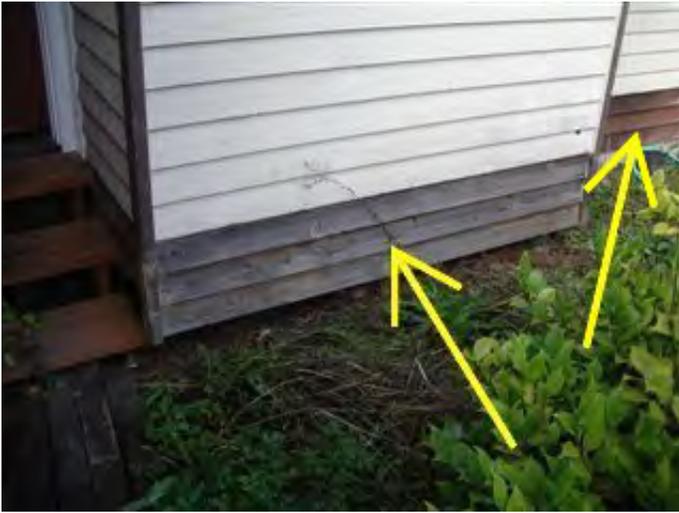
Photo 12-3  
Incomplete finish on siding at east wall by entry.

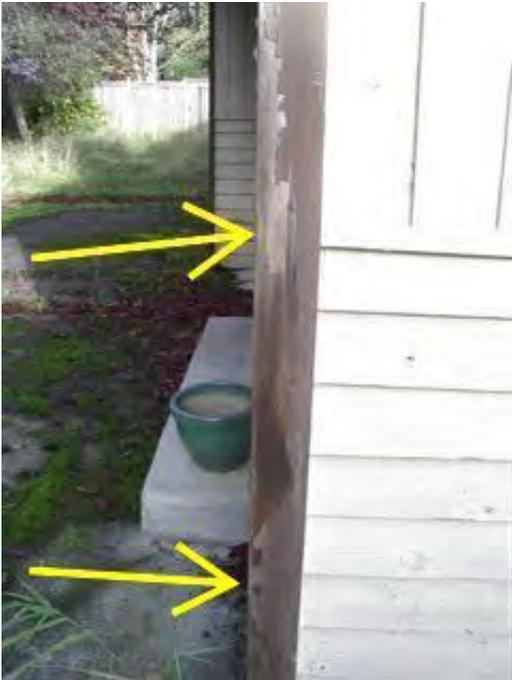
Photo 12-5  
Deteriorated finish at SW corner.

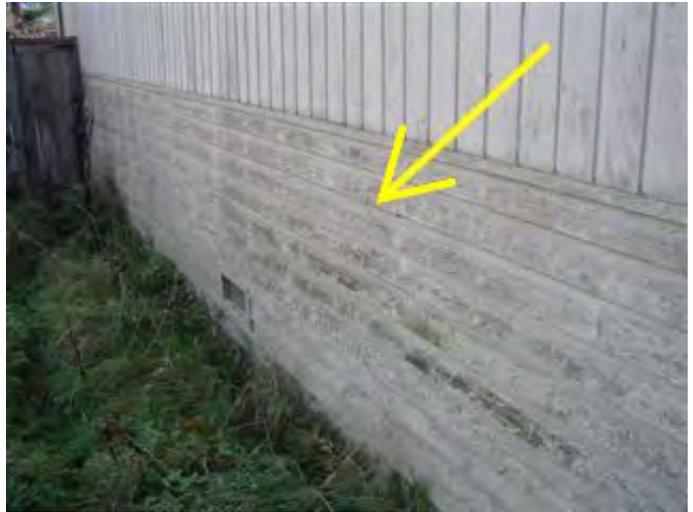
Photo 12-6  
Deteriorated finish on north wall.

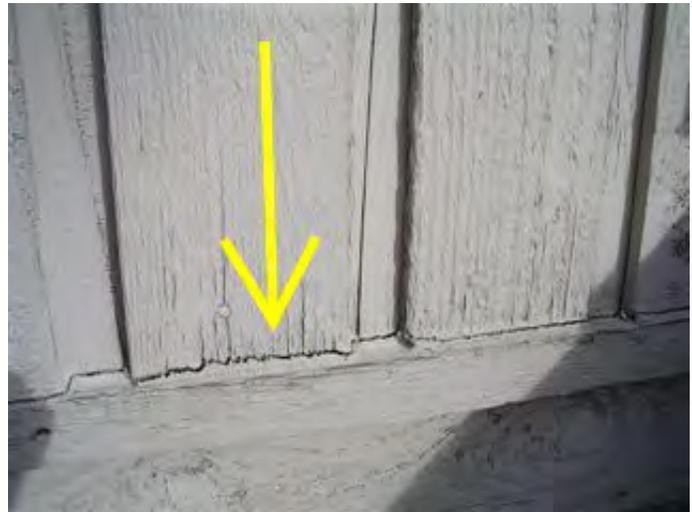
Caulk was deteriorated in some areas. For example, at siding-trim junctions. Recommend that a qualified person renew or install caulk as necessary. Where gaps are wider than 1/4 inch, an appropriate material other than caulk should be used. For more information, visit: <http://www.reporthost.com/?CAULK>

Photo 13-2  
Deteriorated caulk on south side.

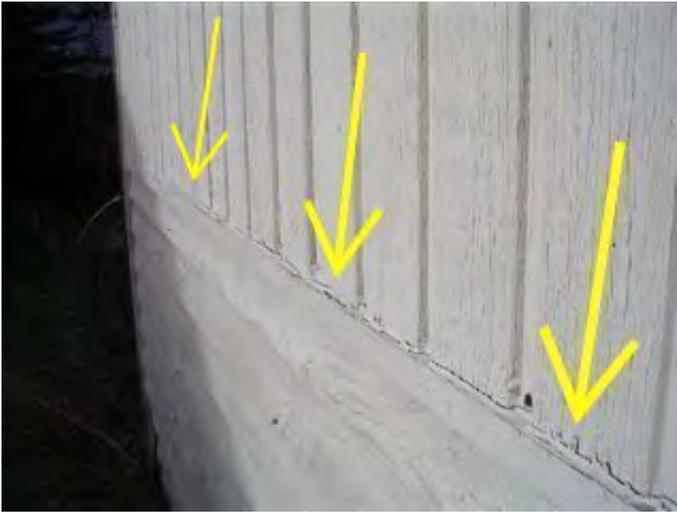
Photo 13-3  
Deteriorated caulk on south side.

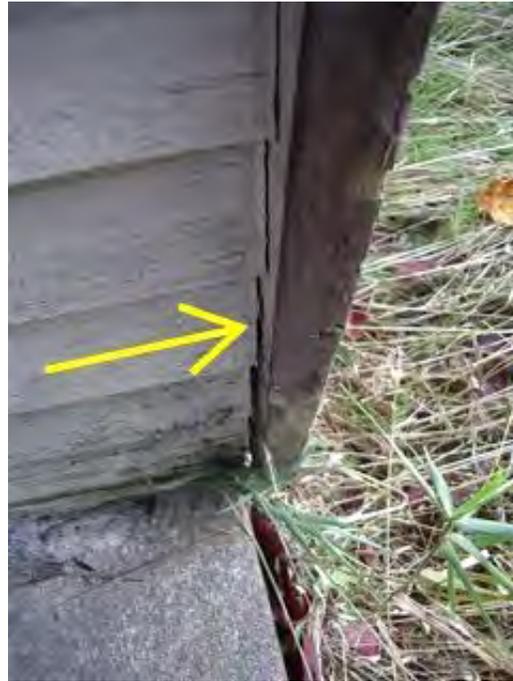
Photo 13-4  
Deteriorated caulk at SW corner.

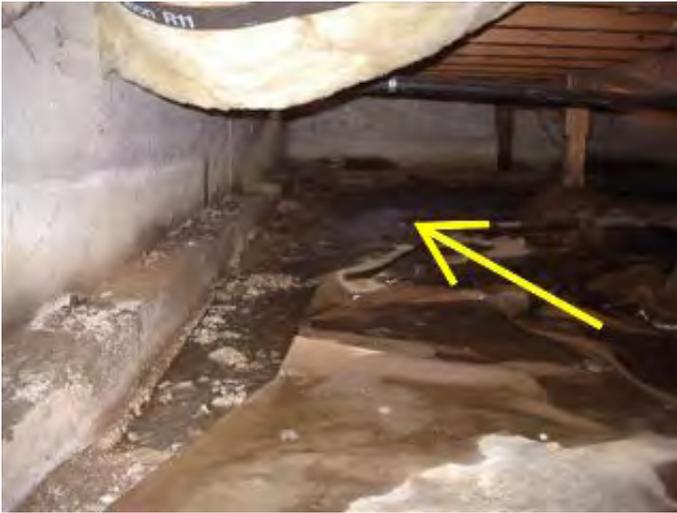
Standing water was found at one or more locations in the crawl space. Water from crawl spaces can evaporate and enter the structure above causing high levels of moisture in the structure. This is a conducive condition for wood-destroying organisms. While a minor amount of seasonal water is commonly found in crawl spaces, significant amounts should not be present.

Photo 14-1  
Standing water at NW corner of crawl.

Rain runoff is the most common cause of wet crawl spaces, but water can come from other sources such as groundwater or underground springs. Recommend that a qualified person correct any issues related to outside perimeter grading and/or roof drainage (see any other comments about this in this report). If standing water persists, then recommend that a qualified contractor who specializes in drainage issues evaluate and repair as necessary. Typically such repairs include:

- Repairing, installing or improving underground footing and/or curtain drains
- Applying waterproof coatings to foundation walls
- Digging trenches in the crawl space to collect or divert water
- Installing sump pumps

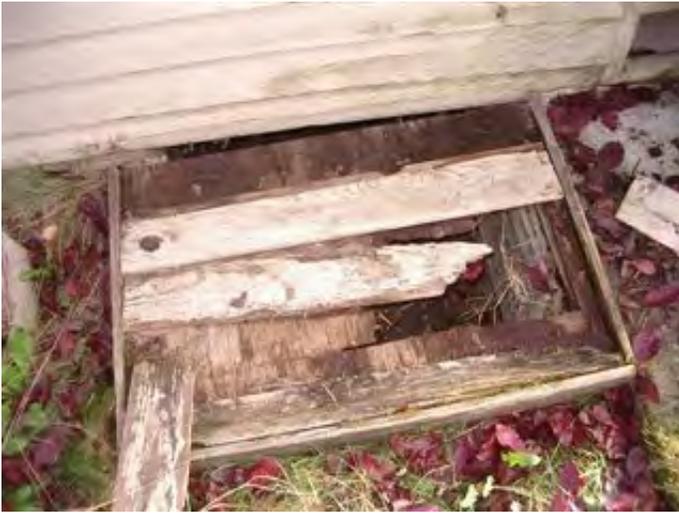
One or more outdoor crawl space access hatches or doors were missing, damaged, deteriorated or substandard. Water and/or vermin can enter the crawl space. Recommend that a qualified person replace, install or repair hatches or doors where necessary.

Photo 15-1  
Deteriorated crawl access hatch.

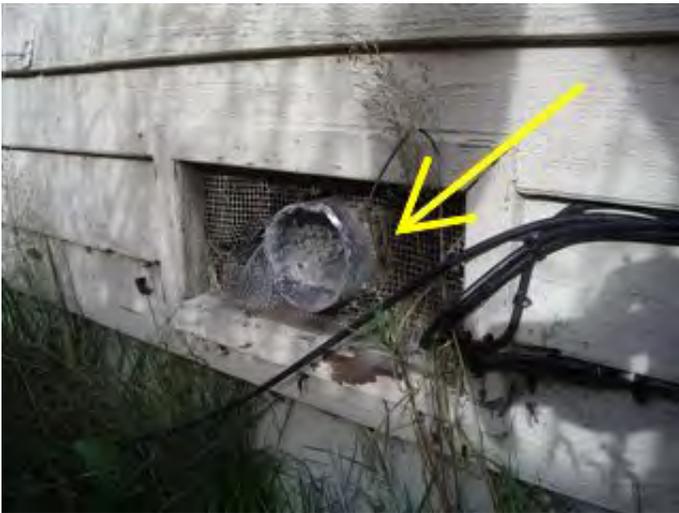
The screens for one or more crawl space vents were damaged. Vermin or pets can enter the crawl space and nest, die and/or leave feces and urine. Vermin often damage under-floor insulation too. Recommend that a qualified person install or replace screens where necessary using 1/8-inch to 1/4-inch wire mesh.

Photo 16-1  
Gaps in crawl vent on south side.

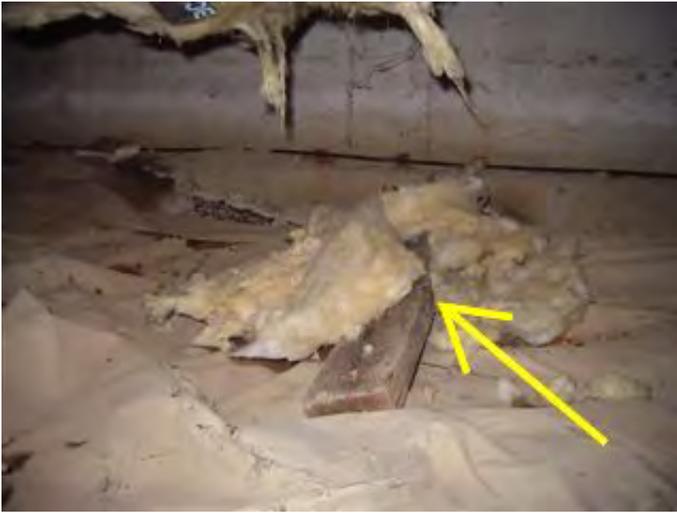
Under-floor insulation was damaged or deteriorated in some areas, and may result in reduced energy efficiency. Recommend that a qualified person repair or replace insulation as necessary.

Photo 17-1  
Fallen insulation.

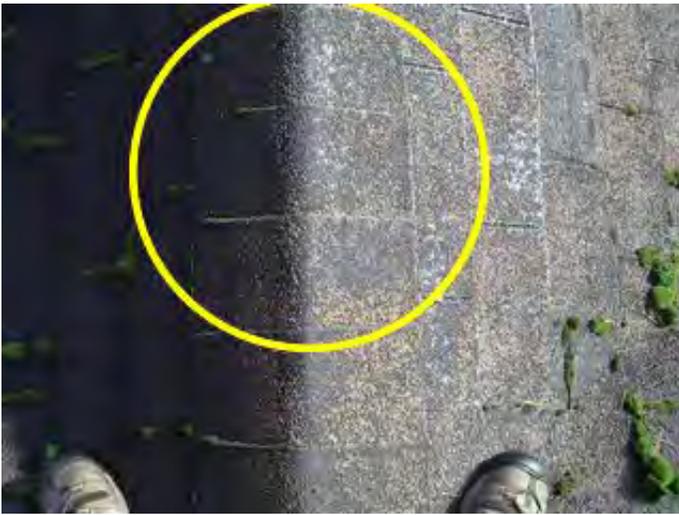
- 19) 🧰🔍 The roof surface was significantly deteriorated and appeared to be at or beyond its service life. It needs replacing now. This is a conducive condition for wood-destroying organisms. Consult with a qualified contractor to determine replacement options. Note that some structural repairs are often needed after old roof surfaces are removed and the structure becomes fully visible. Related roofing components such as flashings and vents should be replaced or installed as needed and per standard building practices.

Photo 19-1  
Deteriorated shingles on garage ridge.

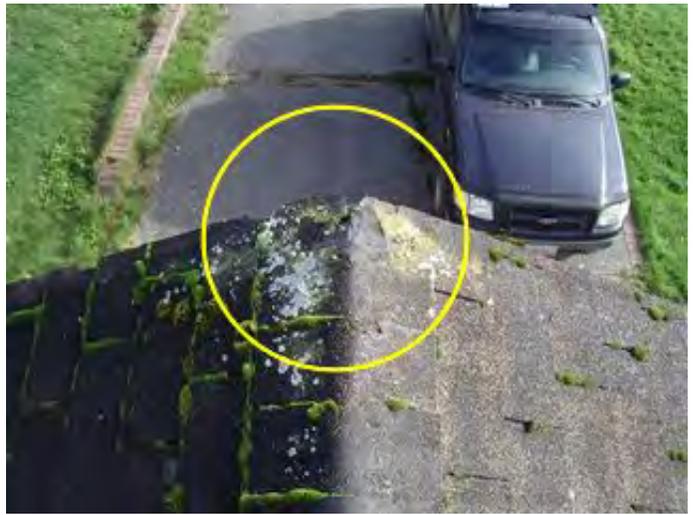
Photo 19-2  
Damaged shingles on garage ridge.

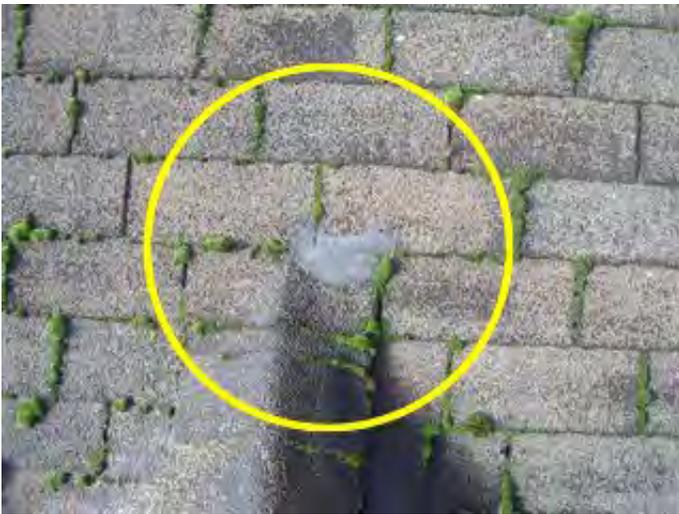
Photo 19-3  
Repairs on garage ridge.

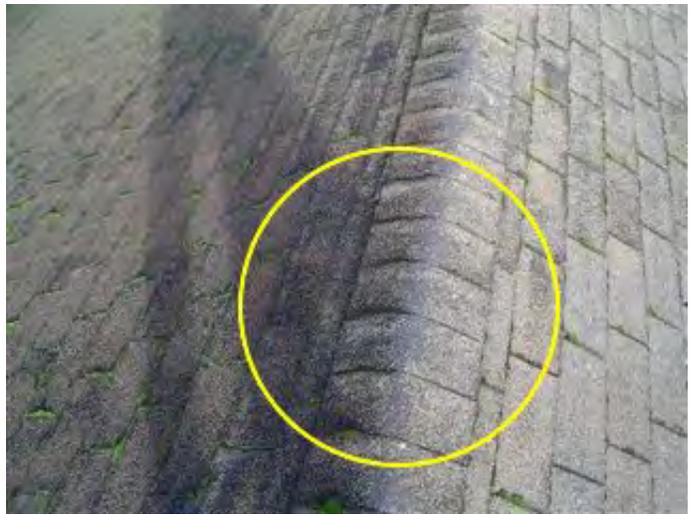
Photo 19-4  
Deteriorated shingles on house ridge.

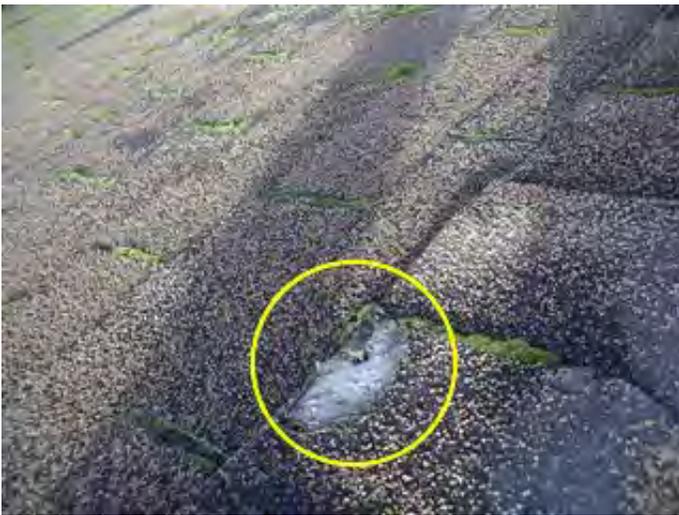
Photo 19-5  
Popped nail on house ridge.

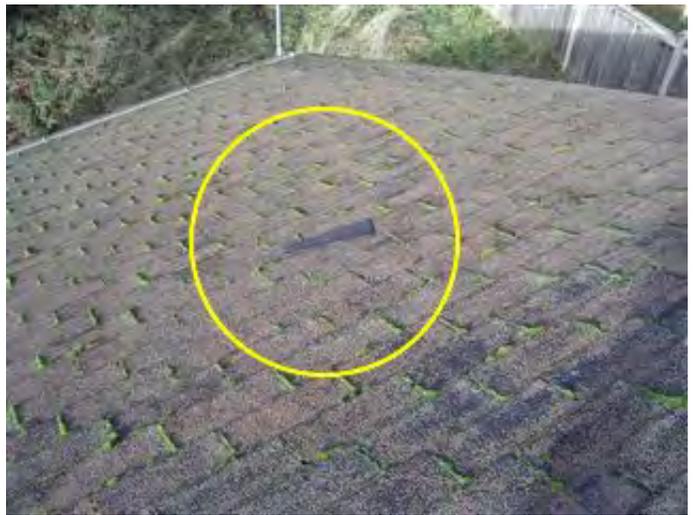
Photo 19-6  
Loose shingle.

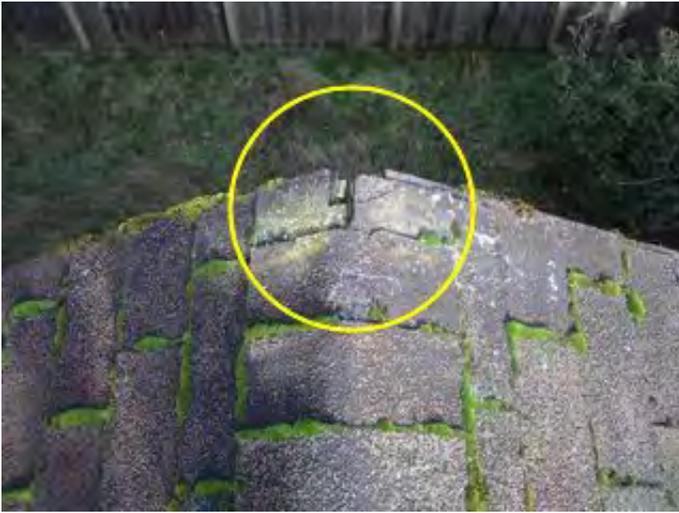
Photo 19-7  
Damaged shingles on north end ridge.

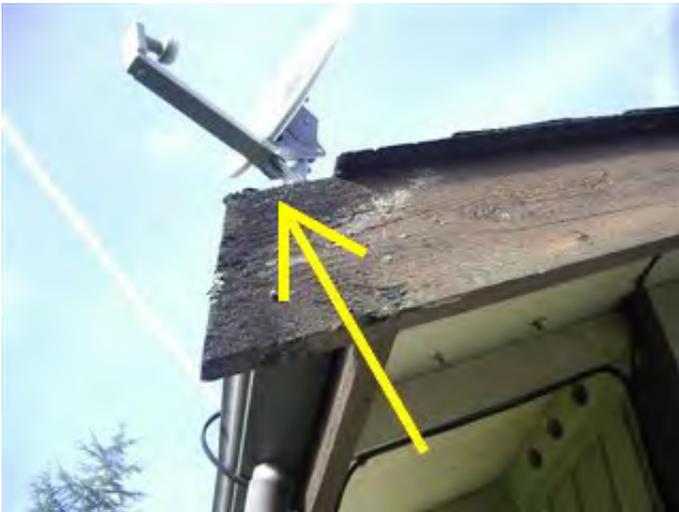
Barge boards, which are the trim boards at gable ends of roofs, were exposed at their lower ends, and were rotten. Standard building practices call for shingles or flashing to be installed over them to prevent rot. Recommend that a qualified contractor replace rotten boards and install shingles or flashing over exposed barge board ends where missing.

Photo 20-1  
Exposed barge board tail.

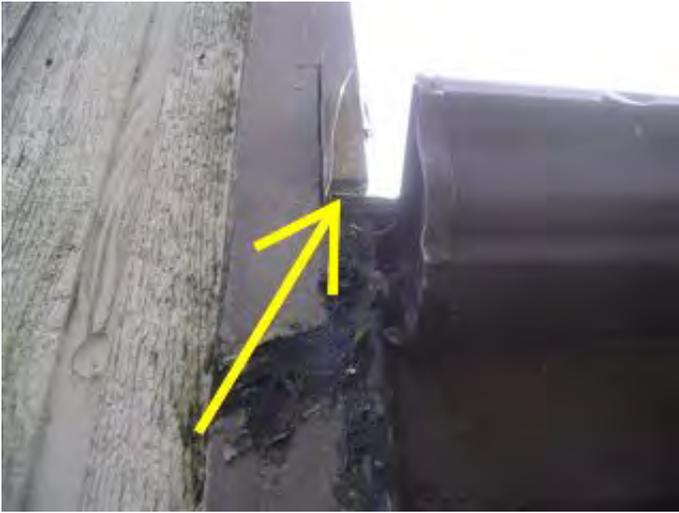
Kick-out flashing was missing at one or more locations. Such flashing should be located at the bottom of slopes where roof surfaces intersect with exterior walls above. It directs rainwater away from exterior walls and into gutters so that rainwater is less likely to run down the front surfaces of siding or flow behind siding. Recommend that a qualified contractor install kickout flashings where missing and per standard building practices.

Photo 21-1  
Missing kick-out flashing at chimney chase.

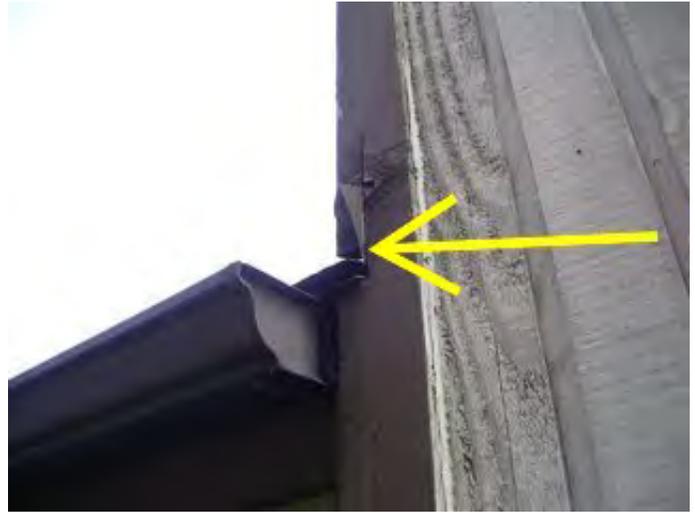
Photo 21-2  
Missing kick-out flashing at chimney chase.

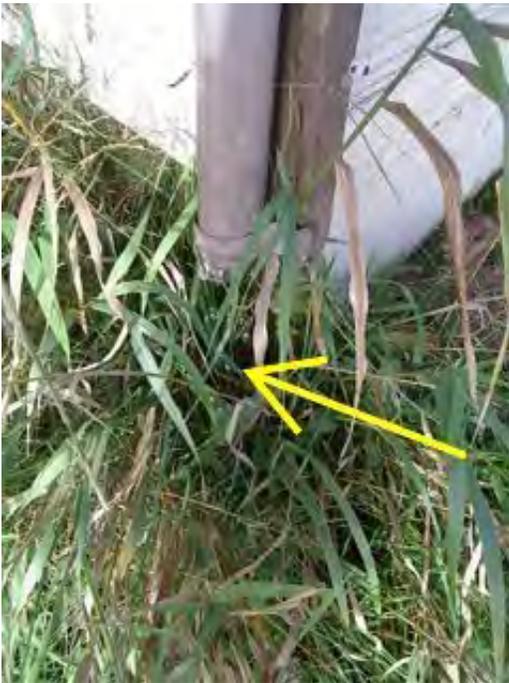
Extensions such as splash blocks or drain pipes for one or more downspouts were missing. Water can accumulate around the building foundation or inside crawl spaces or basements as a result. Recommend that a qualified person install, replace or repair extensions as necessary so rainwater drains away from the structure.

Photo 22-1  
Incomplete downspout at SE corner of garage.

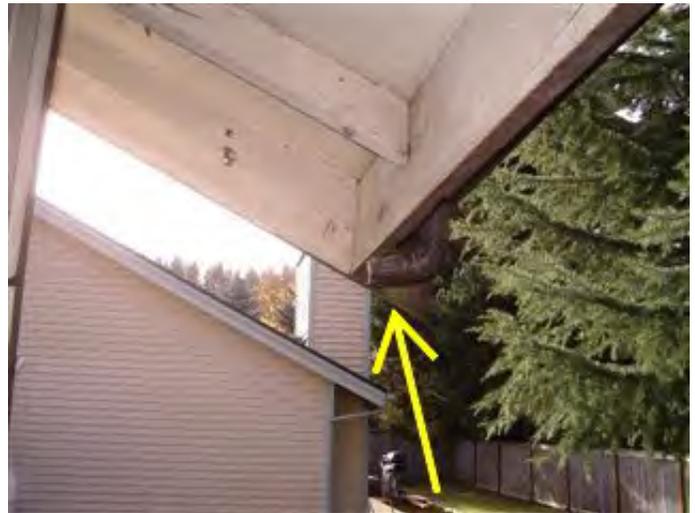
Photo 22-2  
Missing downspout at SW corner.

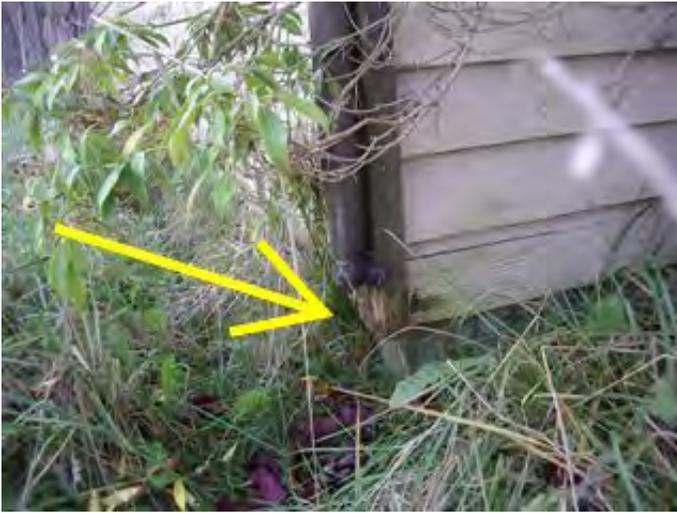
Photo 22-3  
Incomplete downspout at NW corner.

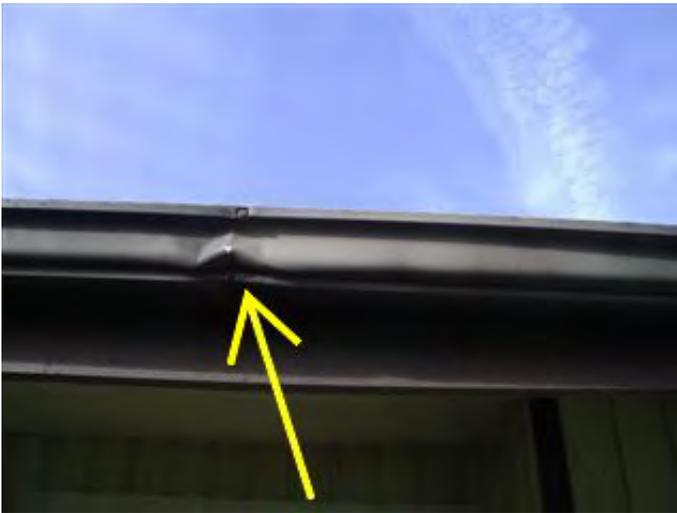
One or more gutters were damaged. Rainwater can come in contact with the building exterior or accumulate around the building foundation as a result. This is a conducive condition for wood-destroying organisms. Recommend that a qualified person repair as necessary.

Photo 23-1  
Damaged gutter on east side.

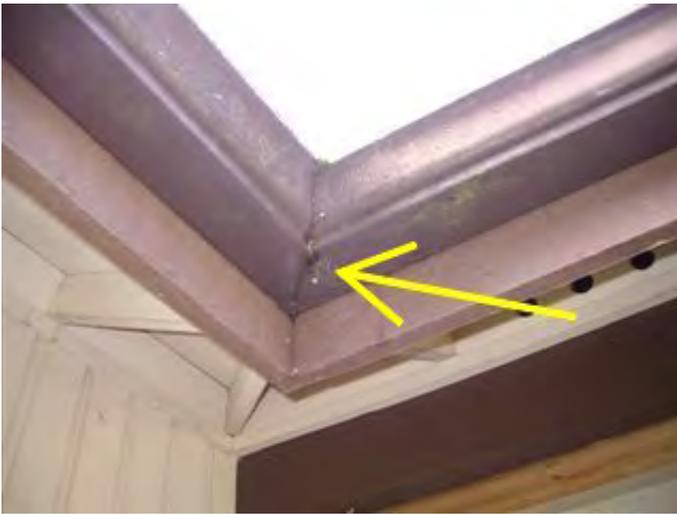
One or more gutters were leaking. Rainwater may come in contact with the building exterior or accumulate around the foundation as a result. This is a conducive condition for wood-destroying organisms. Recommend that a qualified person repair as necessary.

Photo 24-1  
Leaking gutter over entry.

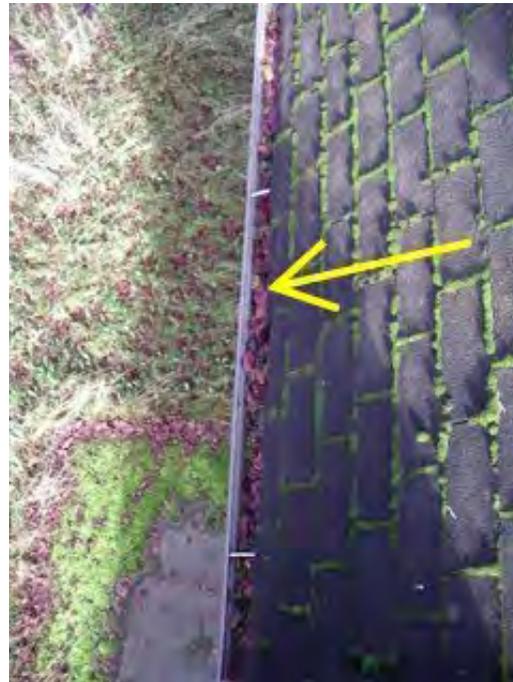
25) 🧰 Significant amounts of debris have accumulated in one or more gutters or downspouts. Gutters can overflow and cause water to come in contact with the building exterior, or water can accumulate around the foundation. This is a conducive condition for wood-destroying organisms. Recommend cleaning gutters and downspouts now and as necessary in the future.

Photo 25-2  
Debris in west gutter.

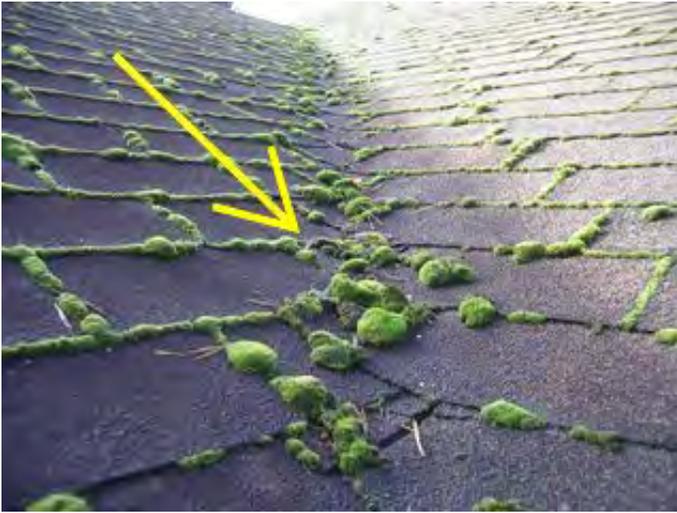
26) 🧰 Moss was growing on the roof. As a result, shingles can lift or be damaged. Leaks can result and/or the roof surface can fail prematurely. Efforts should be made to kill the moss during its growing season (wet months). Typically, zinc or phosphate-based chemicals are used for this and must be applied periodically. For information on various moss treatment products and their pros and cons, visit:  
<http://www.reporthost.com/?MOSS>

Photo 26-1  
Moss on roof.

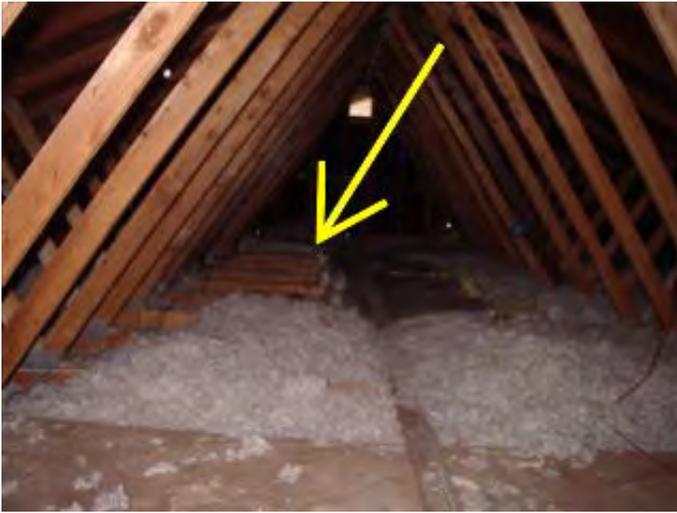
The ceiling insulation in one or more areas of the attic was compacted or uneven and/or missing. Heating and cooling costs may be higher due to reduced energy efficiency. Recommend that a qualified person repair, replace or install insulation as necessary and per standard building practices (typically R-38).

Photo 27-1  
Missing insulation in attic.

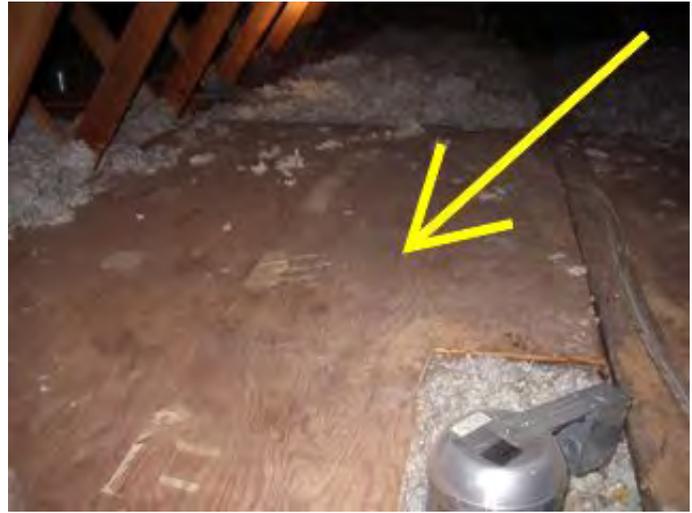
Photo 27-2  
Compacted insulation in attic.

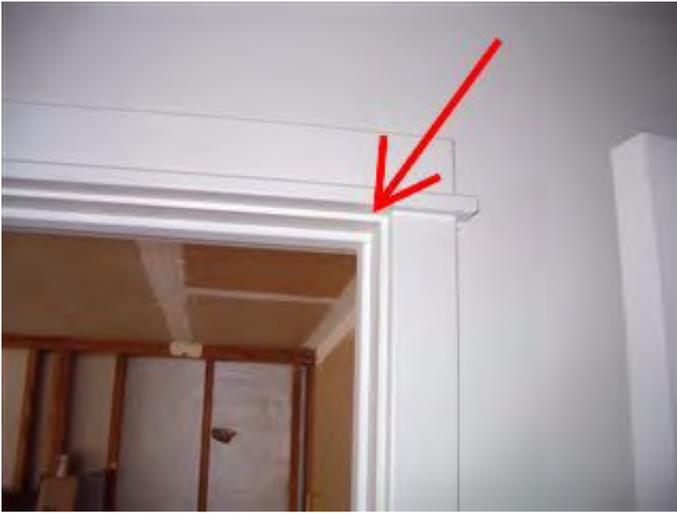
Weatherstripping around or at the base of the door between the garage and the house was missing. House to garage doors should prevent fire and fumes from spreading from the garage to the house. Weatherstripping should form a seal around this door. This is a potential safety hazard. Recommend that a qualified person replace or install weatherstripping as necessary.

Photo 31-1  
Missing weather stripping on garage to house door.

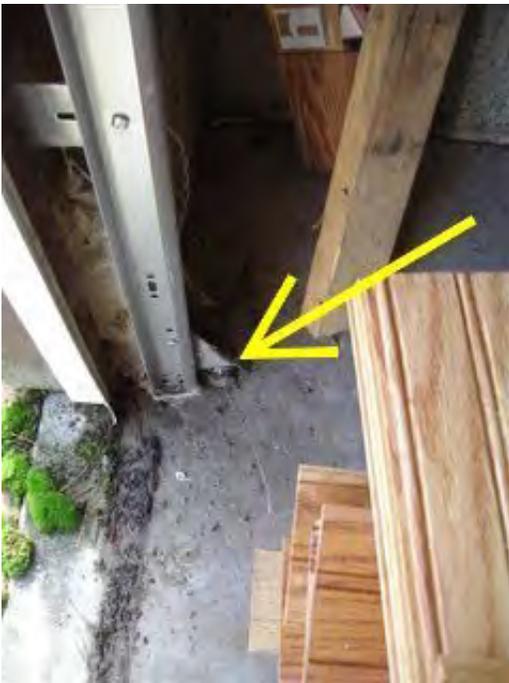
The automatic opener for one or more garage vehicle doors reversed when operated because the photoelectric sensors were loose. These sensors should reverse the door when closing to prevent injury when a person or pet passes through the sensors' beam. This is a safety hazard. A qualified person should repair as necessary. For more information on garage door safety issues, visit:

Photo 32-1  
Loose photoelectric sensor.

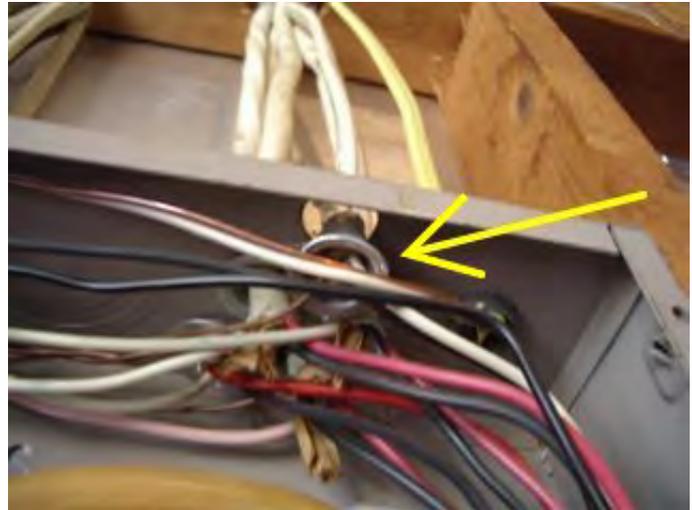
Photo 39-2

Loose bushing.

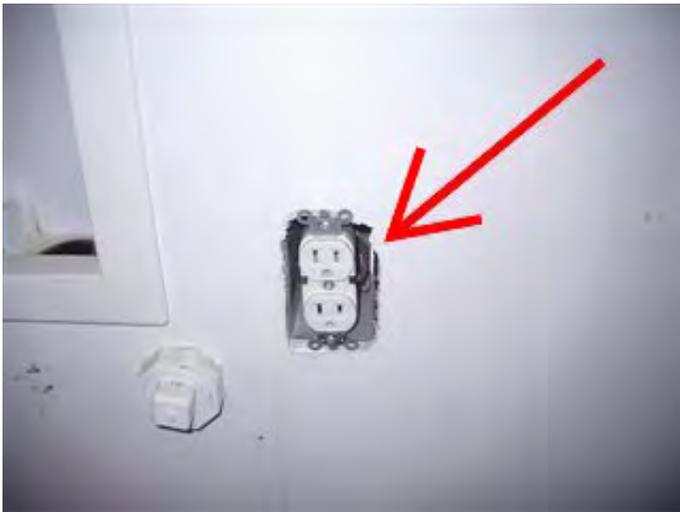
Photo 40-1  
Laundry room.

One or more cover plates for switches, receptacles (outlets) or junction boxes were missing or broken. These plates are intended to contain fire and prevent electric shock from occurring due to exposed wires. Recommend that a qualified person install cover plates where necessary.

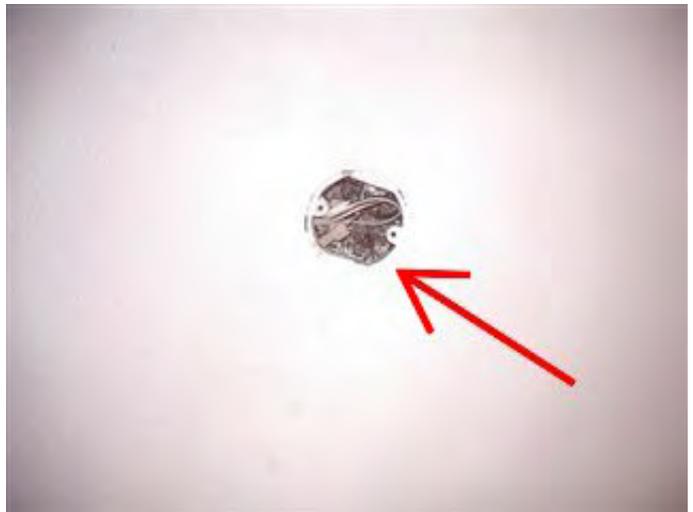
Photo 40-4  
Missing cover on junction box in hall.
