## Eagle Eye Real Estate Inspection Services

# Full General Home Inspection

Property address: **Your Home Town  
USA**

Inspection date: **XX/XX/2014**

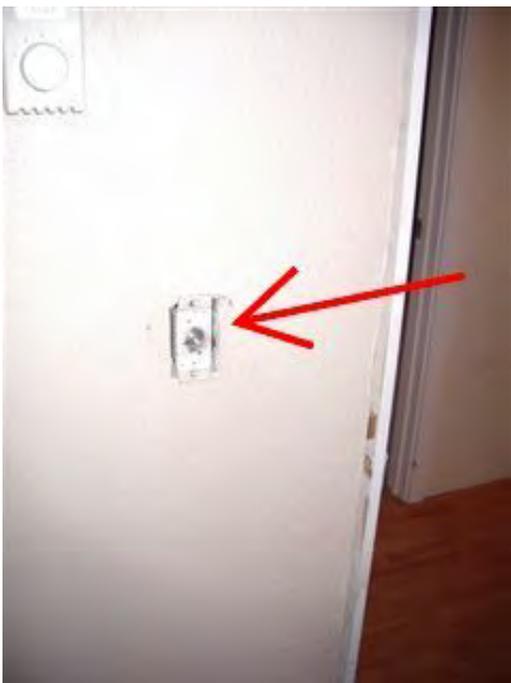
Photo 40-5  
Master bedroom.

One or more cover plates for switches, receptacles (outlets) or junction boxes were missing or broken. These plates are intended to contain fire and prevent electric shock from occurring due to exposed wires. Recommend that a qualified person install cover plates where necessary.

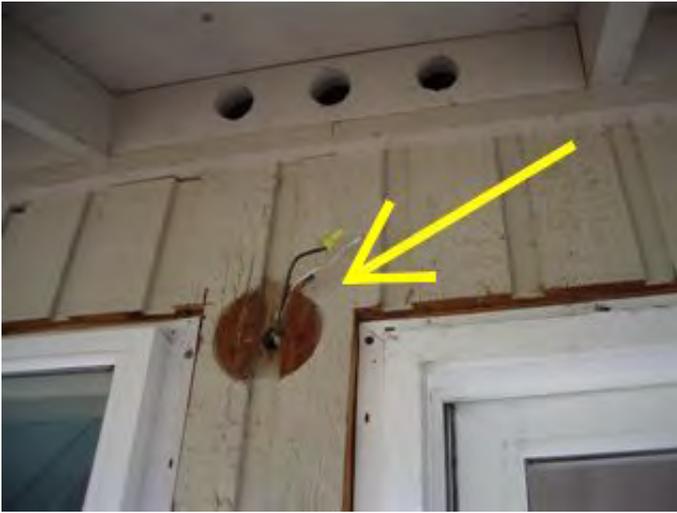
One or more light fixtures were missing. Recommend that a qualified electrician repair or replace light fixtures as necessary.

Photo 44-1  
Missing light fixture at rear patio.

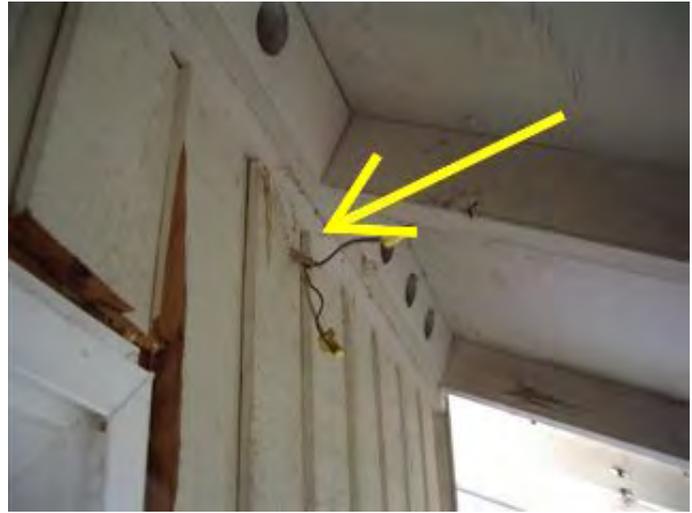
Photo 44-2  
Missing light fixture at rear patio.

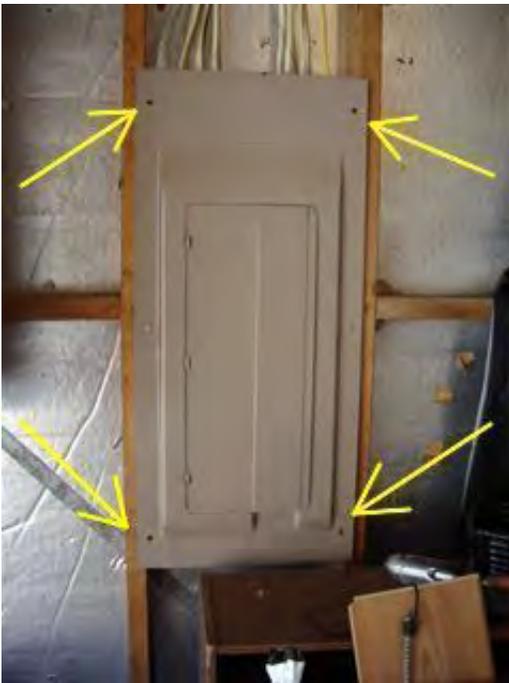
45) 🛠️ One or more screws that attach the cover or dead front to panel(s) #A were missing or not installed. Recommend installing screws where missing so the cover or dead front is secure. Only screws with blunt tips approved for this purpose should be installed, so wiring inside the panel is not damaged. Because energized wires may be located directly behind screw holes, the client should consider having a qualified electrician replace missing screws.

Photo 45-1  
Missing panel screws.

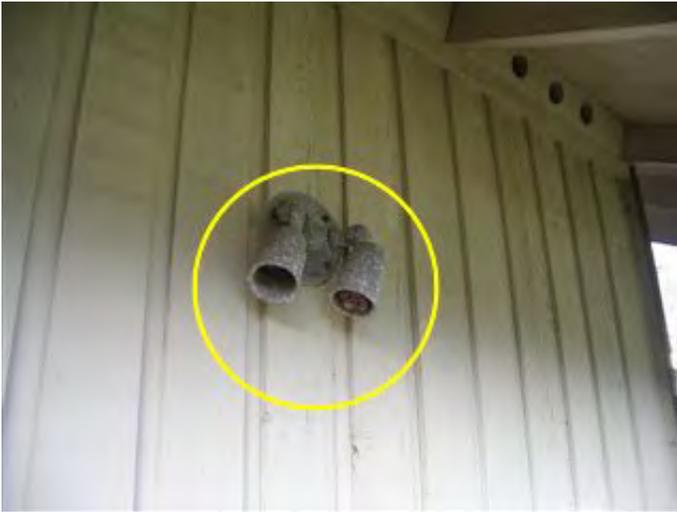
46) 🔍 Bulbs in one or more light fixtures were missing or broken. These light fixtures couldn't be fully evaluated. If replacement bulbs are inoperable, then recommend that a qualified electrician evaluate and repair or replace light fixtures as necessary.

Photo 46-1  
Missing bulbs on east wall fixture.

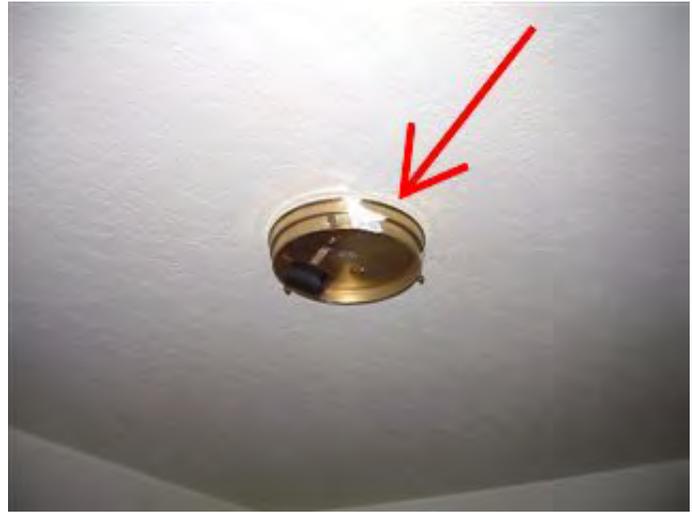
Photo 46-2  
Missing bulb in master closet.

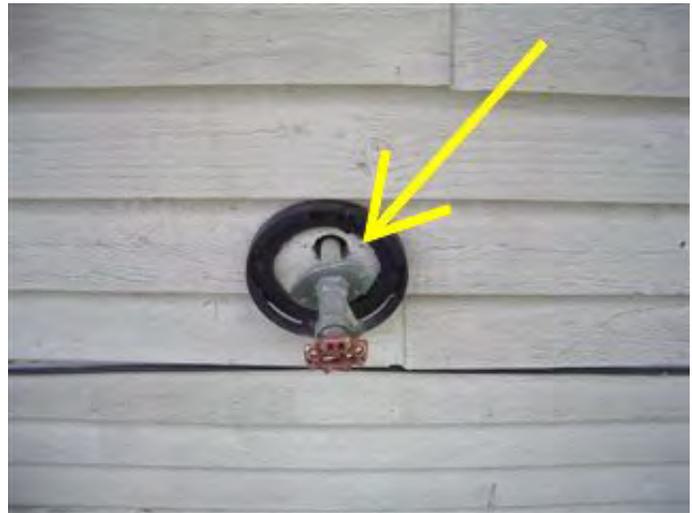
Photo 50-2  
Loose hose bibb on west wall.

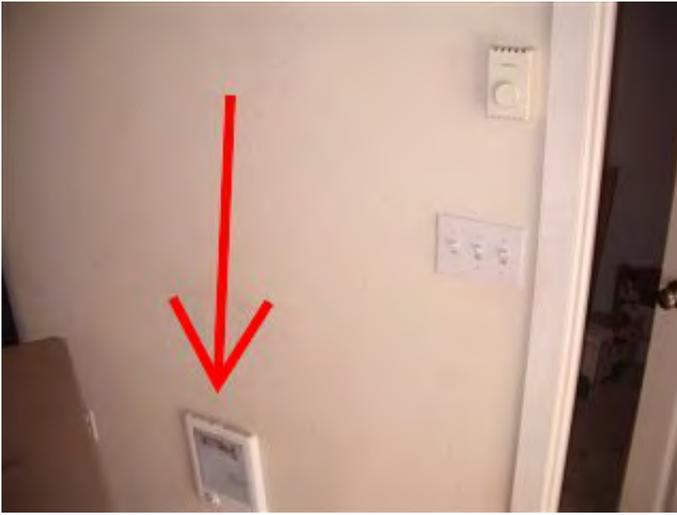
One or more fan-assisted electric heaters were inoperable. Recommend that a qualified electrician repair or replace heaters as necessary.

Photo 53-1  
Kitchen heater was inoperable.

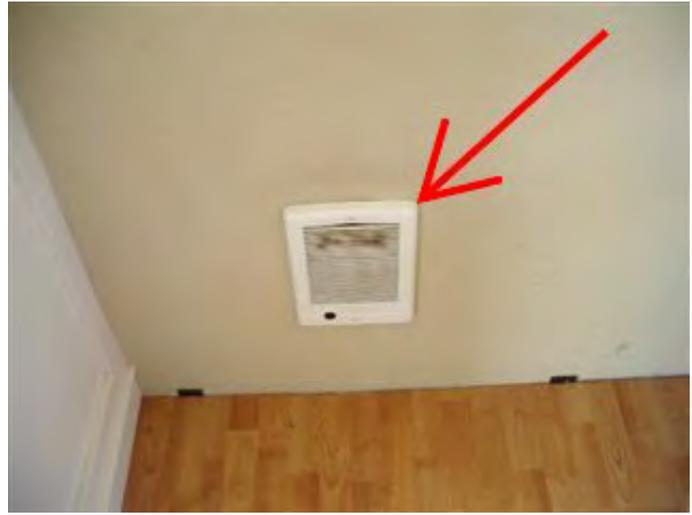
Photo 53-2  
Dining room heater was inoperable.

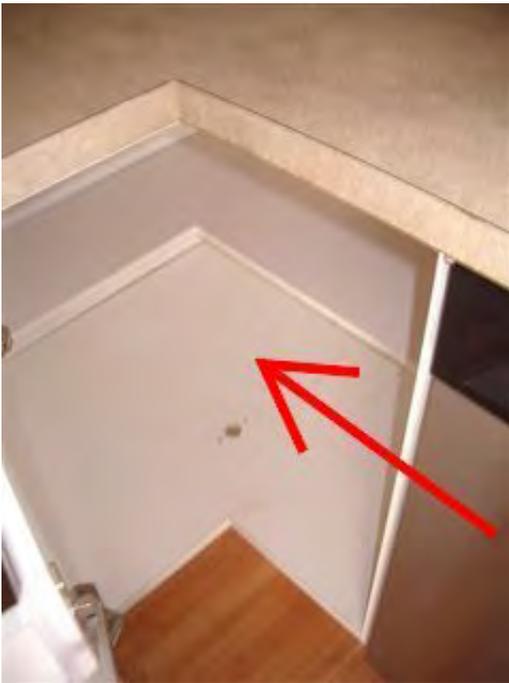
60) 🔧 Shelving or other components were missing from one or more cabinets. Recommend that a qualified person replace as necessary.

Photo 60-1  
Missing turntable in corner cabinet.

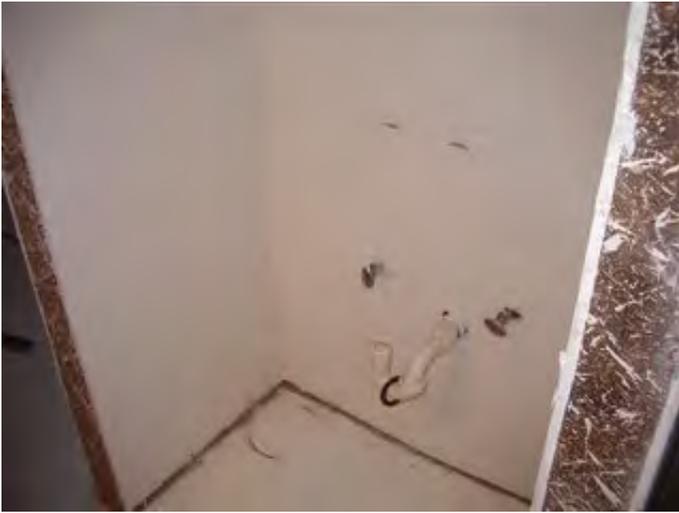
Bathroom #B was incomplete and missing fixtures including sink, toilet, shower fixtures, flooring, wall finish, etc.

Photo 64-1  
Bathroom #B was incomplete.

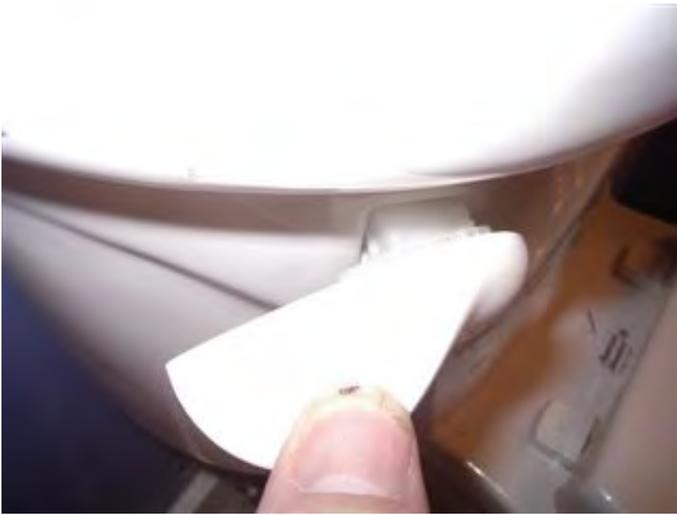
The handle for the toilet flush valve at location(s) #A was loose. Recommend that a qualified person replace or repair handles as necessary.

Photo 65-1  
Loose handle on toilet in bathroom #A.

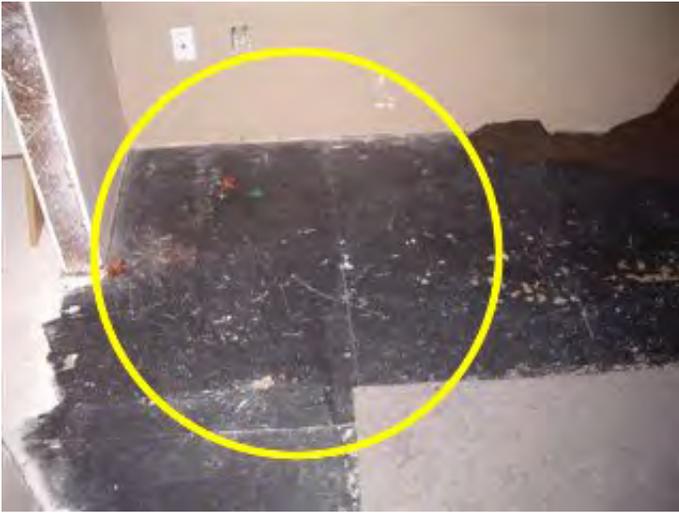
Flooring was missing in the master bedroom.

Photo 69-1  
No flooring in master bedroom.
