## **Eagle Eye Real Estate Inspection Services**

# Condominium Inspection

Property address: **Your Home Town  
USA**

Report number: 20141020-2

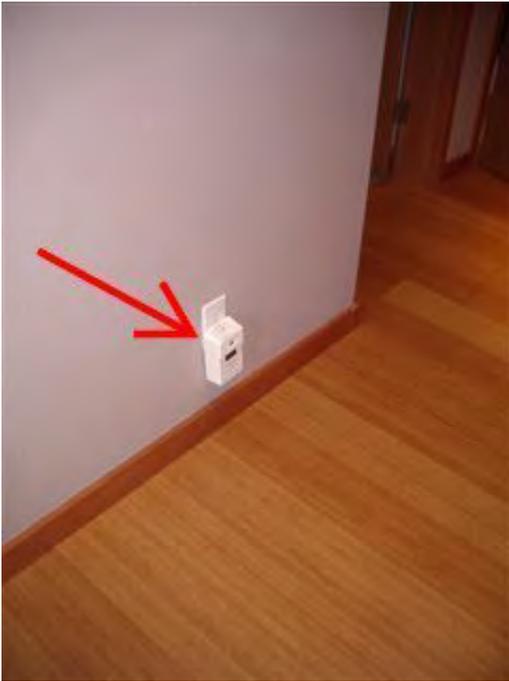
One or more "plug-in" type carbon monoxide alarms were found. Because such CO alarms can be easily removed, recommend that the client verify that CO alarms haven't been removed upon taking occupancy. If removed, then recommend installing new CO alarms outside of each separate sleeping area in the immediate vicinity of the bedrooms on each level and in accordance with the manufacturer's recommendations. Note that some states and/or municipalities require CO alarms to be installed for new construction and/or for homes being sold. For more information, visit:

Photo 4-1  
Plug in CO alarm.

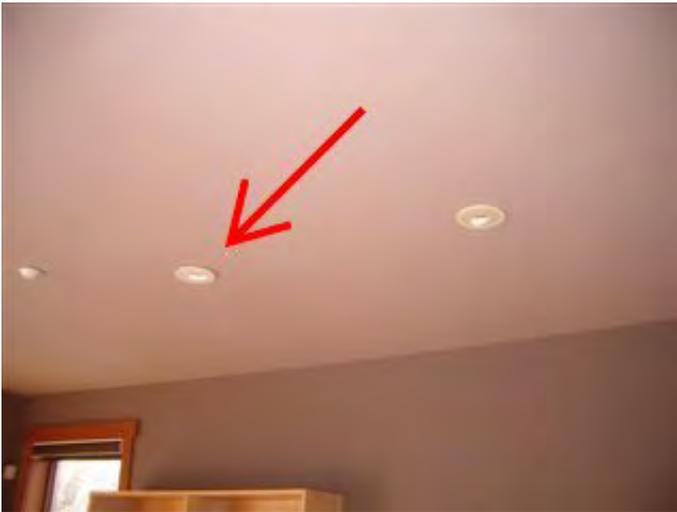
One or more light fixtures were loose. Recommend that a qualified electrician repair or replace light fixtures as necessary.

Photo 5-1  
Loose light fixture over fireplace.

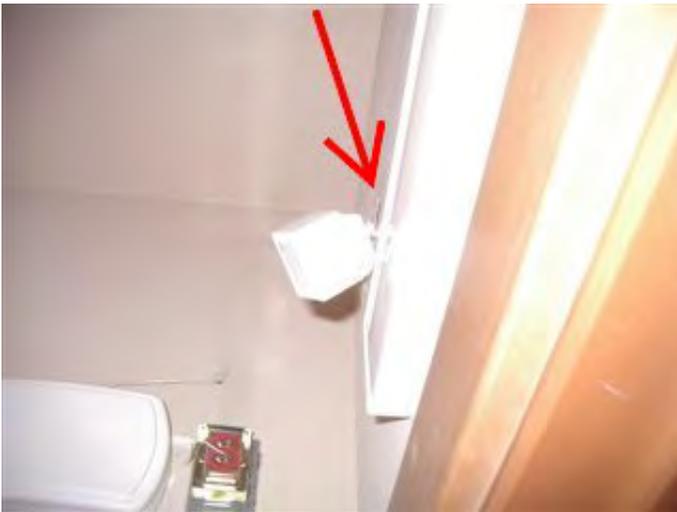
One or more light fixtures were inoperable (didn't turn on when nearby switches were operated) and components were loose. Recommend further evaluation by replacing bulbs and/or consulting with the property owner. If replacing bulbs doesn't work and/or no other switch(es) can be found, then recommend that a qualified electrician evaluate and repair or replace light fixtures as necessary.

Photo 6-1  
Loose motion sensor on light in entry coat closet.

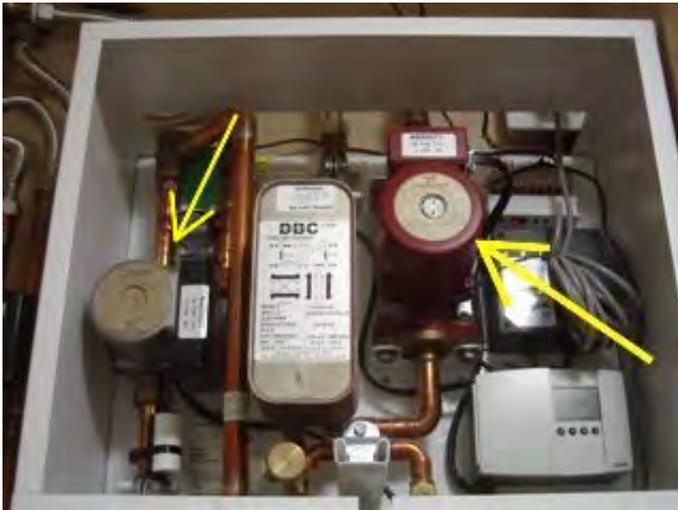
A circulating pump was installed for the hot water supply. It is intended to make hot water immediately available when faucets are turned on. Timers are typically integrated with these pumps, and should be configured so water circulates only at desired times for better energy efficiency. The client should familiarize themselves with the timer's operation and configure it as needed. Note that this is a specialty item and excluded from this inspection. The inspector did not determine if it was serviceable or operable.

Photo 10-1  
Circulating pumps.

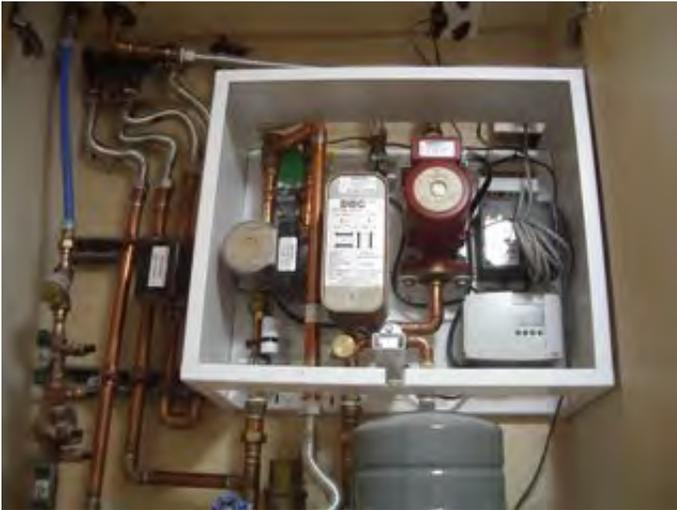
Photo 11-1

A hydronic/domestic hot water (DHW) system was installed, where one water heater appeared to supply hot water for both potable water (drinking, washing and bathing) and for heating interior spaces. This appears to be an "open" system, where a cross connect allows water from the hydronic loop to mix with water from the potable water loop. If not configured so high temperature flushes occur, this type of system can act as an "amplifier" for Legionella bacteria due to stagnant water being at low temperatures in the hydronic loop when the interior space heating system is inactive. This poses a risk for Legionnaires' disease. Such "open" systems are not allowed in some municipalities due to this risk. Recommend consulting with a qualified hydronic heating specialist to determine if the system is configured to perform high temperature flushes, and/or to discuss alternatives or modifications to this system. For more information, visit:

Domestic hot water and radiant heat controls.

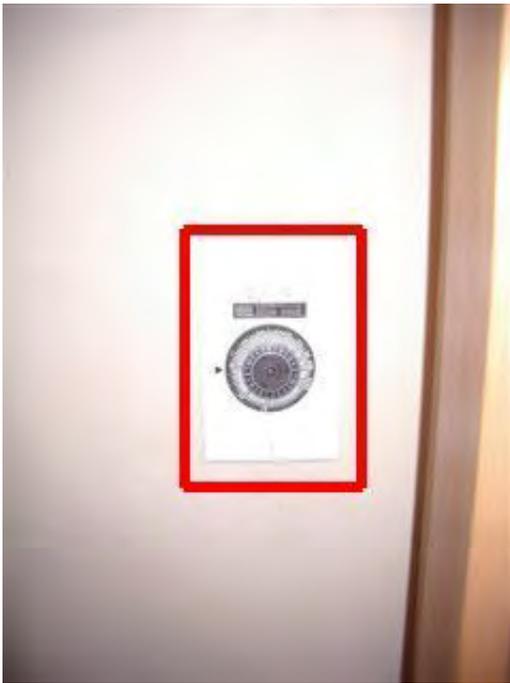
An exhaust fan with a 24 or 12 hour timer was installed and served as a simple ventilation system. The timer can be configured to operate the fan automatically one or more times per day for a set length of time. These fans help reduce moisture and stale air inside the house. Guidelines vary for when and how long such fans should be configured to operate depending on the size of the house, number of occupants and rating of the fan. Recommend reviewing instructions or documentation for the timer and configuring the fan as necessary. The inspector notes these systems when present, but does not determine their adequacy, or if the timer is operable. For more information, visit:

Photo 13-1  
24 hour timer in laundry.

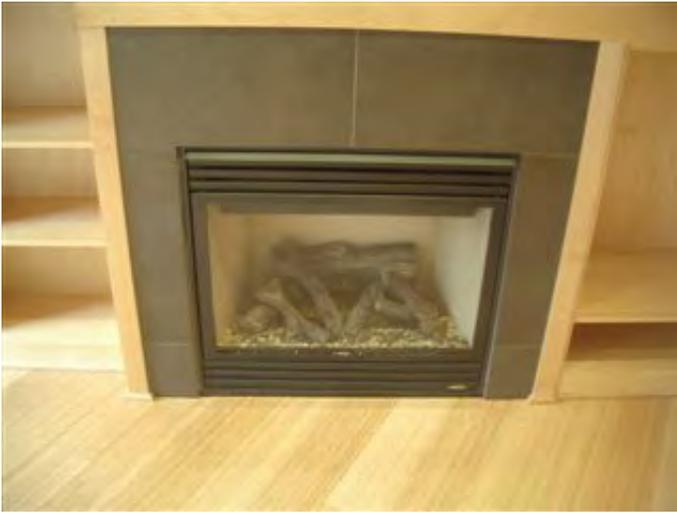
Recommend that the client review all available documentation for gas-fired fireplaces and stoves. Depending on how they are operated (for routine heating versus ambiance), such appliances may need servicing annually or every few years. Consult with the property owner and/or a qualified specialist to determine if service is needed now.

Photo 15-1  
Living room.

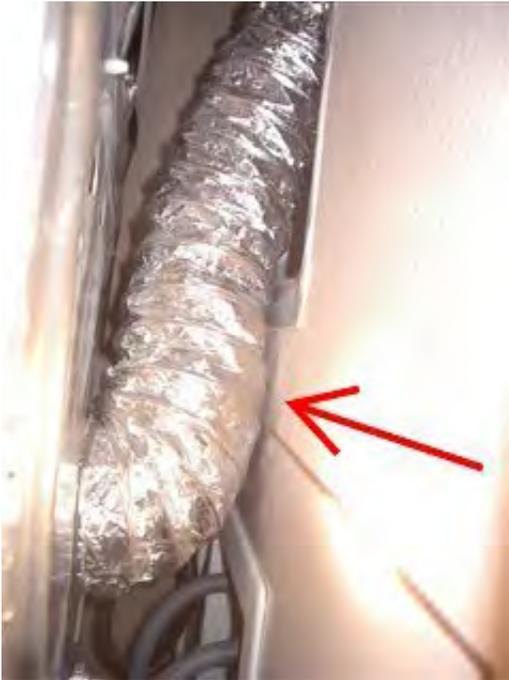
Photo 18-1

The clothes dryer was equipped with a vinyl or mylar, accordion-type, flexible exhaust duct. The U.S. Consumer Product Safety Commission considers these types of ducts to be unsafe, and a fire hazard. They can trap lint and are susceptible to kinks or crushing, which can greatly reduce the air flow and cause overheating. Recommend that such ducts be replaced with a rigid or corrugated semi-rigid metal duct, and by a qualified contractor if necessary. For more information, visit:

Mylar dryer duct.

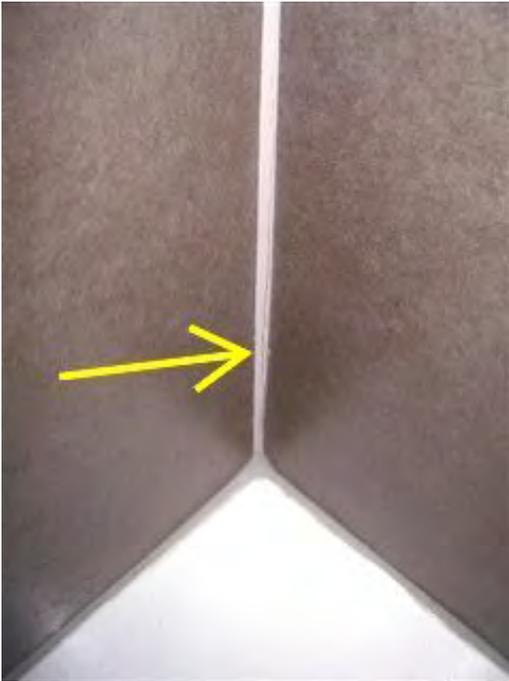
Tile and/or grout in the shower enclosure at location(s) #A were deteriorated (e.g. loose or cracked tiles, missing grout) or substandard. Water can damage the wall structure as a result. Recommend that a qualified contractor repair as necessary.

Photo 19-1  
Bathroom #A.

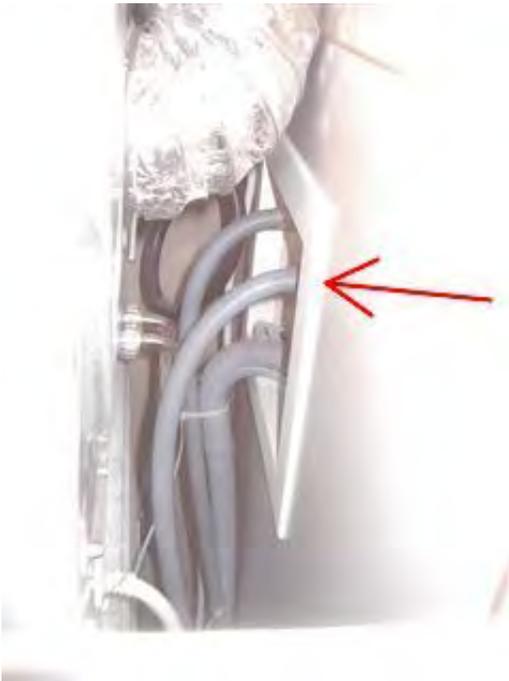
Rubber water supply hoses were installed at the clothes washer. These hoses are prone to bursting when deteriorated, which can result in flooding and significant water damage. Recommend upgrading to braided, stainless steel hoses.

Photo 20-1  
Rubber washer hoses.
