Eagle Eye Real Estate Inspection Services

Full General Home Inspection

Property address: **Your Home Town
USA**

Inspection date: **XX/XX/2014**

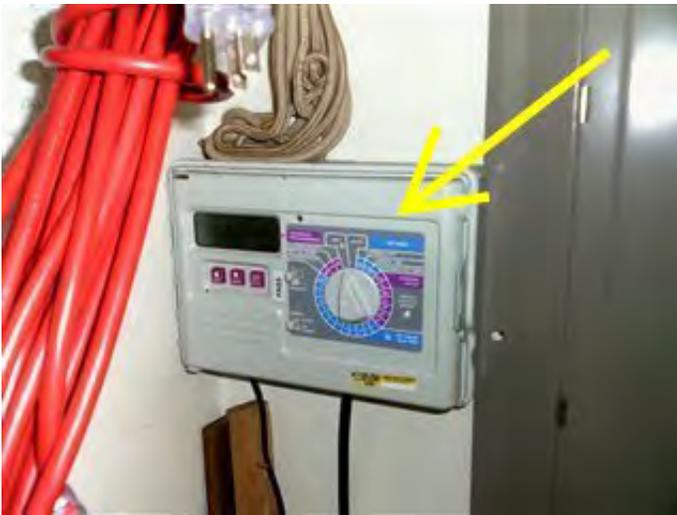
Based on visible equipment or information provided to the inspector, this property appeared to have a yard irrigation (sprinkler) system. These are specialty systems and are excluded from this inspection. Comments in this report related to this system are made as a courtesy only and are not meant to be a substitute for a full evaluation by a qualified specialist. When this system is operated, recommend verifying that water is not directed at building exteriors, or directed so water accumulates around building foundations. Sprinkler heads may need to be adjusted, replaced or disabled. Consider having a qualified plumber verify that a backflow prevention device is installed per standard building practices to prevent cross-contamination of potable water. Recommend that a qualified specialist evaluate the irrigation system for other defects (e.g. leaks, damaged or malfunctioning sprinkler heads) and repair if necessary.

Photo 25-1
Sprinkler control.

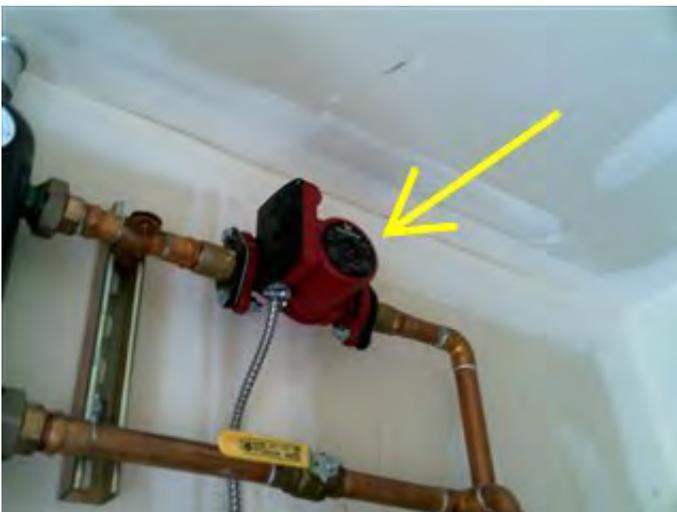
Photo 28-1

Several circulating pumps were installed for the hot water supply. They are intended to make hot water immediately available when faucets are turned on. Timers are typically integrated with these pumps, and should be configured so water circulates only at desired times for better energy efficiency. The client should familiarize themselves with the timer's operation and configure it as needed. Note that this is a specialty item and excluded from this inspection. The inspector did not determine if it was serviceable or operable.

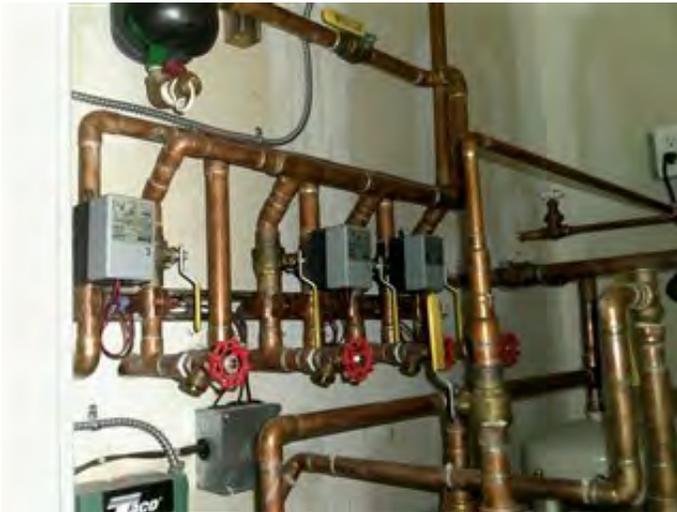
Photo 30-1

This home appeared to have a radiant hydronic (hot water) heating system. These systems are typically heated with a boiler or water heater. The distribution piping is mostly hidden and inaccessible. Only a limited evaluation was performed, typically by measuring floor temperatures at the beginning of the inspection and again at the end after the system has been turned on for some time. Even if this system is operable, the inspector does not determine if it is adequate or fully functional. Manufacturers of these systems typically recommend that they be serviced annually, especially if a boiler is used for the heat source. Recommend consulting with the property owner about past maintenance or repairs, and reviewing documentation if possible. If this system has not been serviced within the last year, or if unable to determine when it was last serviced, recommend that a qualified specialist evaluate and perform maintenance or repairs if necessary.

Radiant floor heating supply piping.

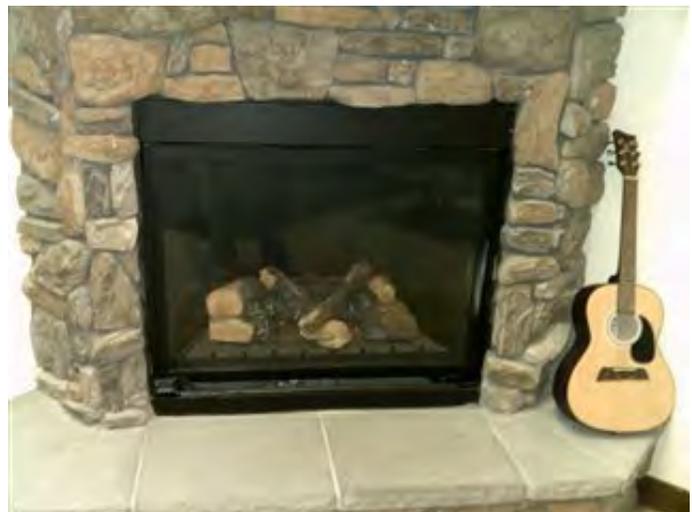
Photo 33-2

Master bedroom.

33) 🛠️ 🔍 Recommend that the client review all available documentation for gas-fired fireplaces and stoves. Depending on how they are operated (for routine heating versus ambiance), such appliances normally need servicing annually or every few years. Consult with the property owner and/or a qualified specialist to determine if service is needed now.
