## **Eagle Eye Real Estate Inspection Services**

# Full General Home Inspection

Property address: **Your Home Town  
USA**

Inspection date: **XX/XX/2014**

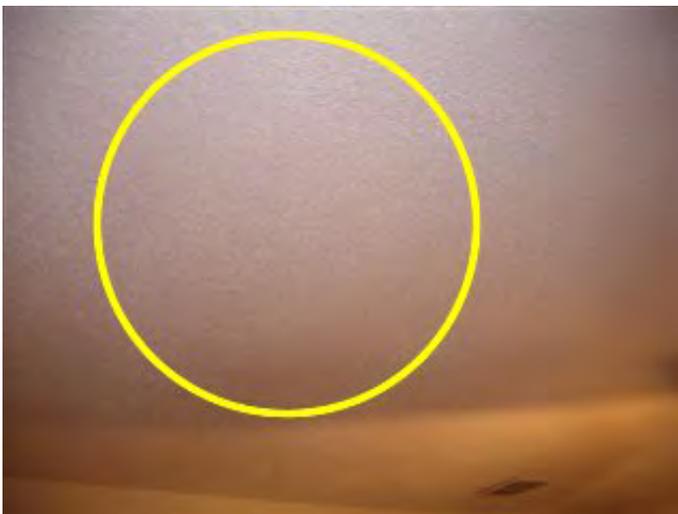
Photo 1-1

Basement ceiling in SW bedroom.

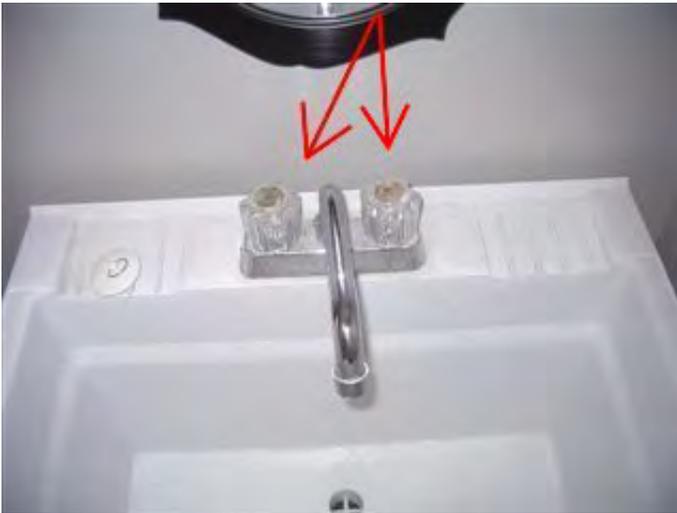
Photo 63-1

The hot and cold water supplies appeared to be reversed at the sink at location(s) #C. Normally, cold water is controlled by the right faucet handle and hot by the left. For mixing faucets, cold is supplied with the handle to the right and hot when the handle is to the left, or as indicated by the faucet's markings. At a minimum this is an inconvenience, but it can also result in accidental scalding. Recommend that a qualified plumber repair as necessary.

Reverse plumbed laundry sink.

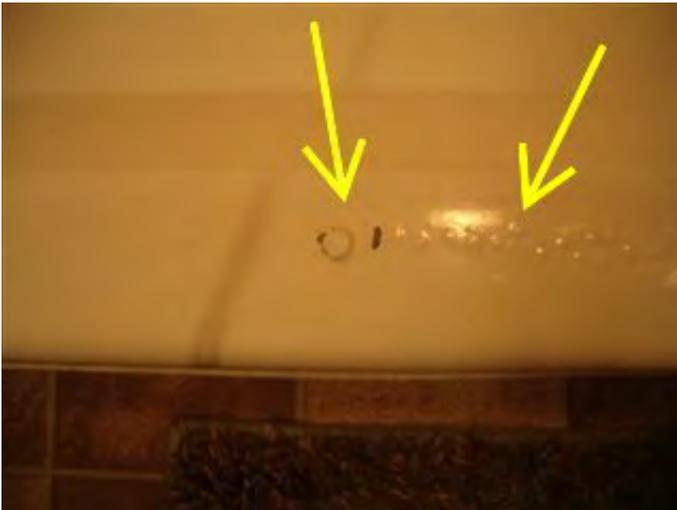
Photo 64-1

The shower enclosure at location(s) #B was deteriorated, damaged or substandard. Water can damage the wall structure as a result. Recommend that a qualified contractor repair or replace the surround as necessary.

Deteriorated curb on bathroom #B shower enclosure.

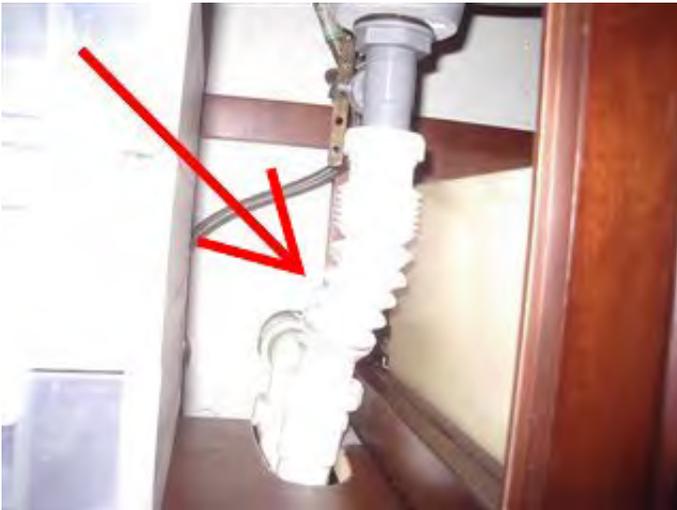
Ribbed, flexible drain pipe was used at the sink at location(s) #B and D. This type of drain pipe accumulates debris more easily than smooth wall pipe and is likely to clog. Recommend that a qualified plumber replace flexible piping with standard plumbing components (smooth wall pipe) to prevent clogged drains.

Photo 67-1  
Bathroom #B.

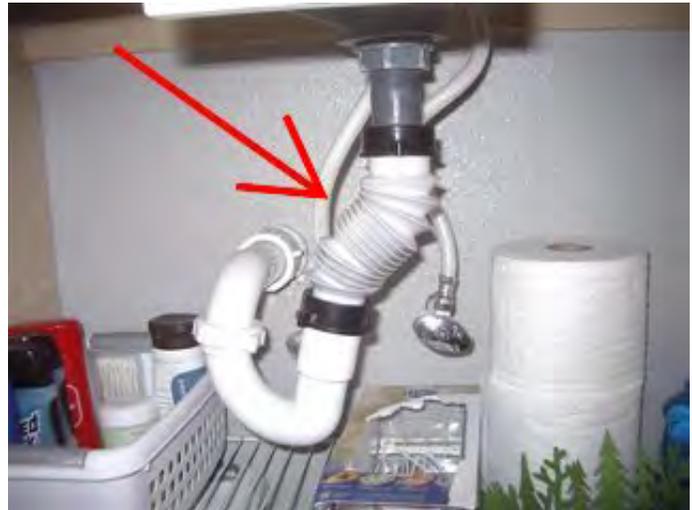
Photo 67-2  
Bathroom #D.

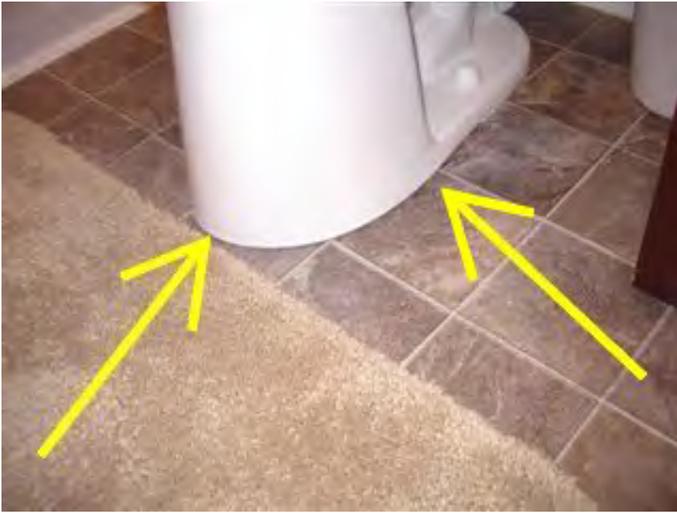
Caulk around the base of the toilet at location(s) #A and D was missing, substandard and/or deteriorated. Modern standards require caulk to be installed around the entire toilet base where it meets the floor for sanitary reasons. Without it, soiled water can soak into flooring and sub-floor materials if the toilet overflows. Condensation from the toilet can also soak into the flooring. Recommend that a qualified person caulk around toilet bases per standard building practices.

Photo 68-1  
Bathroom #A.
