## Eagle Eye Real Estate Inspection Services

# Full General Home Inspection

Property address: **Your Home Town  
USA**

Inspection date: **XX/XX/2014**

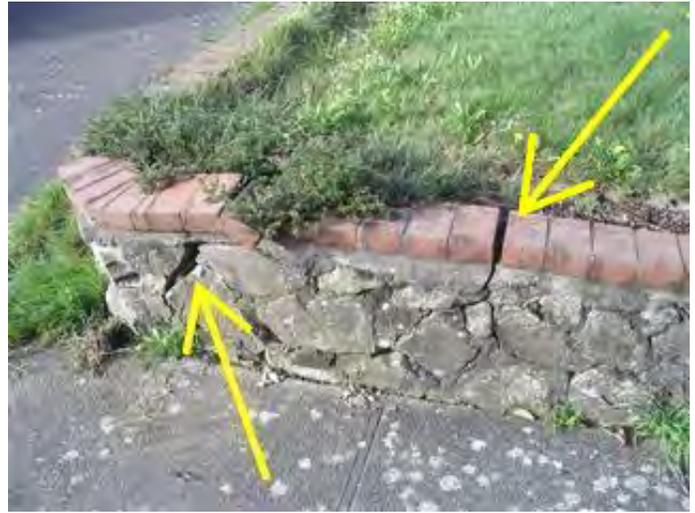
Significant cracks, deterioration, leaning and/or bowing were found in one or more retaining walls. Recommend that a qualified contractor evaluate and repair or replace sections as necessary. Note that some retaining walls, based on their height or size, may require evaluation by a structural engineer.

Photo 3-2  
Retaining wall at sidewalk.

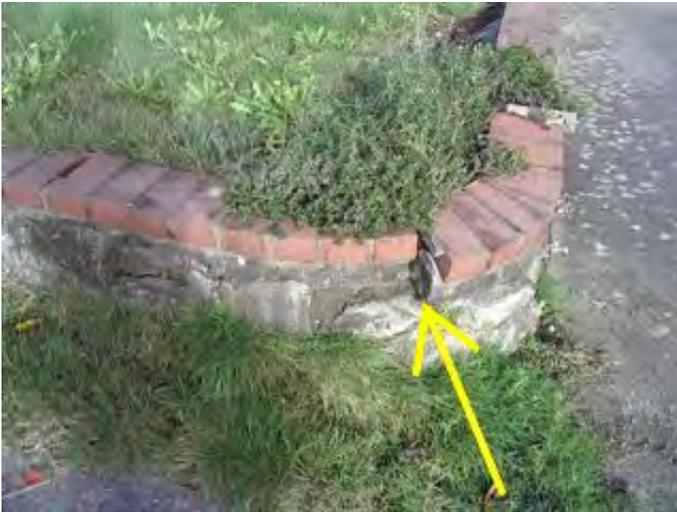
Photo 3-3  
Retaining wall at sidewalk.

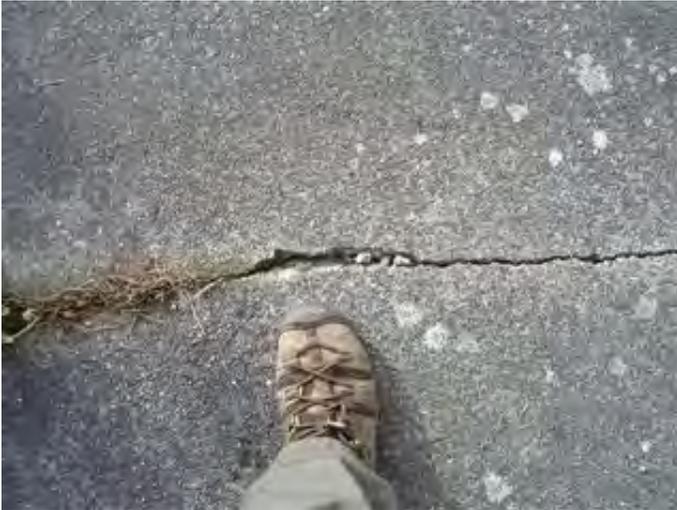
6) **i** Minor deterioration (e.g. cracks, holes, settlement, heaving) was found in the driveway, but no trip hazards were found. The client may wish to have repairs made for cosmetic reasons.

Photo 6-1  
Driveway.

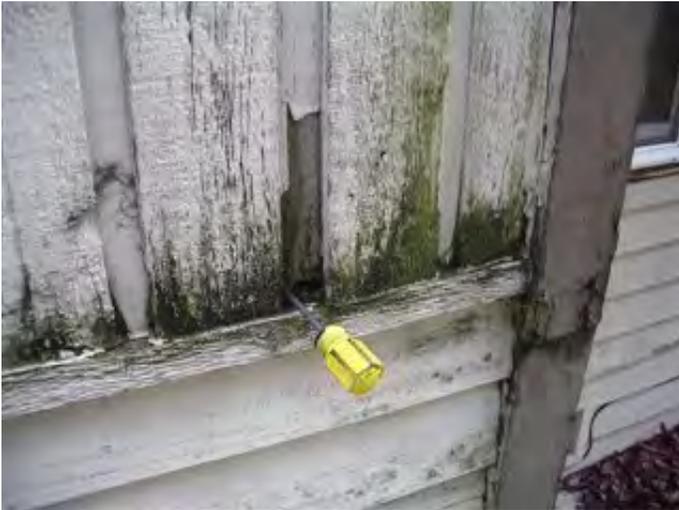
Fungal rot was found at one or more sections of siding or trim. Conducive conditions for rot should be corrected (e.g. wood-soil contact, reverse perimeter slope). Recommend that a qualified person repair as necessary. All rotten wood should be replaced.

Photo 9-3  
Rot in siding on chimney chase.

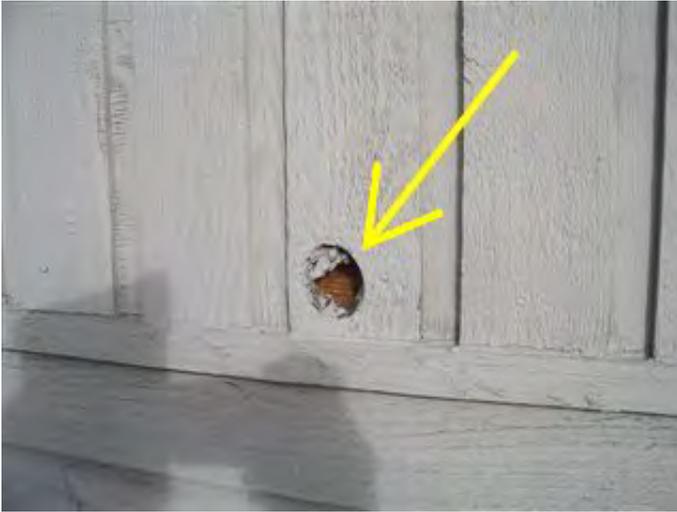
One or more holes or gaps were found in siding or trim. Vermin, insects or water may enter the structure. Recommend that a qualified person repair as necessary.

Photo 10-1  
Hole in siding on south side of garage.

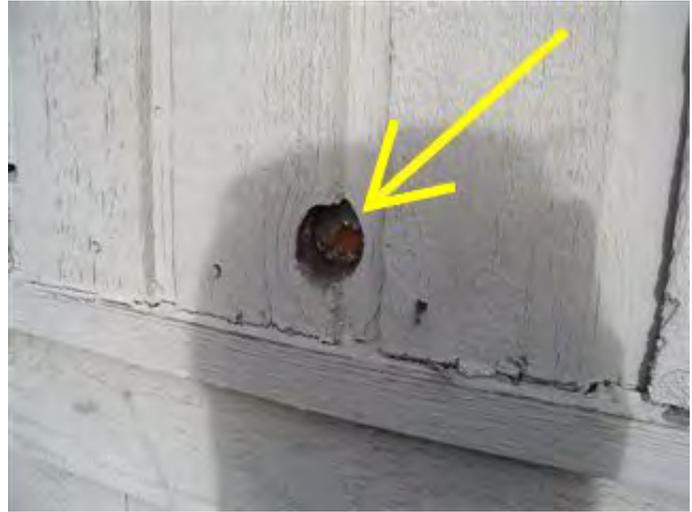
Photo 10-2  
Hole in siding on south side.

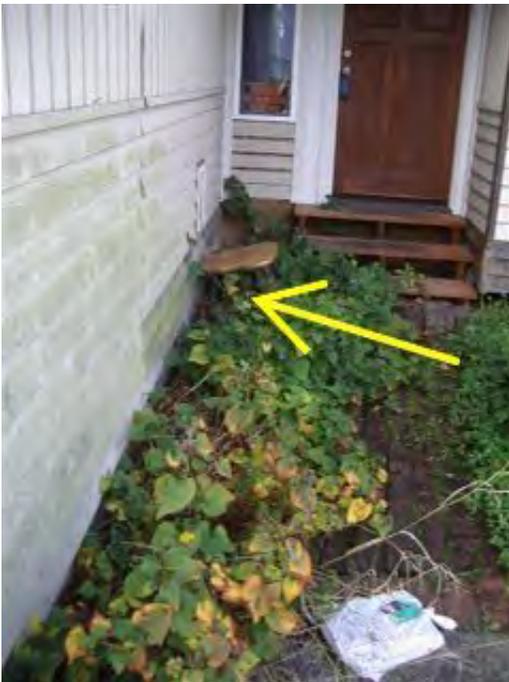
Vegetation such as trees, shrubs and/or vines was in contact with or close to the building exterior. Vegetation can serve as a pathway for wood-destroying insects and can retain moisture against the exterior after it rains. This is a conducive condition for wood-destroying organisms. Recommend pruning, moving or removing vegetation as necessary to maintain at least 6 inches of space between it and the building exterior. A 1-foot clearance is better.

Photo 11-1  
Vegetation north wall of garage.

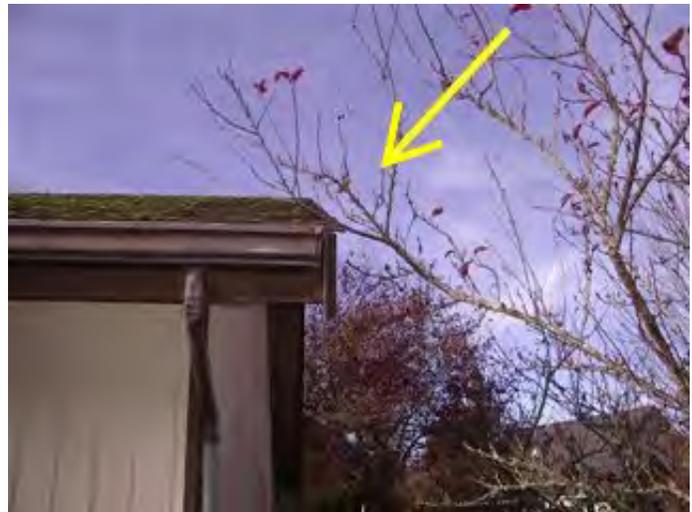
Photo 11-2  
Vegetation contact at NE corner.

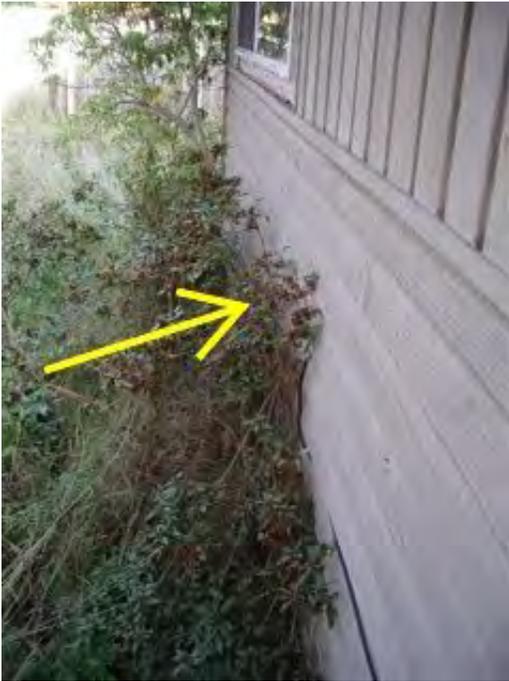
Photo 11-3  
Vegetation on west wall.

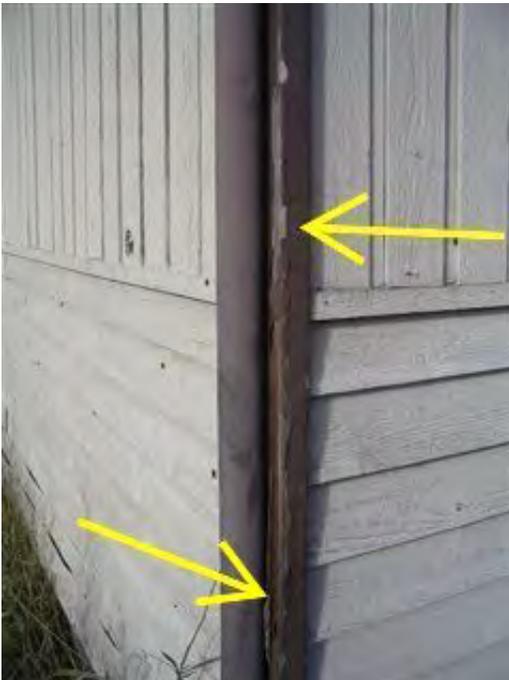
The paint or stain finish in some areas was failing (e.g. peeling, faded, worn, thinning). Siding and trim with a failing finish can be damaged by moisture. Recommend that a qualified contractor prep (e.g. clean, scrape, sand, prime, caulk) and repaint or restain the building exterior where necessary and per standard building practices. Any repairs needed to the siding or trim should be made prior to this.

Photo 12-1  
SE corner of garage.

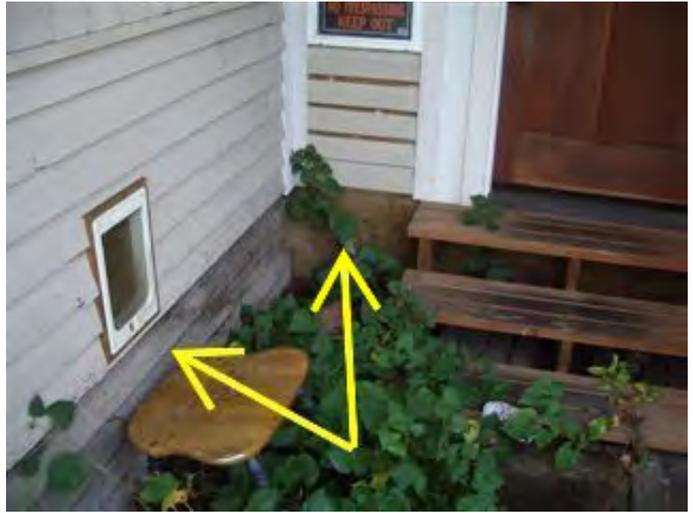
Photo 12-4  
Incomplete finish on siding by entry.

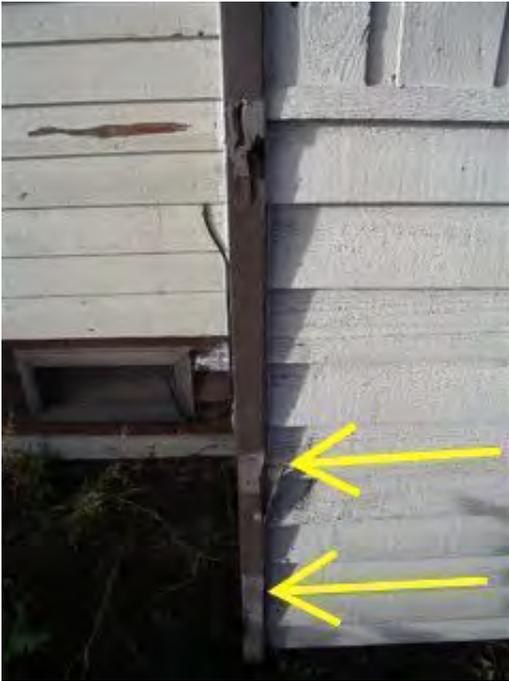
Photo 12-7  
Deteriorated finish on east side.

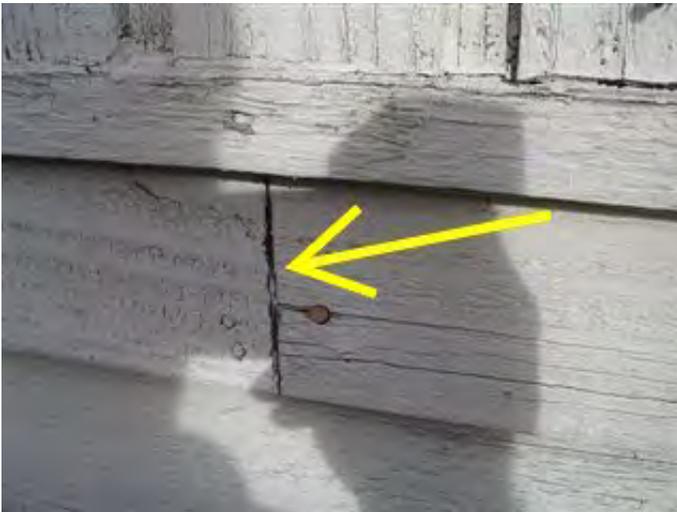
Caulk was deteriorated in some areas. For example, at siding-trim junctions. Recommend that a qualified person renew or install caulk as necessary. Where gaps are wider than 1/4 inch, an appropriate material other than caulk should be used. For more information, visit: <http://www.reporthost.com/?CAULK>

Photo 13-1  
Deteriorated caulk on south side.

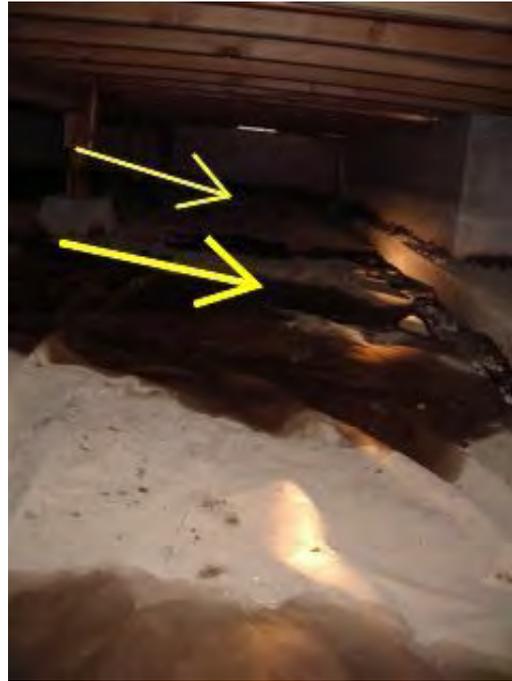
Standing water was found at one or more locations in the crawl space. Water from crawl spaces can evaporate and enter the structure above causing high levels of moisture in the structure. This is a conducive condition for wood-destroying organisms. While a minor amount of seasonal water is commonly found in crawl spaces, significant amounts should not be present.

Photo 14-2  
Standing water along west wall of crawl.

Rain runoff is the most common cause of wet crawl spaces, but water can come from other sources such as groundwater or underground springs. Recommend that a qualified person correct any issues related to outside perimeter grading and/or roof drainage (see any other comments about this in this report). If standing water persists, then recommend that a qualified contractor who specializes in drainage issues evaluate and repair as necessary. Typically such repairs include:

- Repairing, installing or improving underground footing and/or curtain drains
- Applying waterproof coatings to foundation walls
- Digging trenches in the crawl space to collect or divert water
- Installing sump pumps

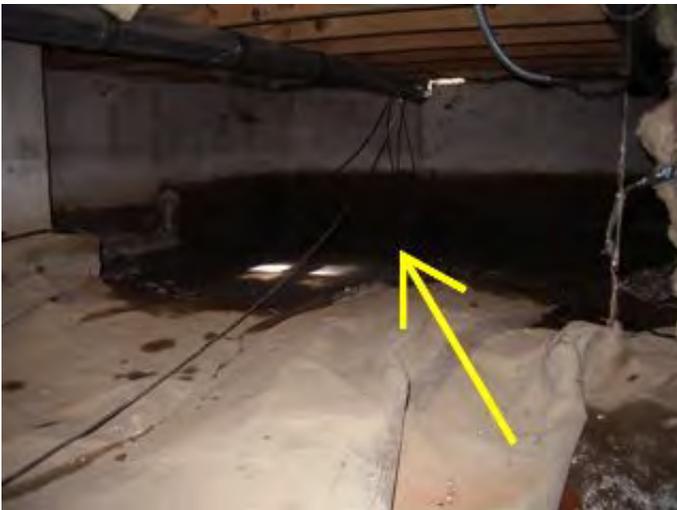
Photo 14-3  
Standing water at SE corner of crawl.

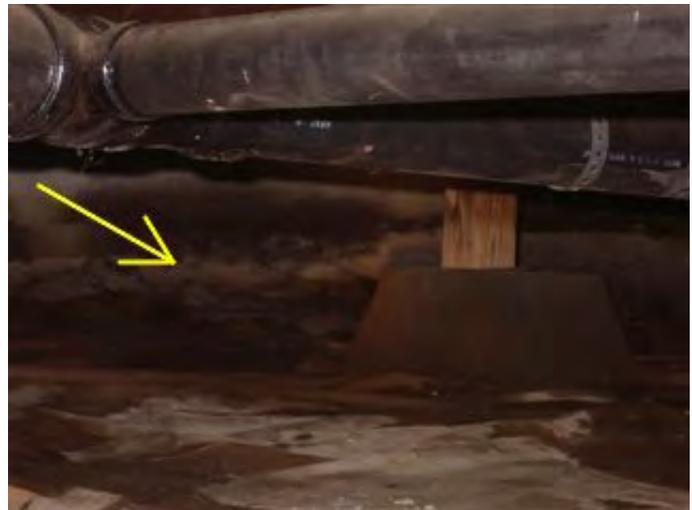
Photo 14-4  
Standing water in NE corner of crawl.

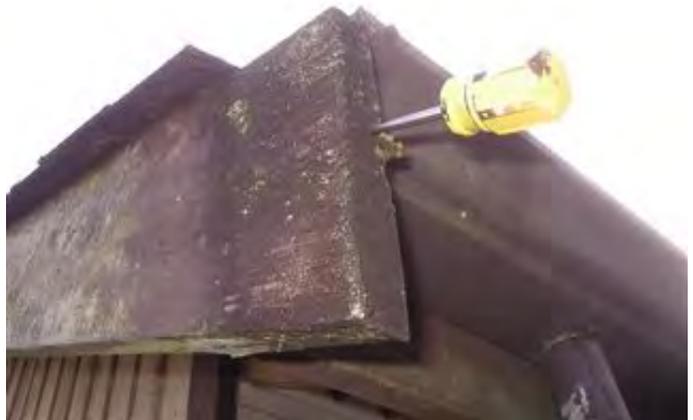
Photo 20-2  
Rot in barge board at NW corner.

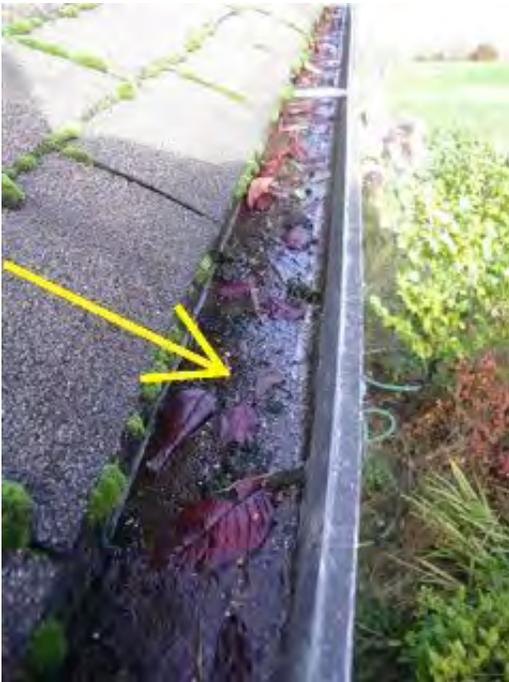
25) 🧰 Significant amounts of debris have accumulated in one or more gutters or downspouts. Gutters can overflow and cause water to come in contact with the building exterior, or water can accumulate around the foundation. This is a conducive condition for wood-destroying organisms. Recommend cleaning gutters and downspouts now and as necessary in the future.

Photo 25-1  
Debris in east gutter.

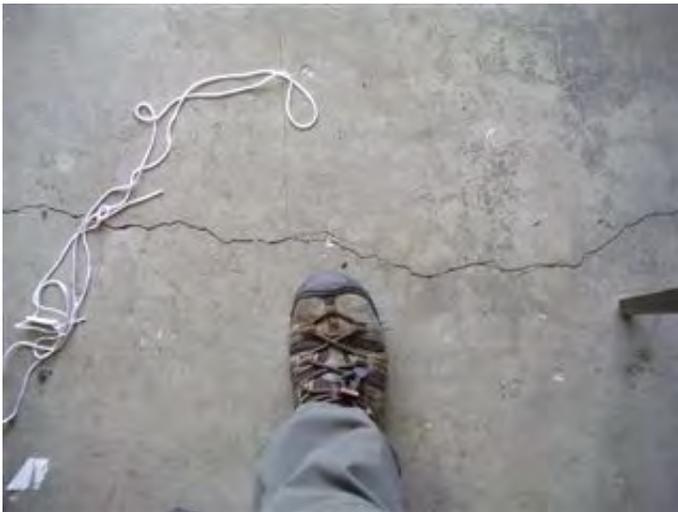
Minor cracks were found in the concrete slab floor. These are common and appeared to be only a cosmetic issue.

Photo 34-1  
Garage floor.

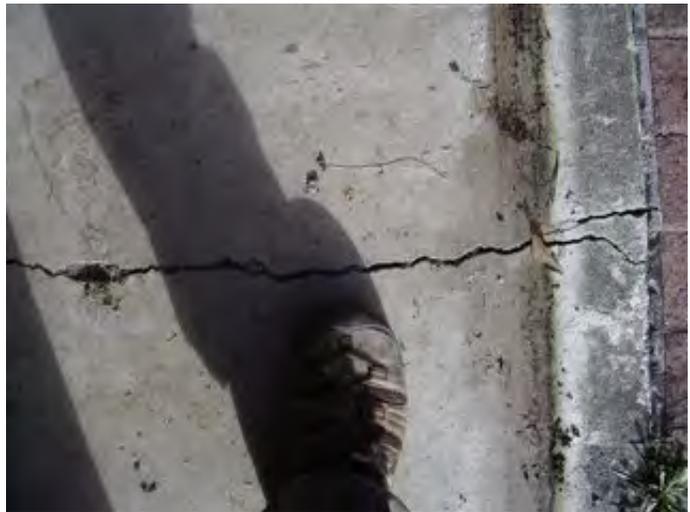
Photo 34-2  
Garage.

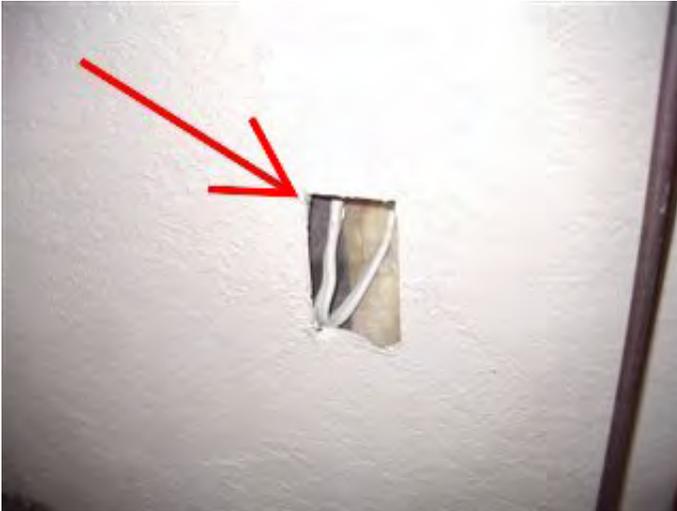
Substandard wiring was found in the living room. For example, exposed wiring not in a junction box. This is a safety hazard. Recommend that a qualified electrician evaluate and repair as necessary and per standard building practices.

Photo 35-1  
Exposed wires not in box by woodstove.

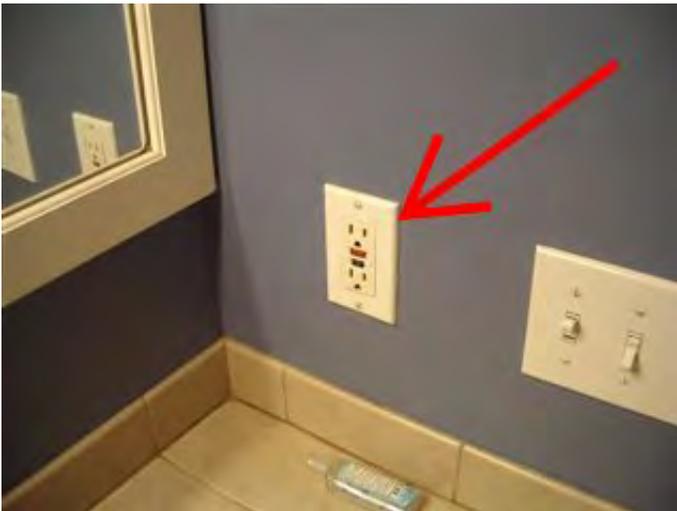
One or more ground fault circuit interrupter (GFCI) receptacles (outlets) wouldn't trip and/or wouldn't trip with a test instrument at the bathroom(s). This is a potential shock hazard. Recommend that a qualified electrician evaluate and repair as necessary.

Photo 36-1  
Bathroom #A GFCI was inoperable.

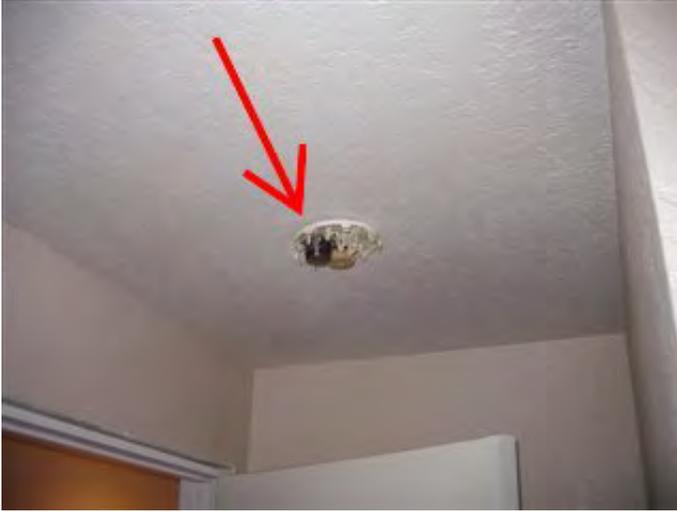
Photo 38-1

One or more smoke alarms were missing, damaged, or missing components. Smoke alarms should be replaced as necessary. For more information, visit:

Missing components in master bedroom smoke alarm.

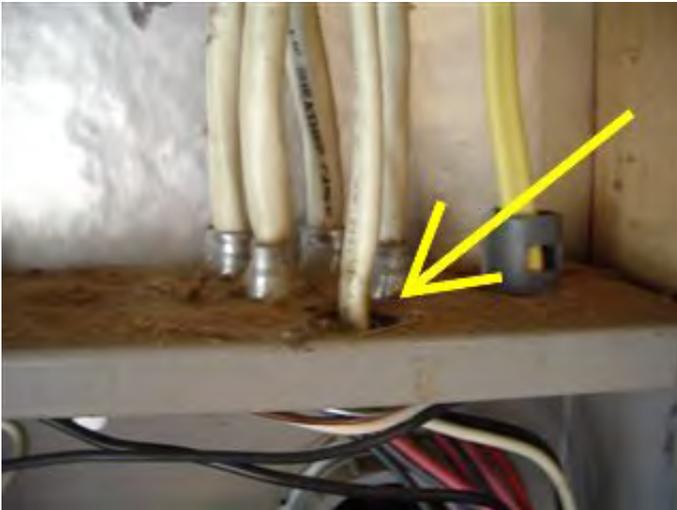
Photo 39-1

One or more bushings were loose from where wires enter holes in panel(s) #A. This is a potential safety hazard because the wiring insulation can be cut or abraded on the metal edge of the hole(s). Recommend that a qualified electrician install bushings where missing.

Loose bushing.

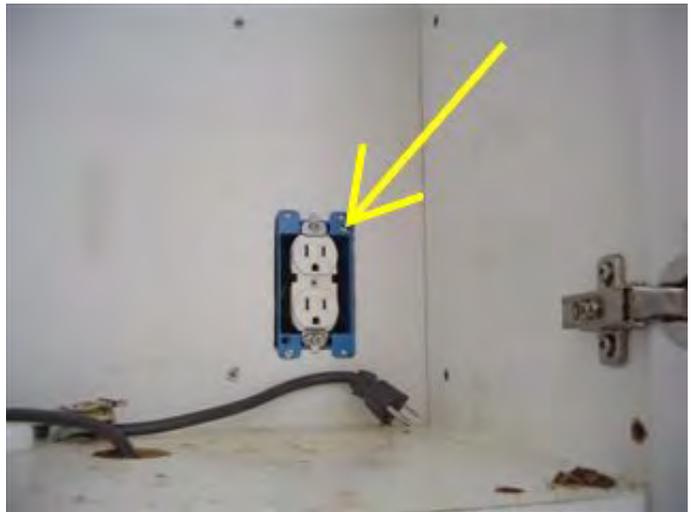
Photo 40-2  
Microwave was unplugged.

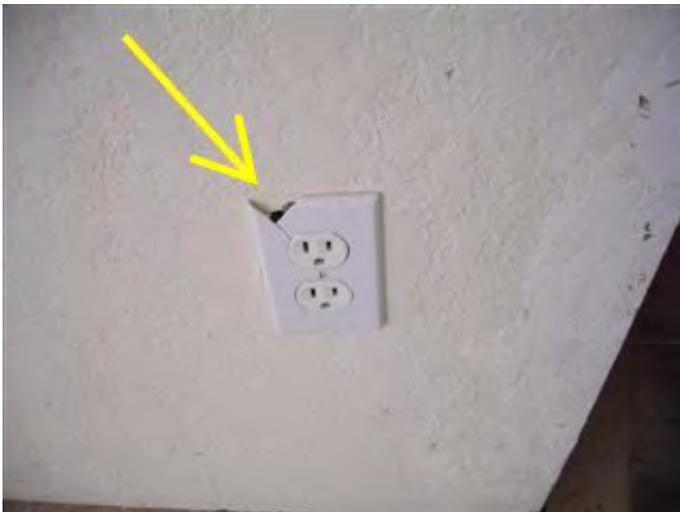
Photo 40-3  
Living room.

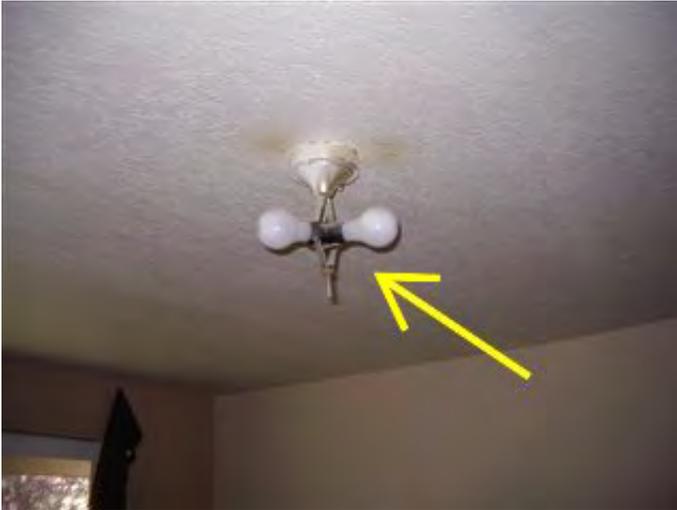
One or more globes or covers for light fixtures were missing or damaged. Recommend replacing as necessary to avoid exposed bulbs. With closet lighting or where flammable stored objects are near light fixtures, missing or broken covers can be a fire hazard.

Photo 43-1  
Missing globe in master bedroom.

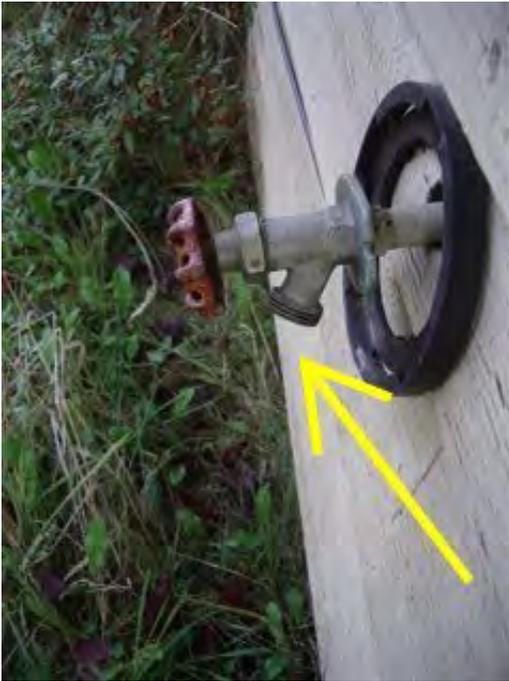
47) 🚰 One or more hose bibs (outside faucets) were missing backflow prevention devices. These devices reduce the likelihood of gray water entering the potable water supply. Recommend installing backflow prevention devices on all hose bibs where missing. They are available at most home improvement stores and are easily installed. For more information, visit:

Photo 47-1  
Missing backflow device on west hose bibb.

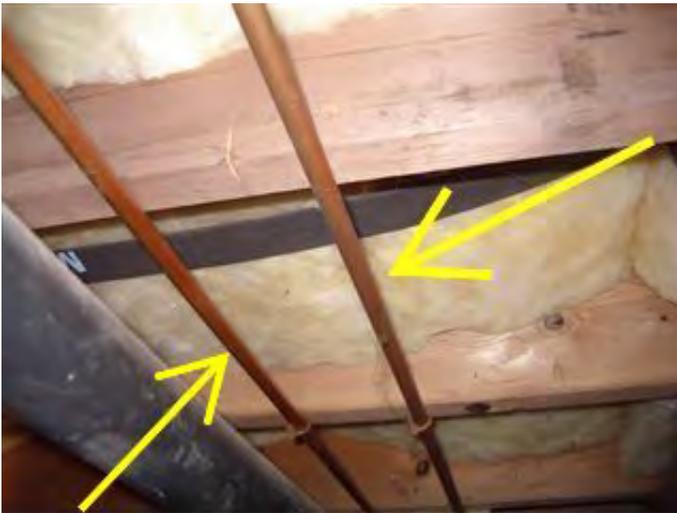
48) 🛠️ Water supply pipes in the crawl space were not insulated. Recommend insulating pipes per standard building practices to prevent them from freezing during cold weather, and for better energy efficiency with hot water supply pipes.

Photo 48-1  
Uninsulated pipes in crawl.

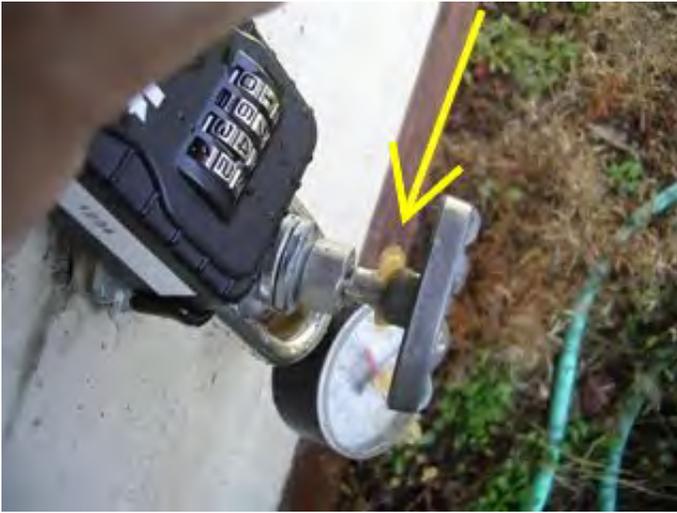
49) 🛠️ One or more hose bibs (outside faucets) leaked when tested. When hose bibs leak while turned off, it's often caused by a worn valve seat or a loose bonnet. When hose bibs leak while turned on, it may be due to worn "packing" around the stem or a defective backflow prevention device. Recommend that a qualified plumber repair as necessary.

Photo 49-1  
Leaking hose bibb on east side.

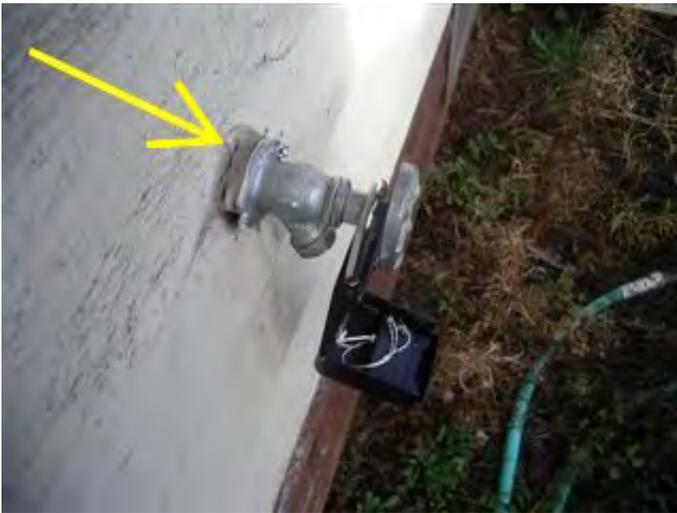
50) 🛠️ One or more hose bibbs (outside faucets) weren't anchored securely to the structure's exterior. Water supply pipes can be stressed when hose bibbs are turned on and off and when hoses are pulled. Leaks may occur as a result. Recommend that a qualified person install fasteners per standard building practices.

Photo 50-1  
Hose bibb on east wall missing fasteners.

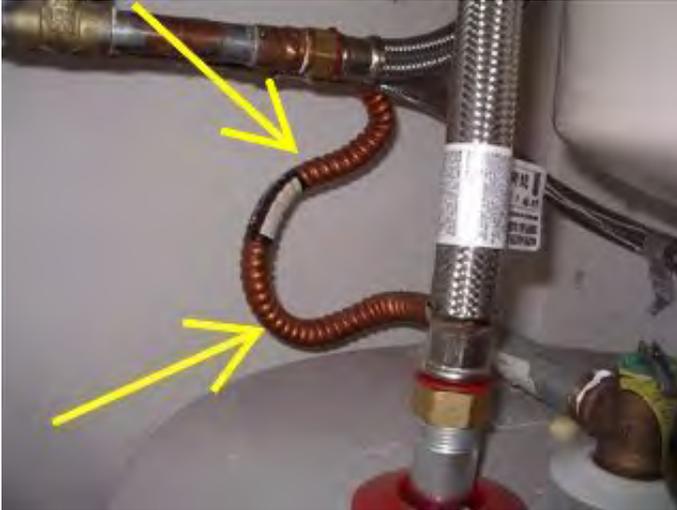
One or more sections of the temperature-pressure relief valve drain line were sloped upwards. This is a potential safety hazard due to the risk of explosion. Water and/or minerals can accumulate in the drain line after periodic discharges and impair the operation of the valve. Also, mineral deposits from accumulated water can accumulate on the valve and impair its operation. A qualified plumber should repair per standard building practices, and so the drain line doesn't slope upwards. For more information, visit: <http://www.reporhost.com/?TPRVALVE>

Photo 52-1  
TPR drainline sloped upwards.

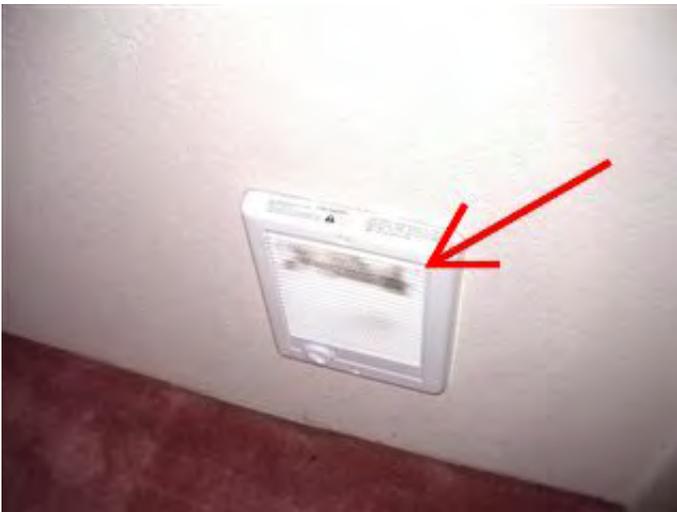
54) 🔑 One or more electric wall heaters had soot or scorch marks on them. For example, in the NE bedroom. Typically, this is caused by dirt or lint build-up near the heating element. Excessive build-up of dirt or lint is a potential fire hazard. Recommend that a qualified person clean heaters as necessary. Note that the power to heaters must be turned off at the electric panel before cleaning them.

Photo 54-1  
Scorch marks on NE bedroom heater.

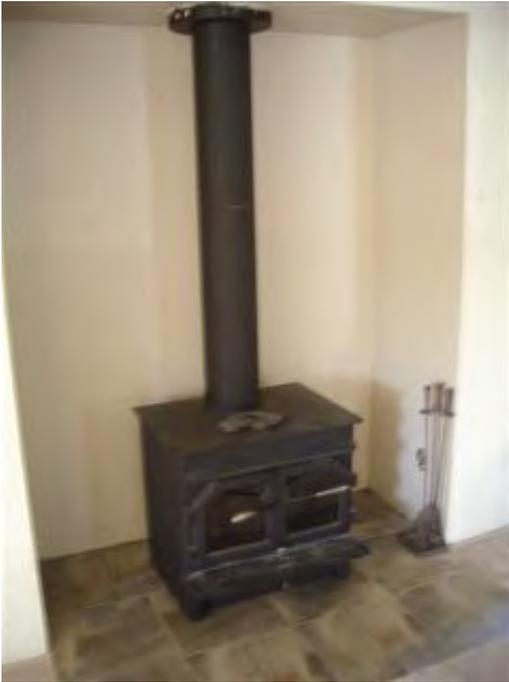
Photo 55-1

One or more wood-burning fireplaces or stoves were found at the property. When such devices are used, they should be professionally inspected and cleaned annually to prevent creosote build-up and to determine if repairs are needed. The National Fire Protection Association states that a "Level 2" chimney inspection should be performed with every sale or transfer of property with a wood-burning device. Recommend consulting with the property owner about recent and past servicing and repairs to all wood-burning devices and chimneys or flues at this property. Recommend that a qualified specialist evaluate all wood-burning devices and chimneys, and clean and repair as necessary. Note that if a wood stove insert is installed, it may need to be removed for such an evaluation. For more information, search for "chimney inspection" at: <http://www.reporthost.com/?CSIA>

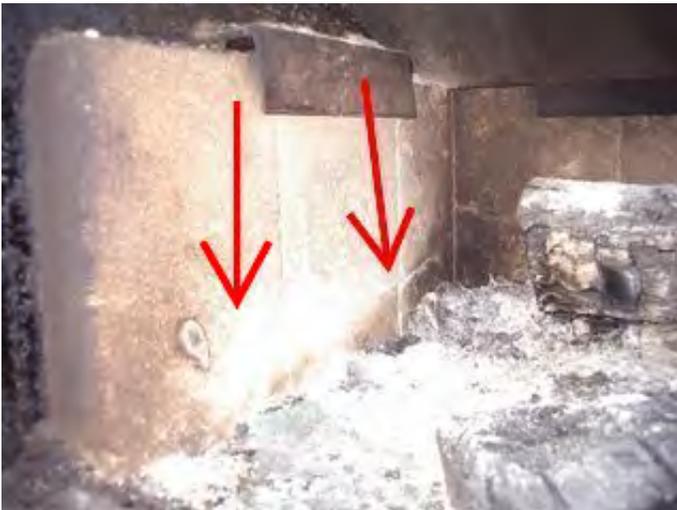
Firebricks lining the wood stove were cracked, broken or missing. Recommend that a qualified person replace firebricks as necessary.

Photo 56-1  
Cracked fire bricks in wood stove.

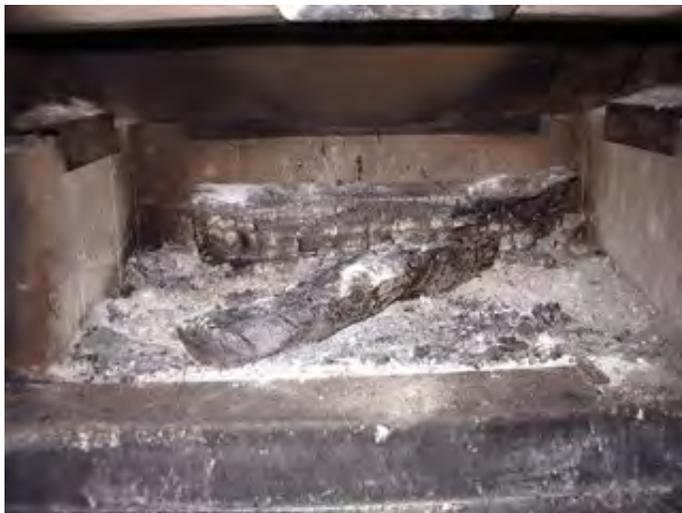
Significant amounts of ash or fire materials were present in one or more fireplace or wood stove fireboxes. As a result, the inspector was unable to fully view or evaluate the firebox(es) and/or components inside (e.g. firebrick, metal liner, log lighter). These components are excluded from this inspection.

Photo 57-1  
Fire materials in wood stove.

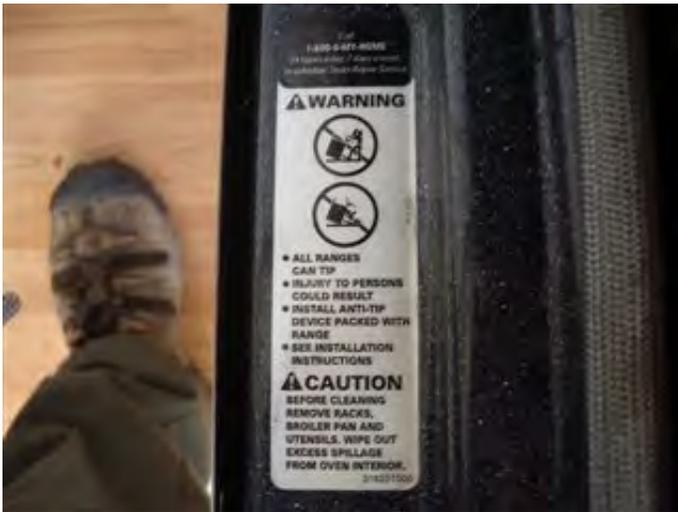
Photo 58-1  
Tip warning on range.

Recommend installing an anti-tip bracket to eliminate this safety hazard. For more information, visit:

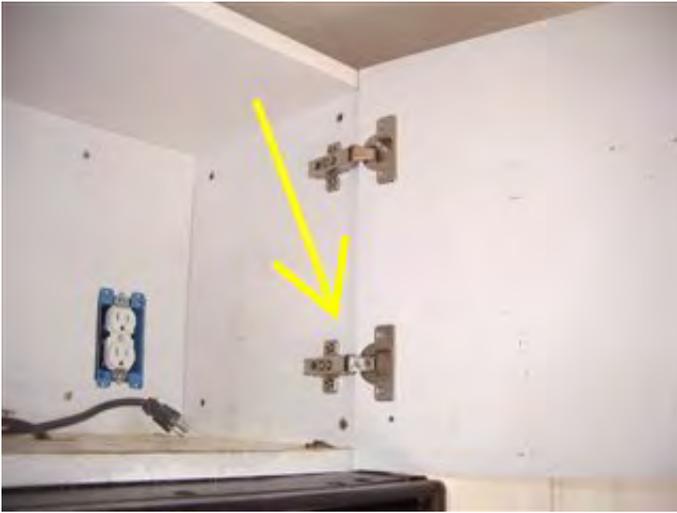
61) 🔧 Cabinet hardware such as hinges, latches, closers, magnets or pulls were loose, missing or damaged at one or more cabinet drawers, doors or turntables. Recommend that a qualified person repair as necessary.

Photo 61-1  
Loose hardware on cabinet door over microwave.

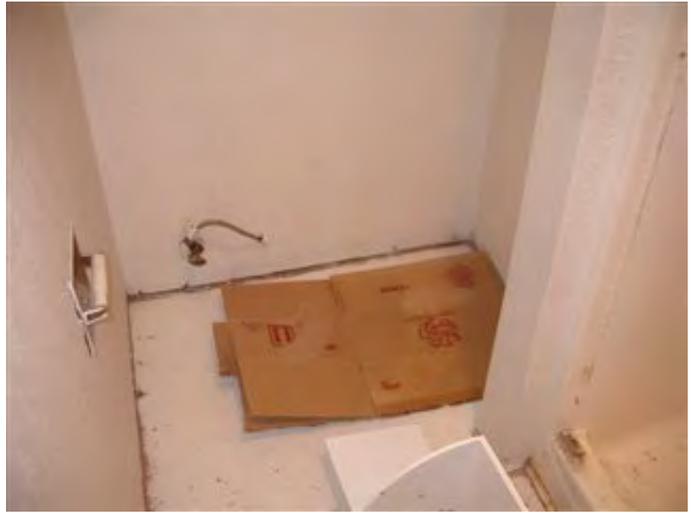
Bathroom #B was incomplete and missing fixtures including sink, toilet, shower fixtures, flooring, wall finish, etc.

Photo 64-2  
Bathroom #B was incomplete.

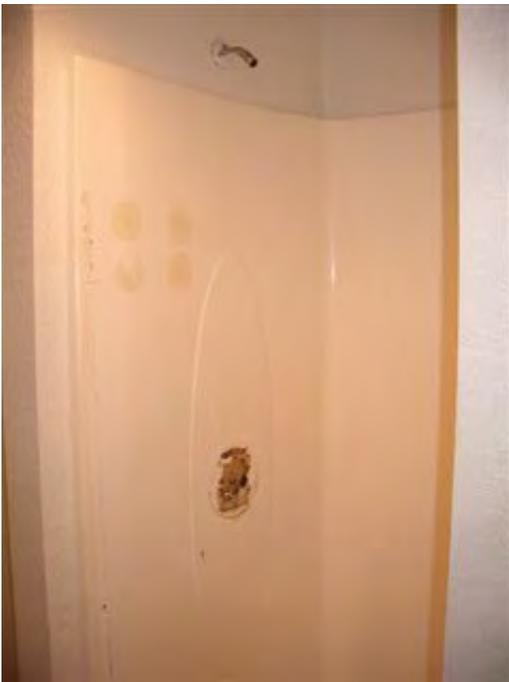
Photo 64-3  
Bathroom #B was incomplete.

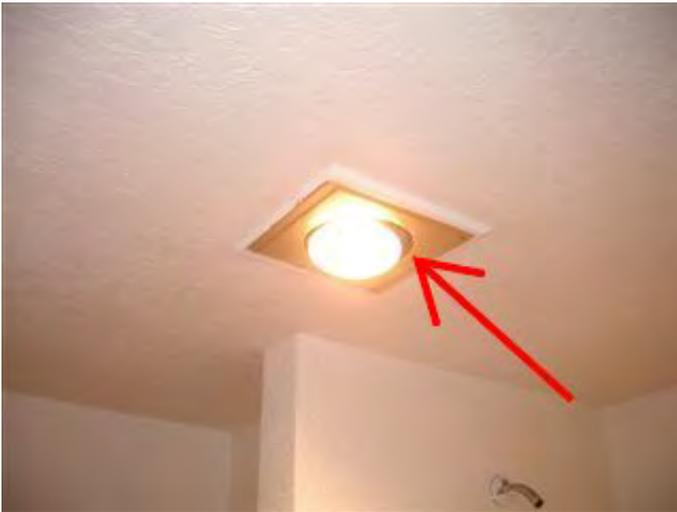
The exhaust fan at location(s) #B was inoperable. Moisture may accumulate and result in mold, bacteria or fungal growth. Recommend that a qualified person clean, repair or replace fans as necessary.

Photo 66-1  
Fan in master bathroom was inoperable.

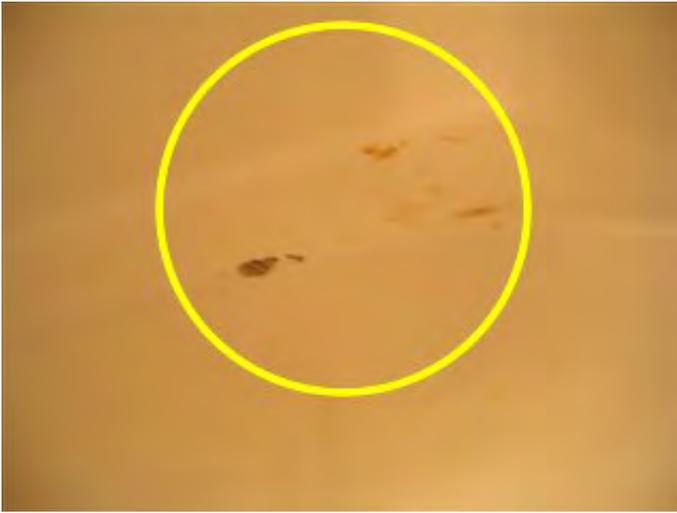
The bathtub at location(s) #A was worn, blemished or deteriorated.

Photo 68-1  
Blemishes in shower #A.

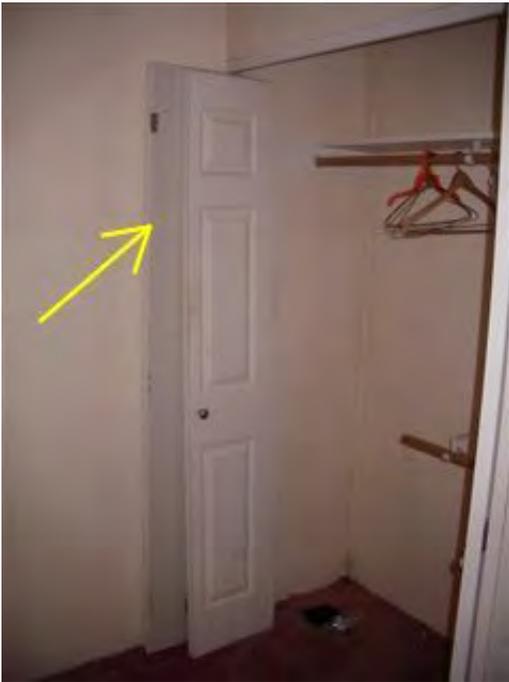
One or more interior doors were damaged. Recommend that a qualified person replace or repair doors as necessary.

Photo 70-1  
NE bedroom closet doors were damaged.

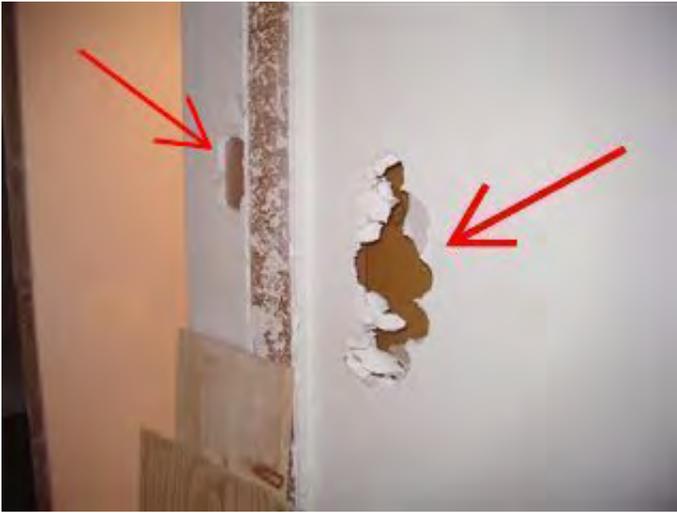
One or more walls were damaged. Recommend that a qualified person repair as necessary.

Photo 71-1  
Damaged drywall in master bathroom.

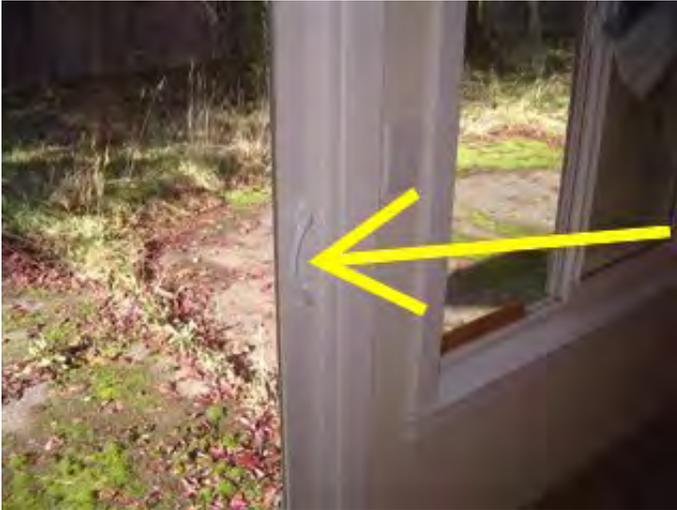
The lock mechanisms on one or more sliding glass doors were inoperable. Recommend that a qualified person repair as necessary.

Photo 72-1  
Locking mechanism on rear patio door was inoperable.

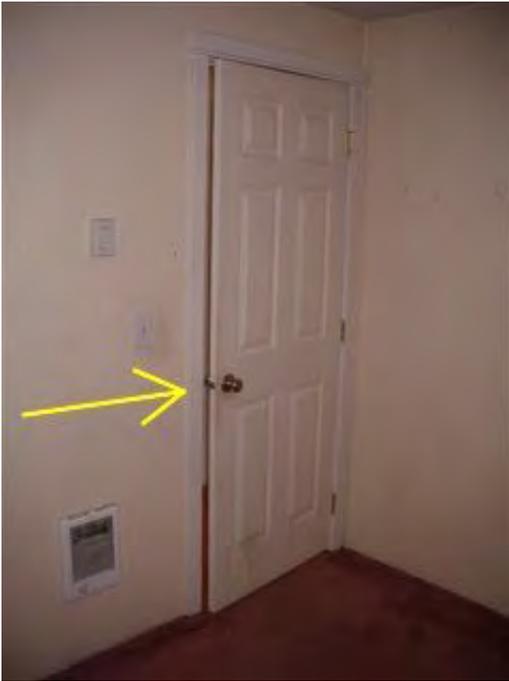
One or more interior doors wouldn't latch or were difficult to latch. Recommend that a qualified person repair as necessary. For example, by adjusting latch plates or locksets.

Photo 73-1  
NE bedroom door would not latch.

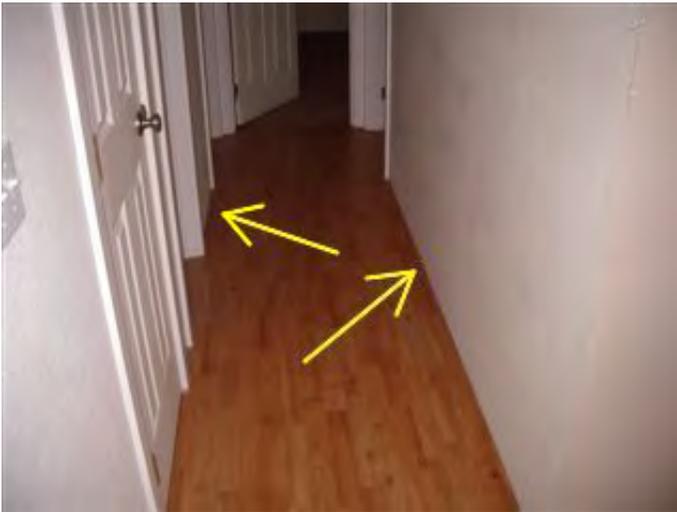
Trim was missing in one or more areas. For example, base in the main hall. Recommend that a qualified person repair as necessary.

Photo 74-1  
Missing base in hallway.

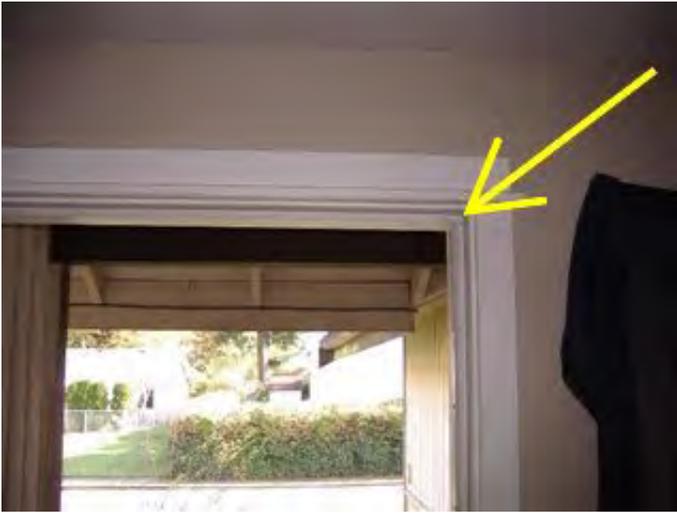
Weatherstripping around one or more exterior doors was missing. Water may enter the building, or energy efficiency may be reduced. Recommend that a qualified person repair or replace weatherstripping as necessary.

Photo 75-1  
Missing weather stripping around entry door.

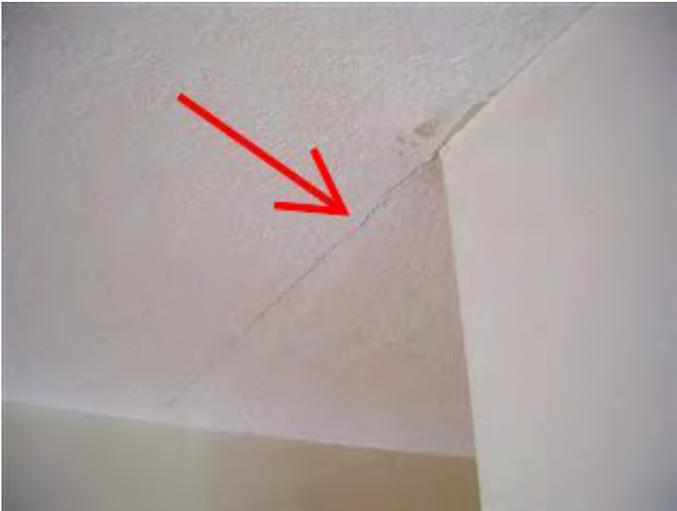
76) 🛠️ Minor cracks, nail pops and/or blemishes were found in walls and/or ceilings in one or more areas. Cracks and nail pops are common, are often caused by lumber shrinkage or minor settlement, and can be more or less noticeable depending on changes in humidity. They did not appear to be a structural concern, but the client may wish to repair these for aesthetic reasons. For recurring cracks, consider using an elastic crack covering product:

Photo 76-1  
Hallway ceiling.

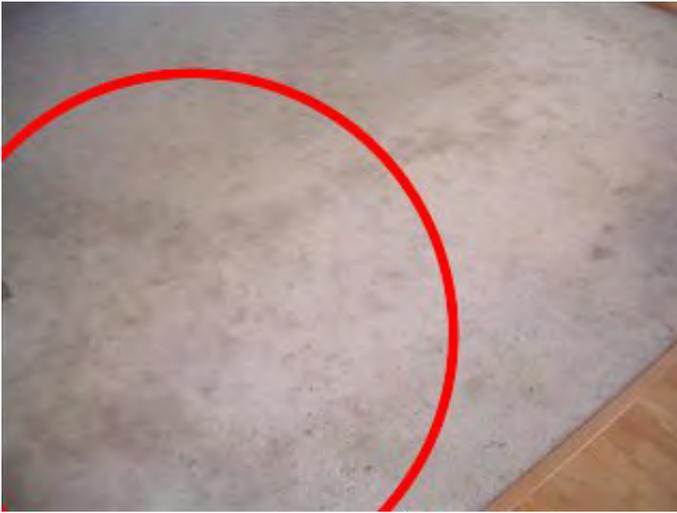
77) 🧹 Carpeting in one or more areas was significantly stained or soiled. Recommend having carpeting professionally cleaned as necessary.

Photo 77-1  
Staining on carpet in living room.
